**Phase 1 Final Design Deliverable**  
**Camp Bird Removal Action**

**Site Name:** Camp Bird Mine

**Prepared by:** Mike Thompson, Project Coordinator, Caldera Mineral Resources, LLC

CAMP BIRD MINE RECLAMATION  
OURAY COUNTY, COLORADO

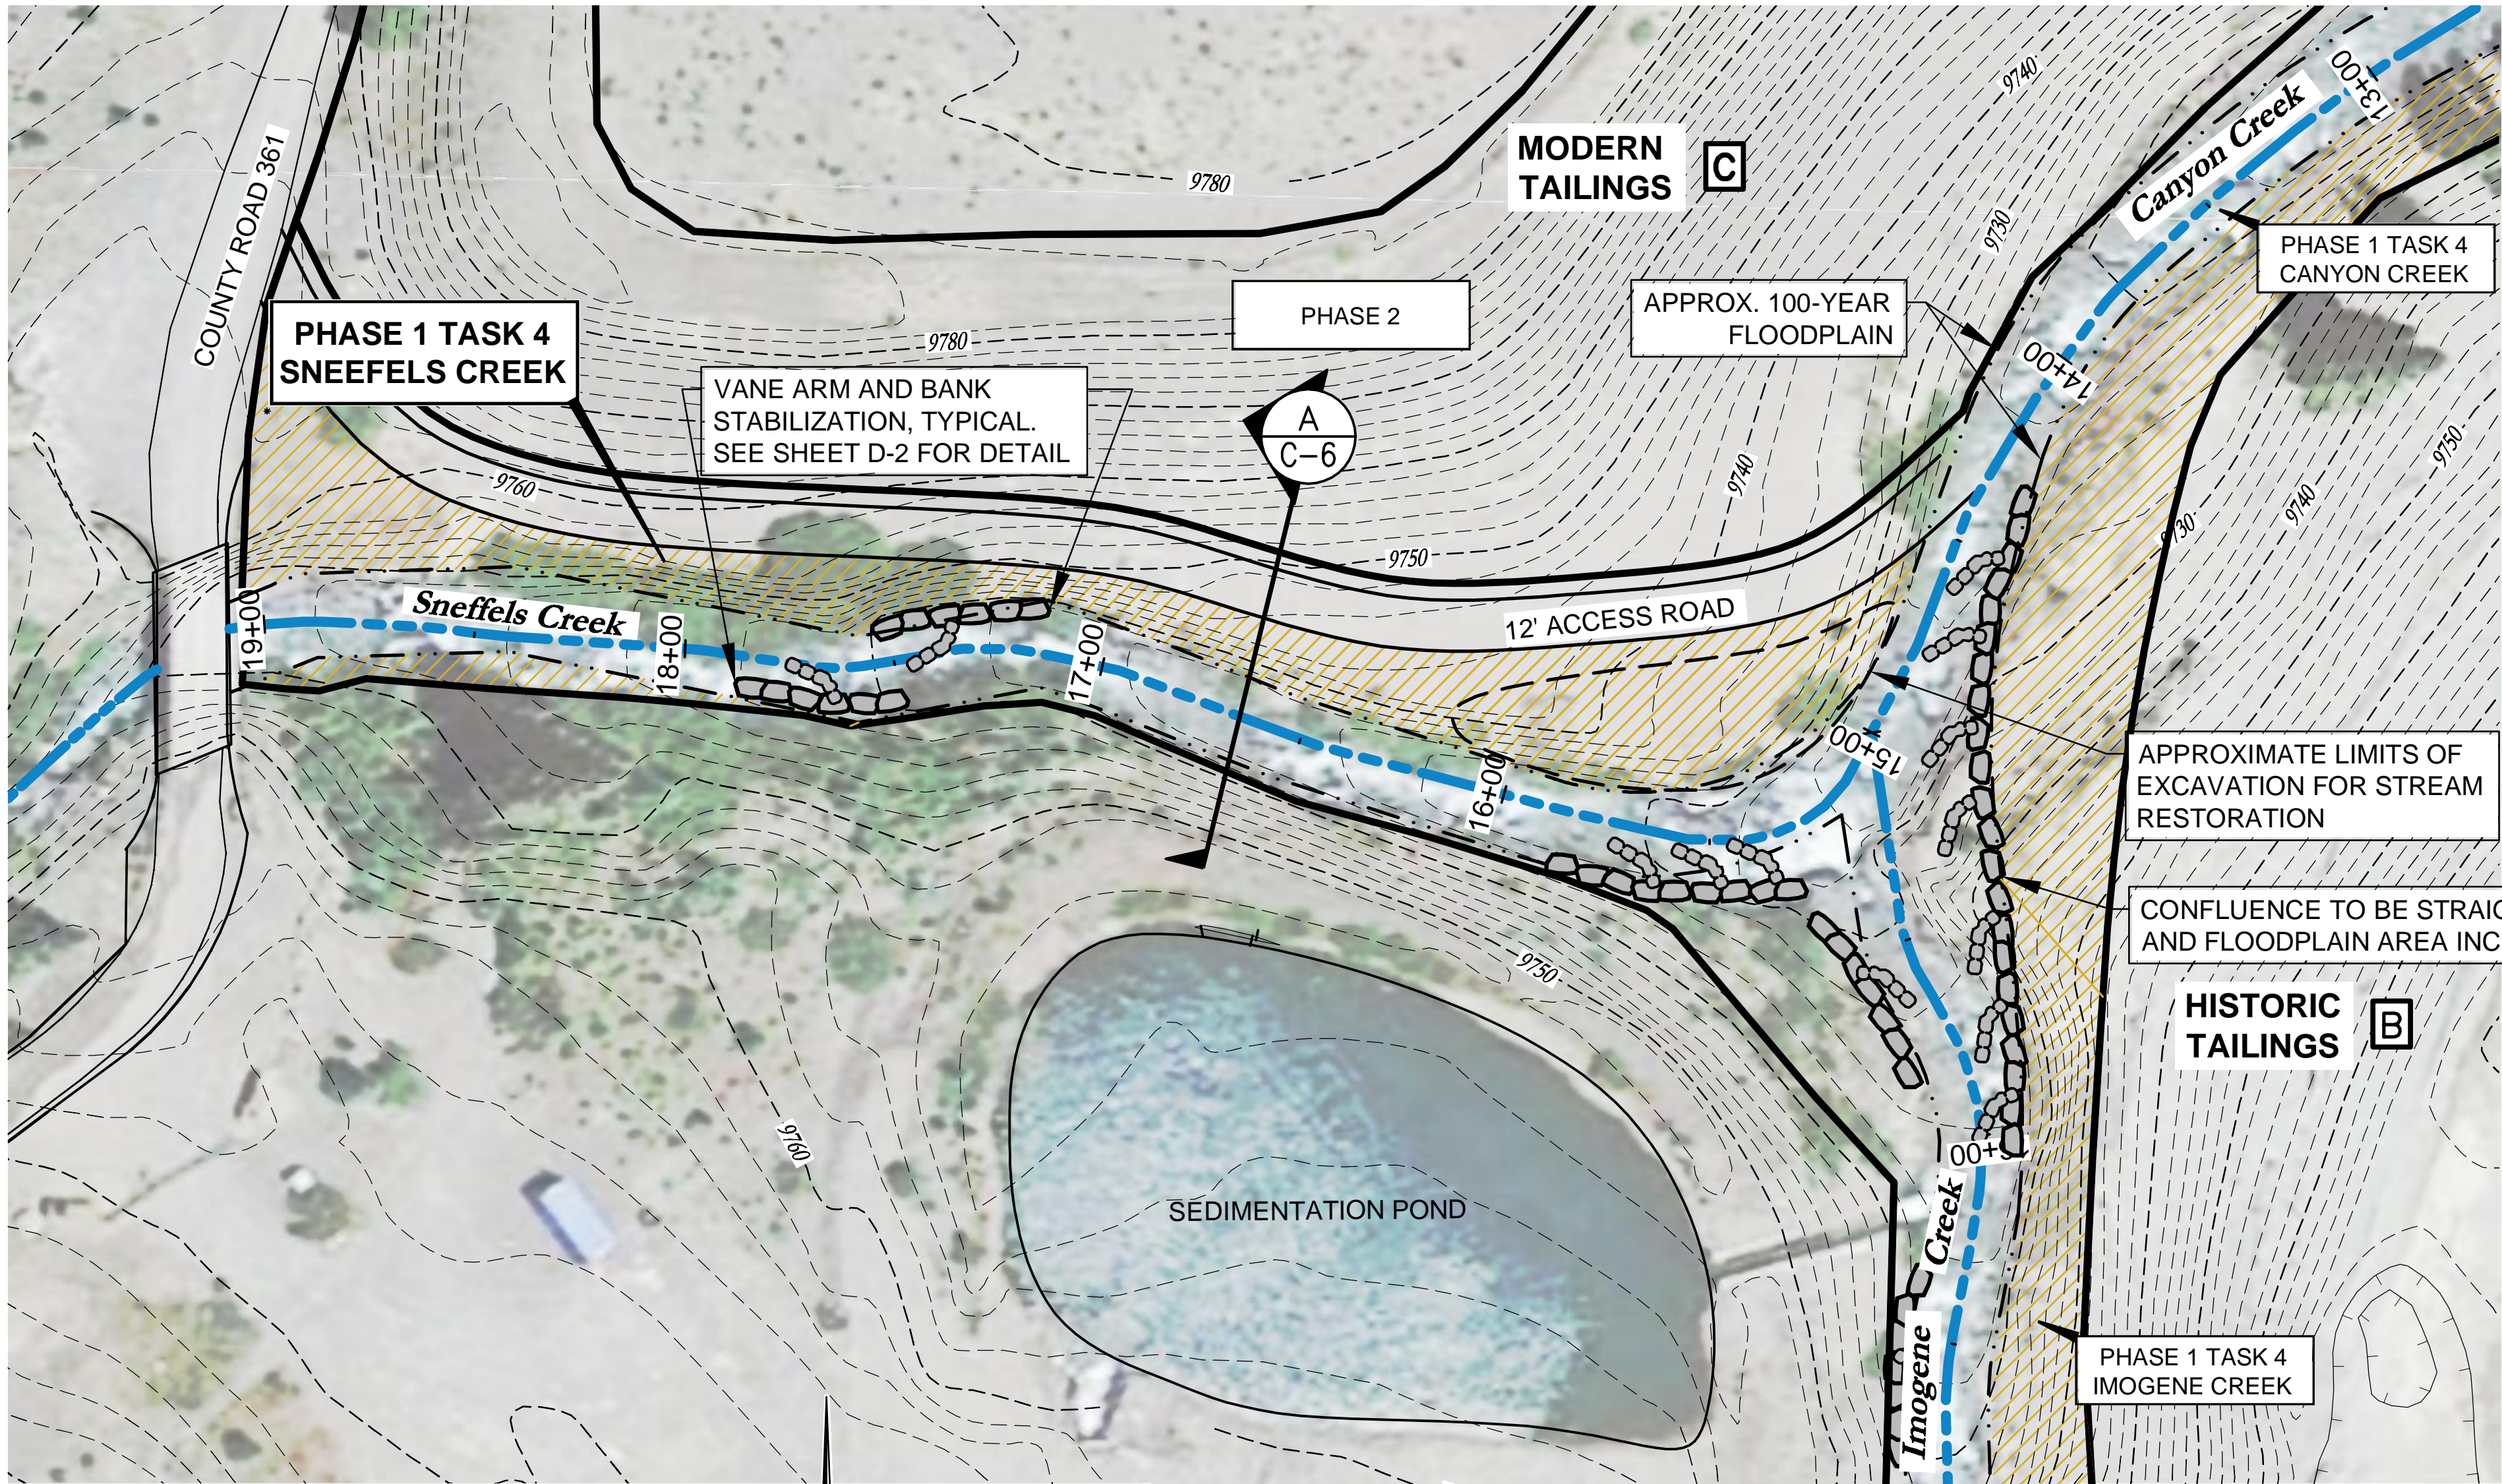
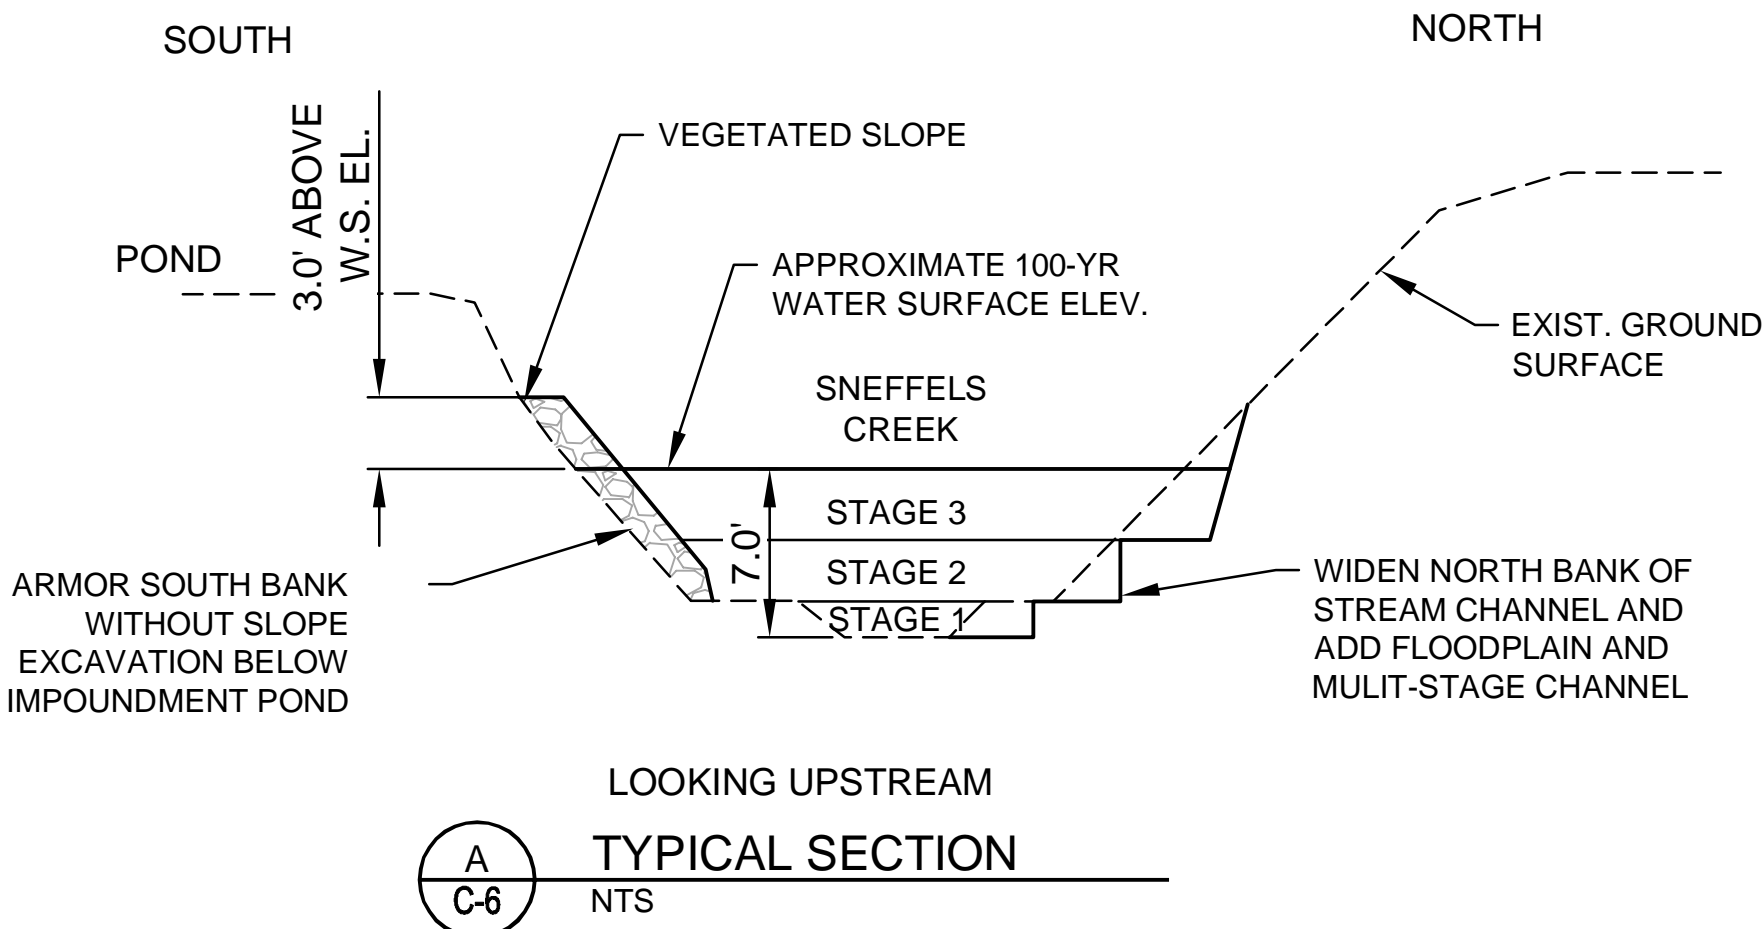
PHASE 1 TASK 4, SNEFFELS CREEK  
RECLAMATION PLAN

PHASE 1 TASK 4  
SNEFFELS CREEK WORK PLAN (2018)

1. Develop access road for construction/vegetation equipment access to Phase 1 Task 4 Area.
2. Excavate north bank of Sneffels Creek and Imogene Creek confluence as shown. Should slurry ("slime") be encountered, cease work and contact DOWL for guidance to stabilize slope per accepted site methods (see Sheet D-1).
3. Install stream restoration features, which includes reshaping Sneffels Creek, installing boulder vane arms and scour pools and adding multi-stage floodplain. Actual locations and dimensions will be decided in the field.
4. Revegetate using approved seed mix and Erosion Control Measures (ECM's) (See Sheet D-3).
5. Vane arm location, extent and quantities are approximate. Location will be determined in the field.

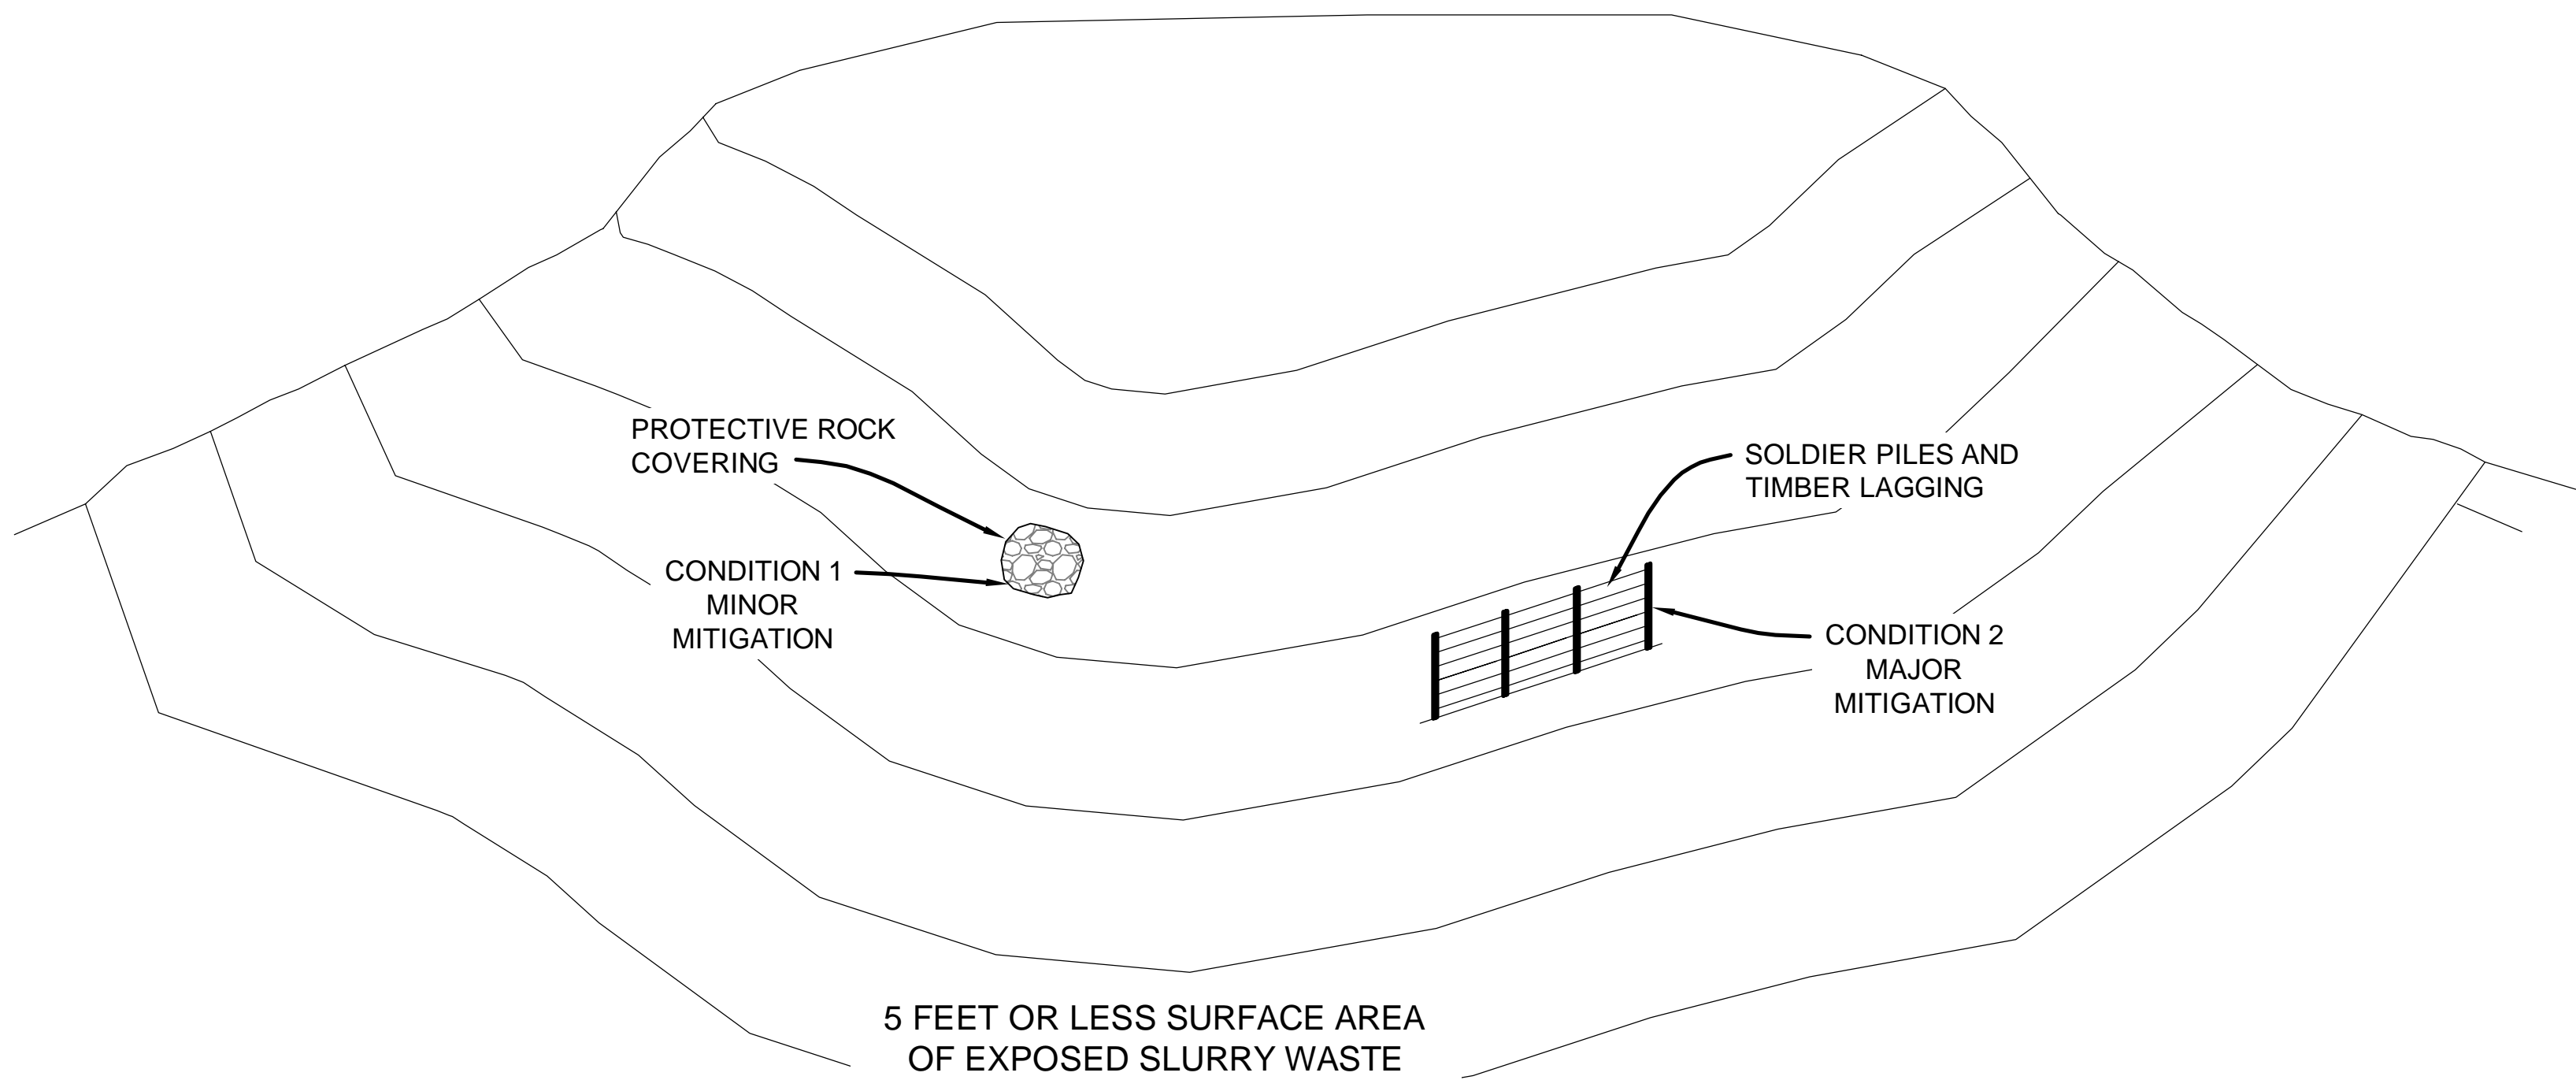
1  
D-1  
NTS  
SCHEMATIC SECTION  
CONDITION 1 MINOR MITIGATION

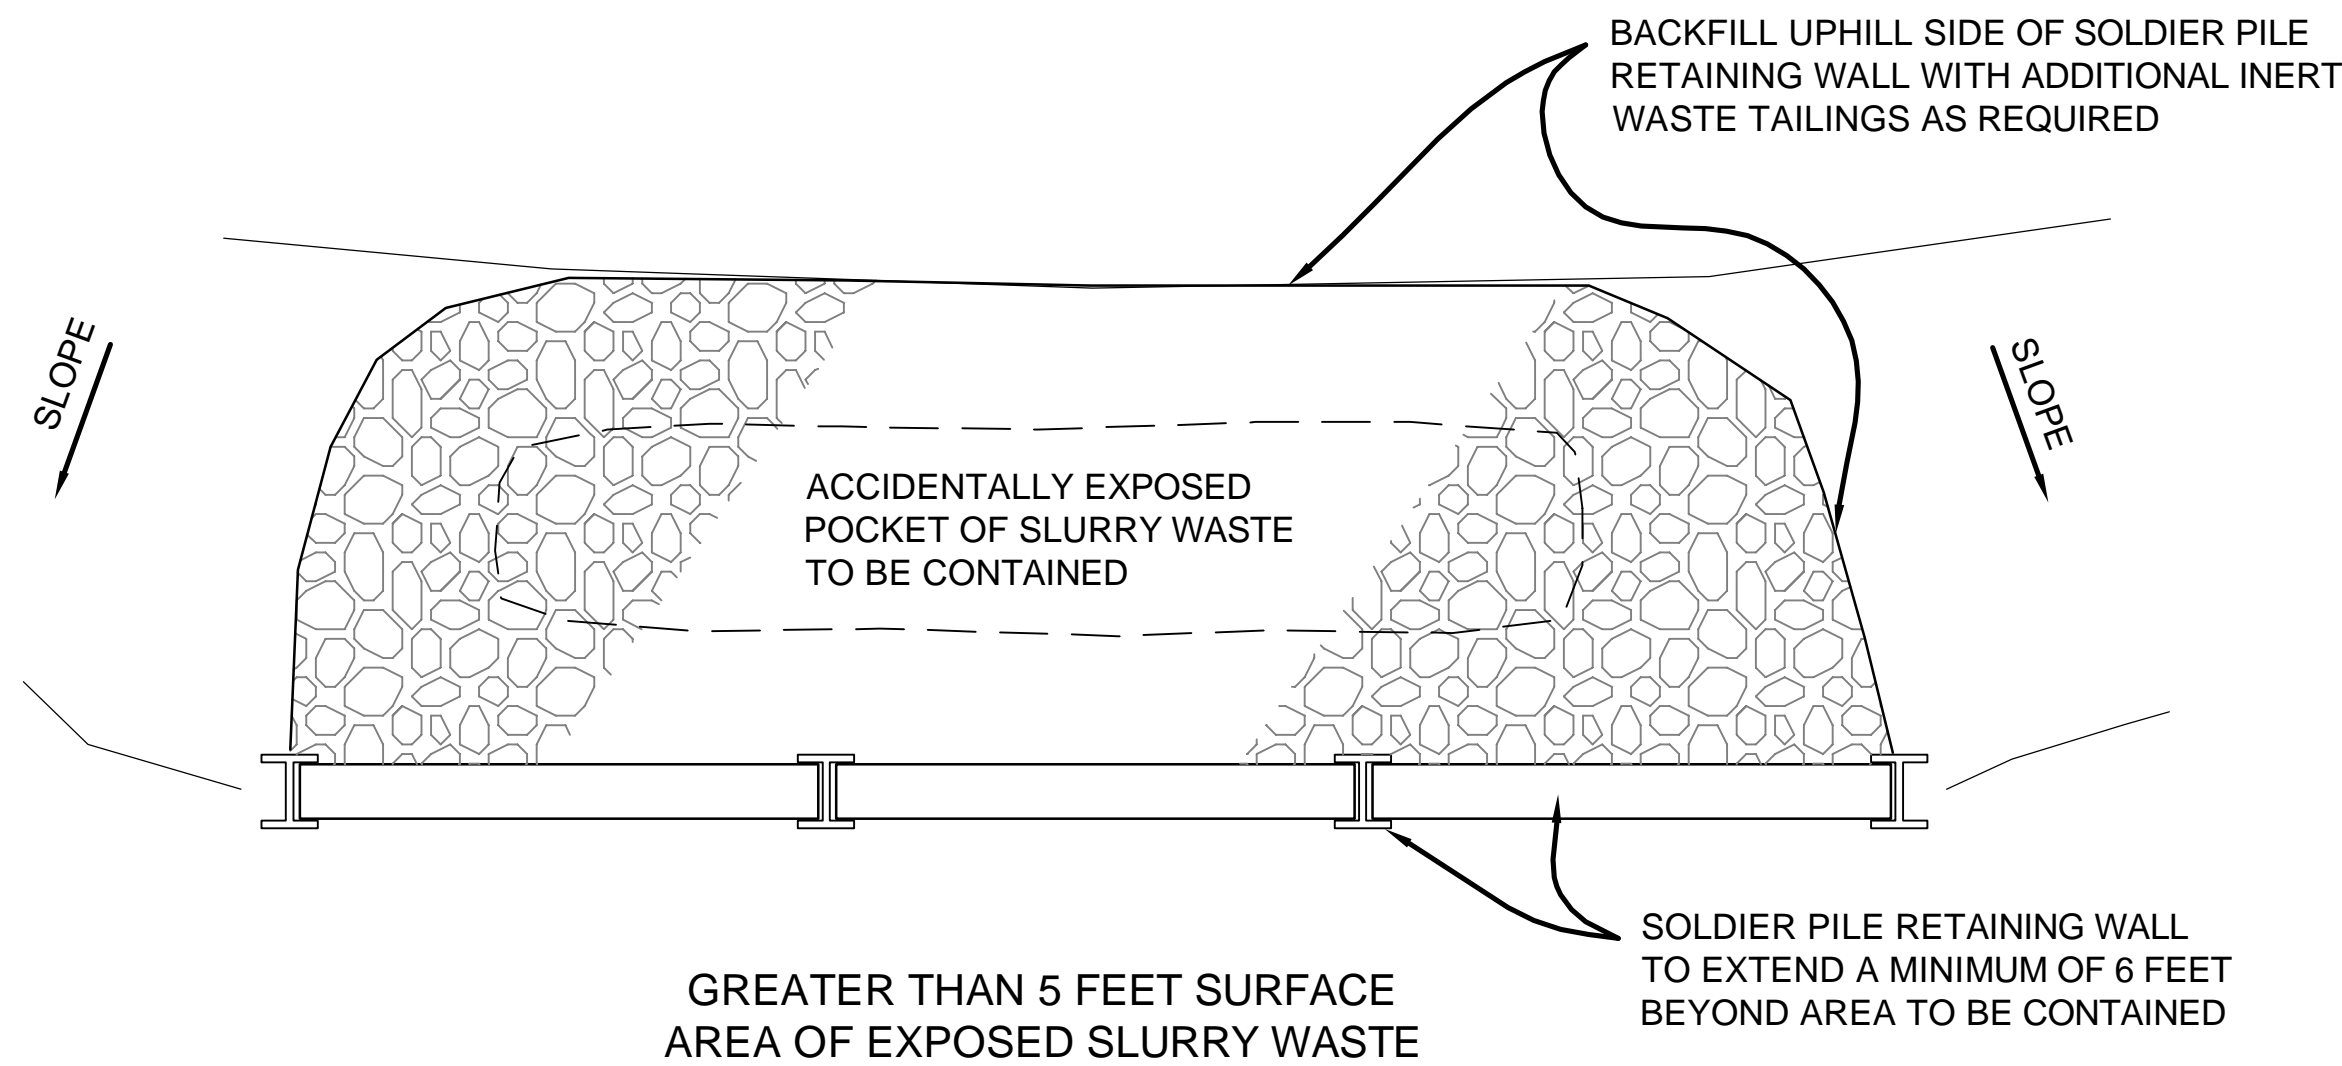
2  
D-1  
NTS  
SCHEMATIC PLAN VIEW  
CONDITION 2 MAJOR MITIGATION

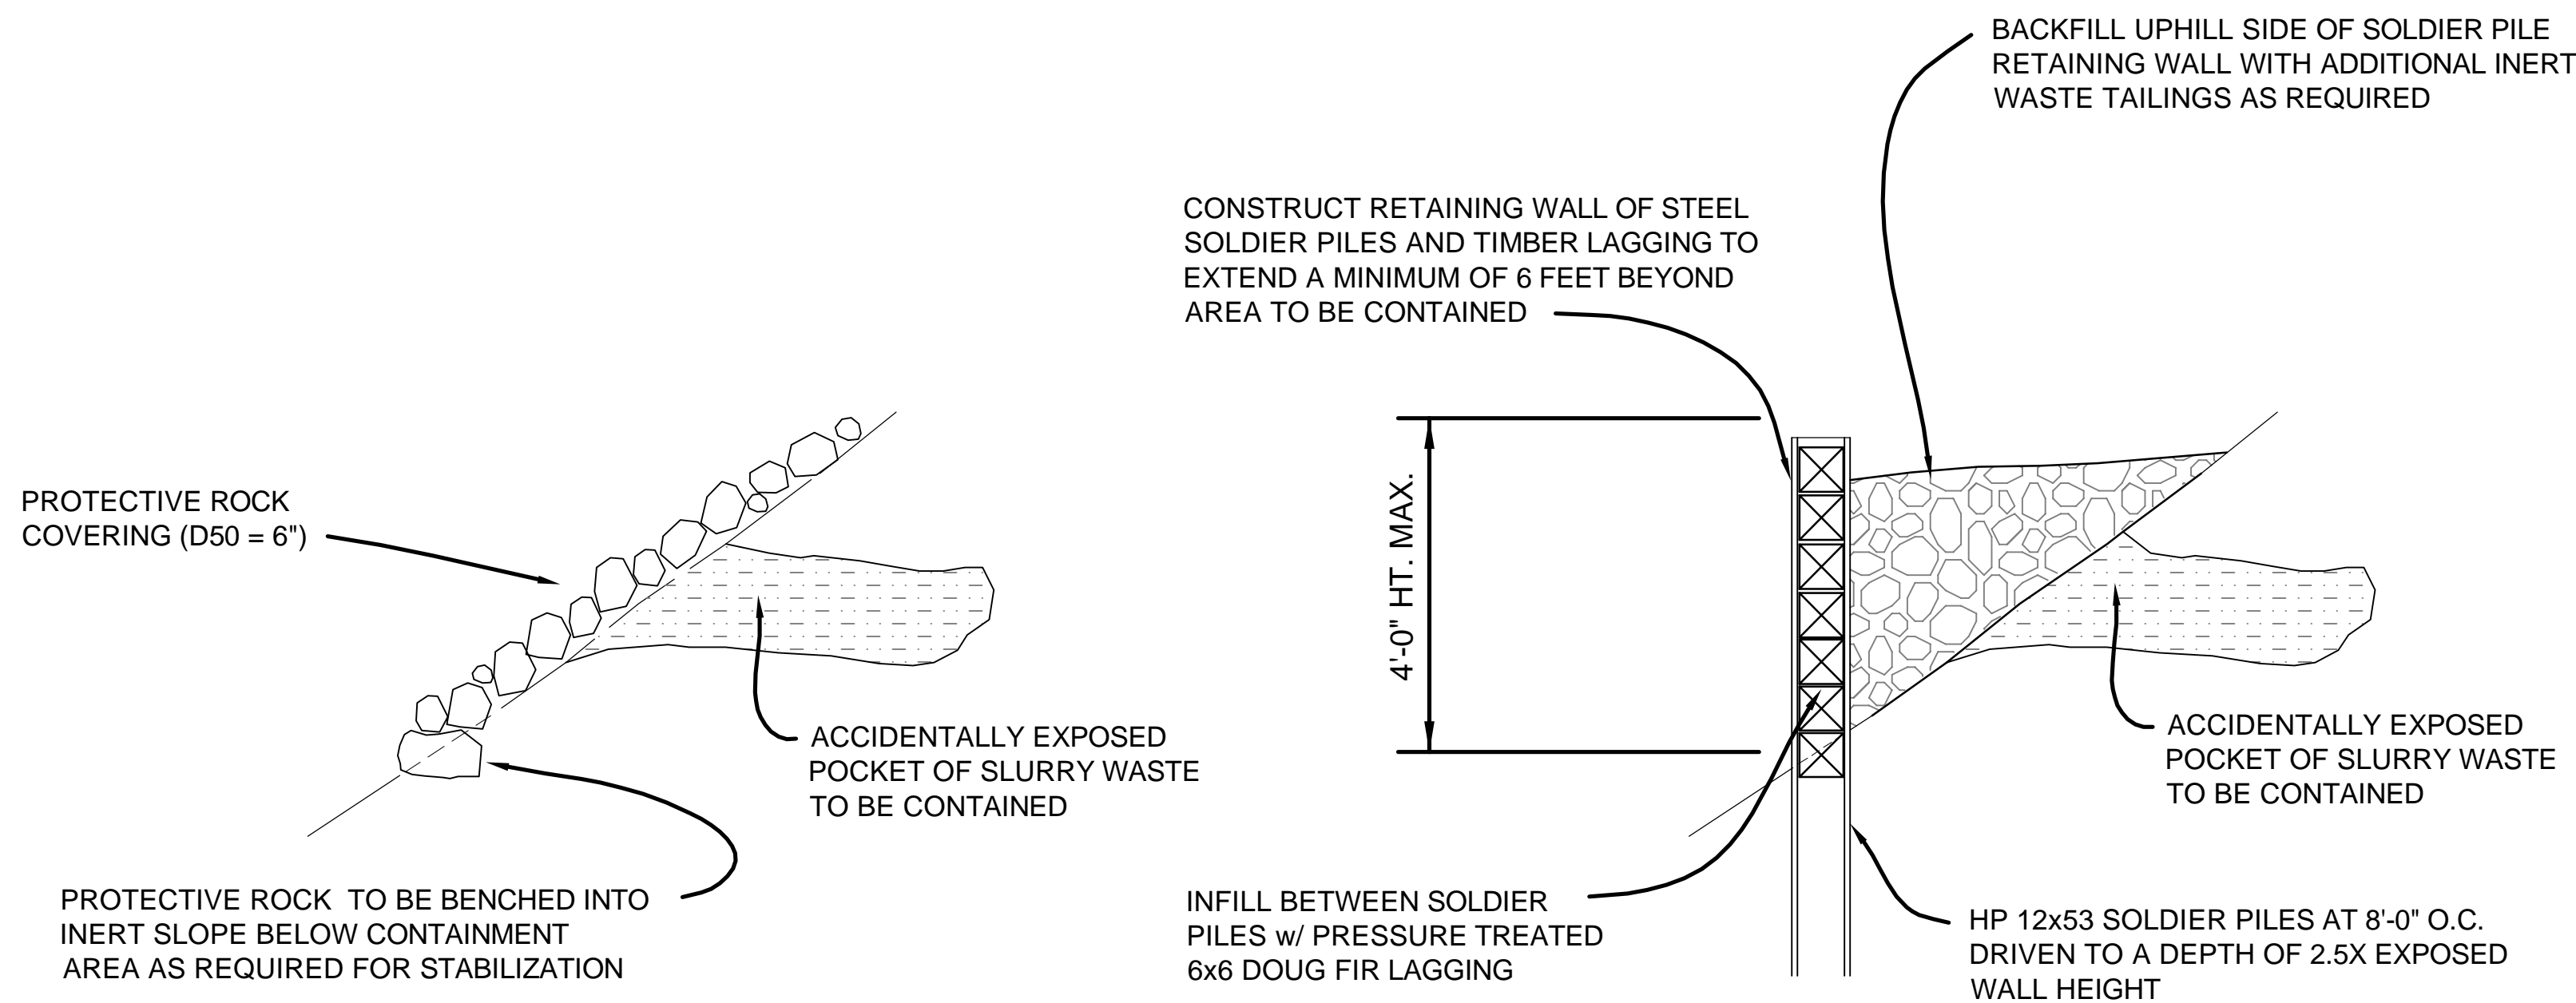
4  
D-1  
NTS  
SCHEMATIC SECTION  
CONDITION 2 MAJOR MITIGATION

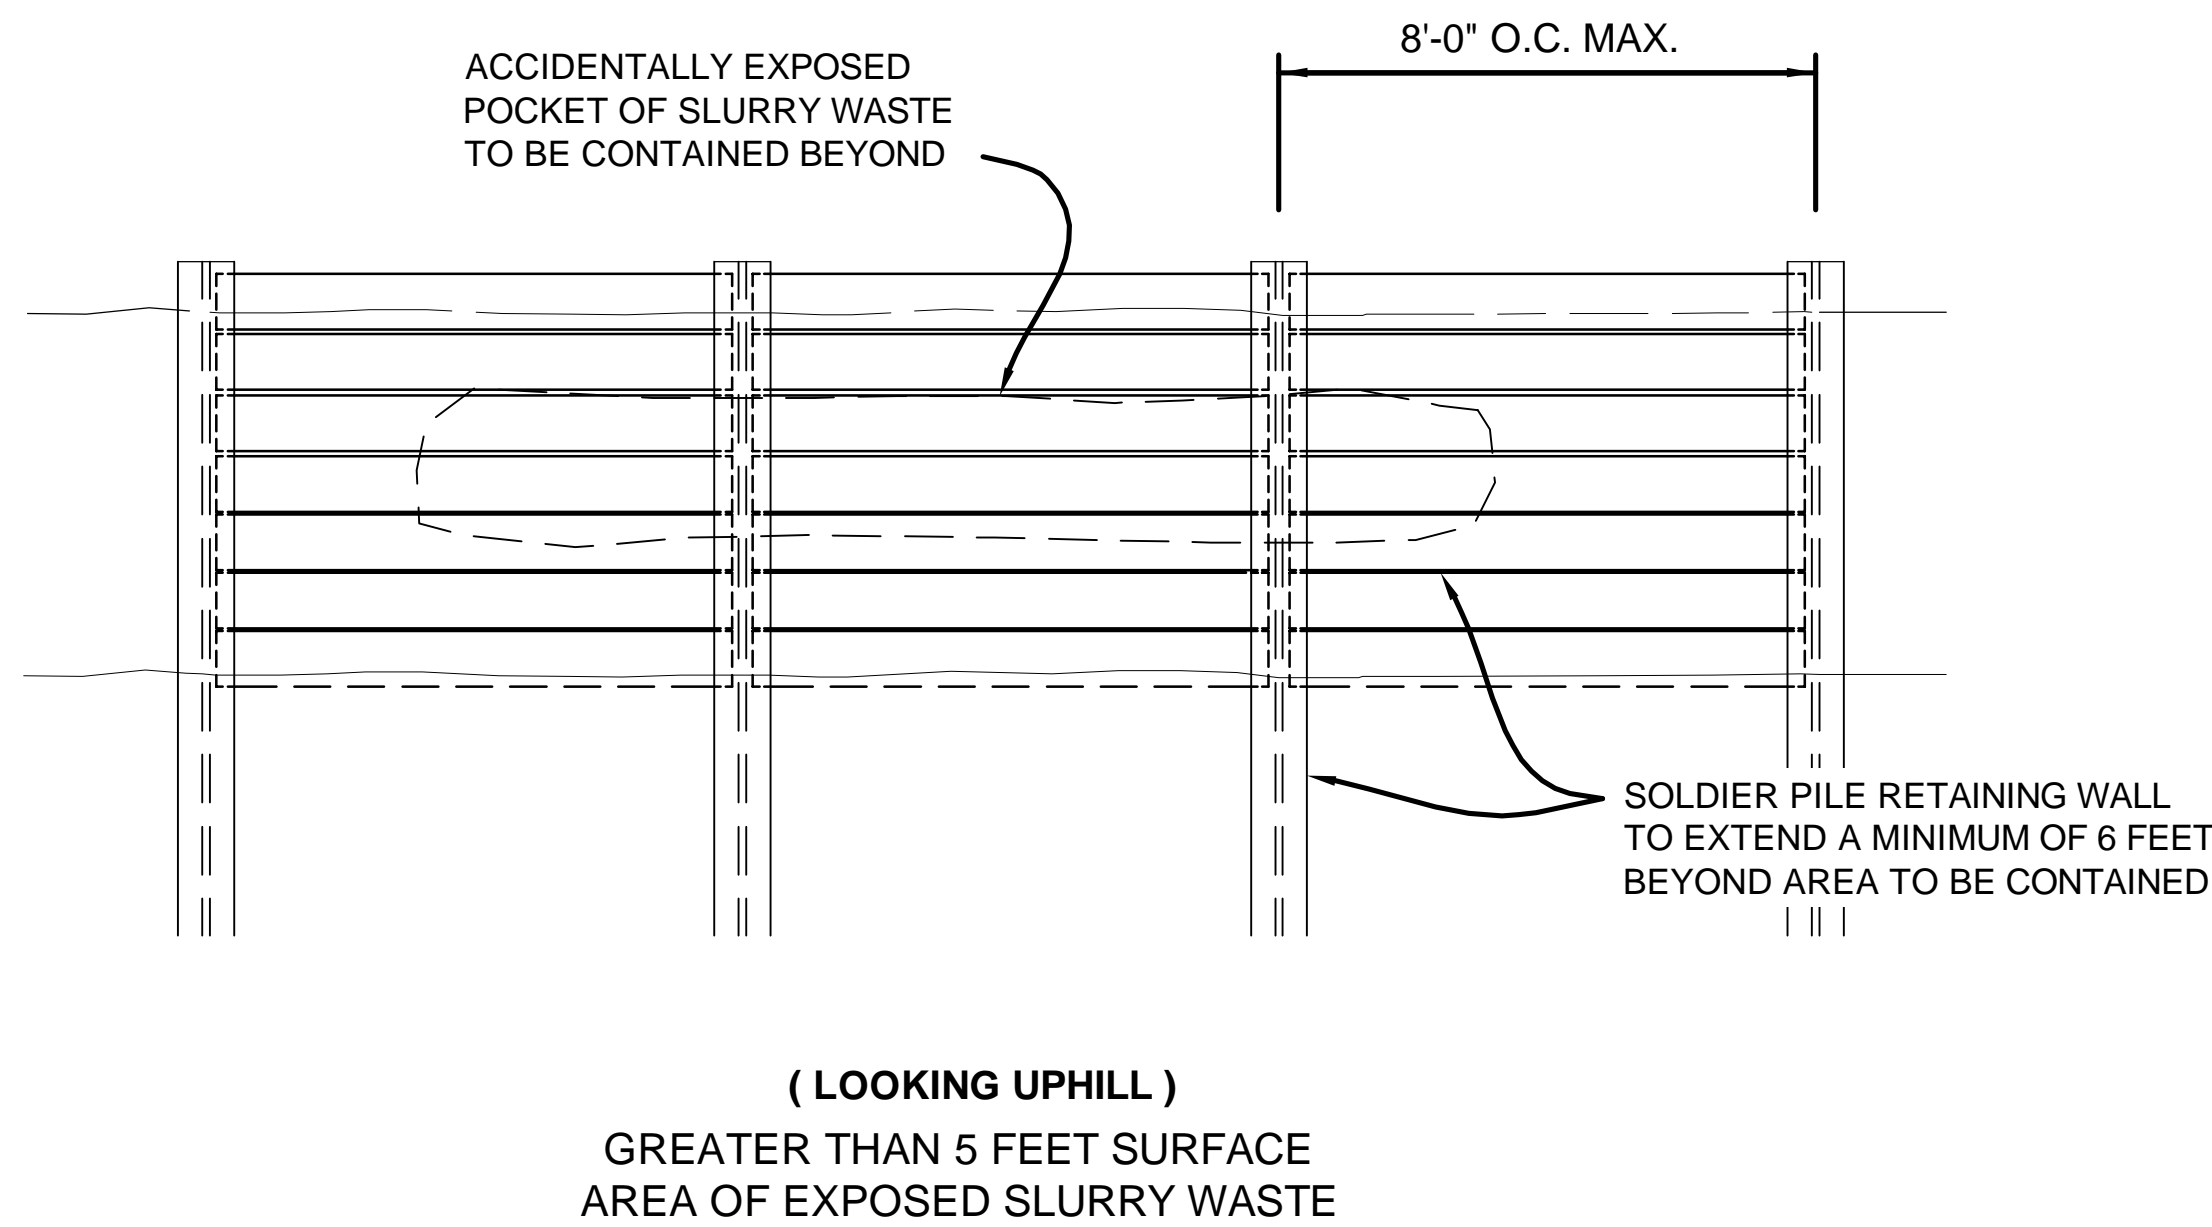
5  
D-1  
NTS  
SCHEMATIC ELEVATION  
CONDITION 2 MAJOR MITIGATION

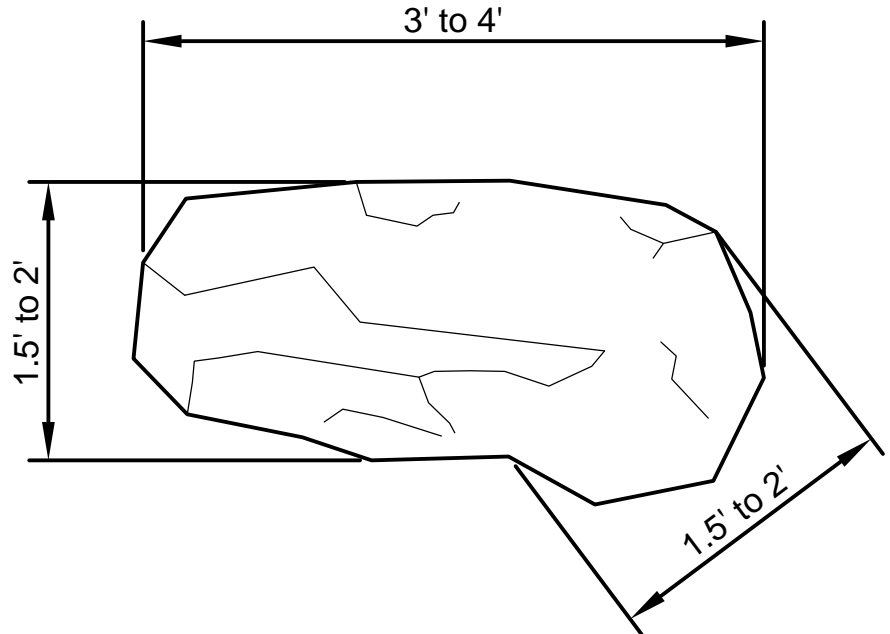
1  
D-2  
BOULDER DETAIL  
NTS

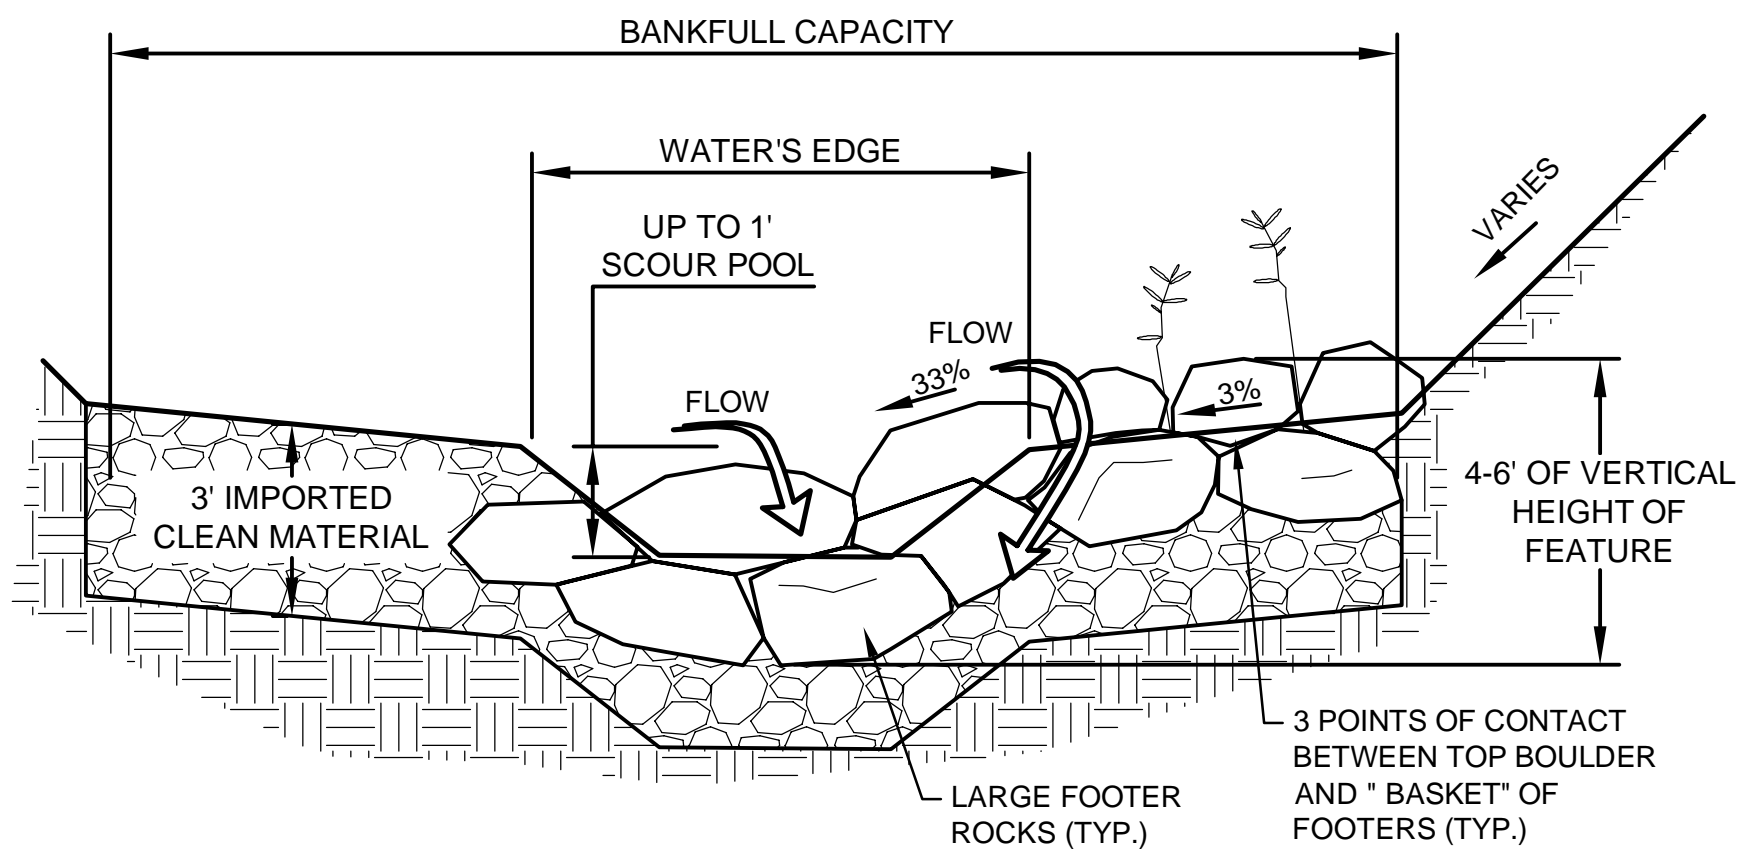
2  
D-2  
TYPICAL VANE ARM DETAIL  
NTS

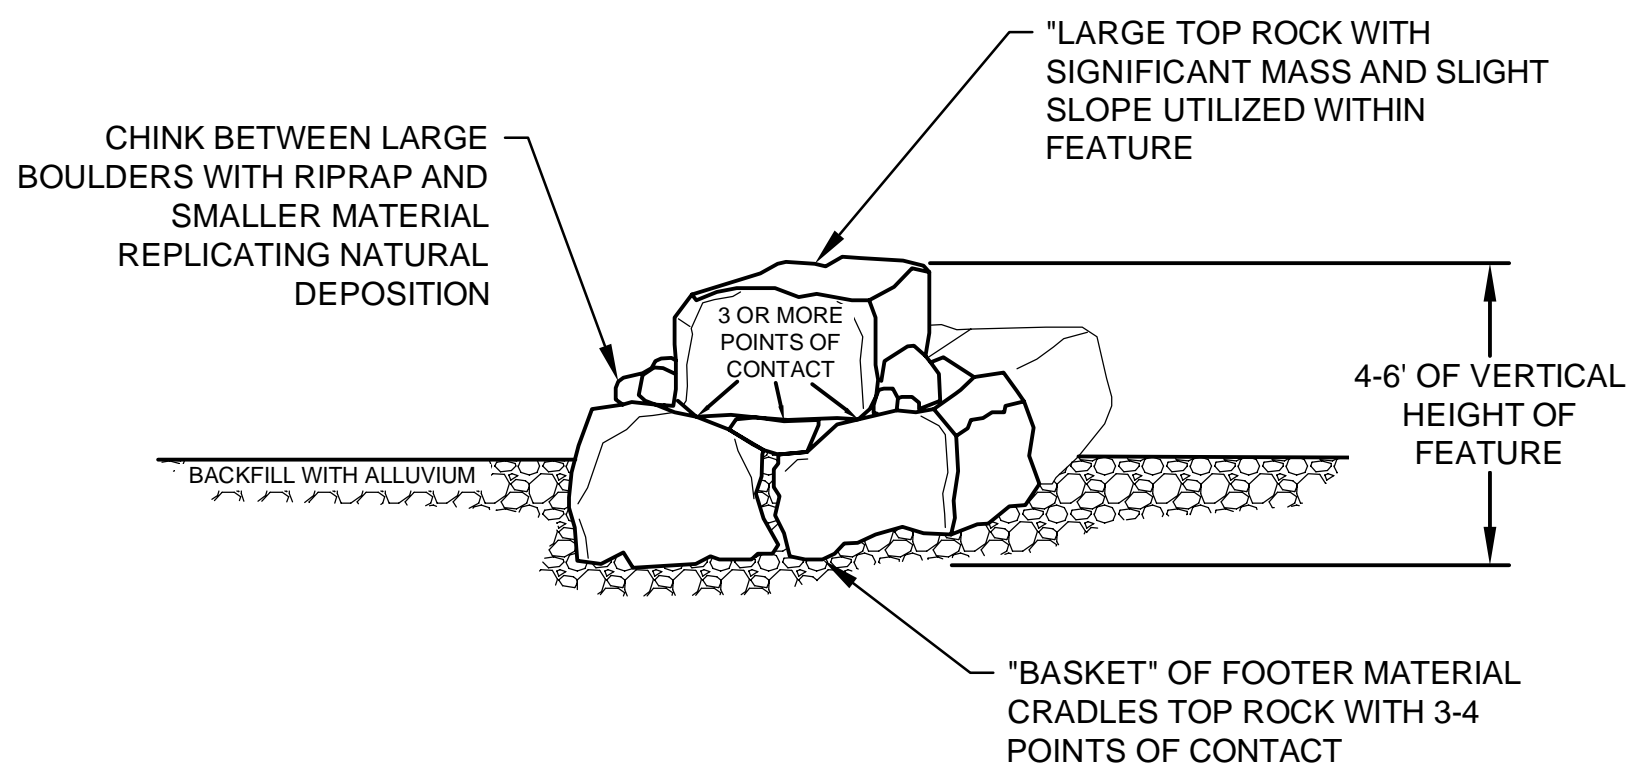
3  
D-2  
TYPICAL FOOTER DETAIL  
NTS

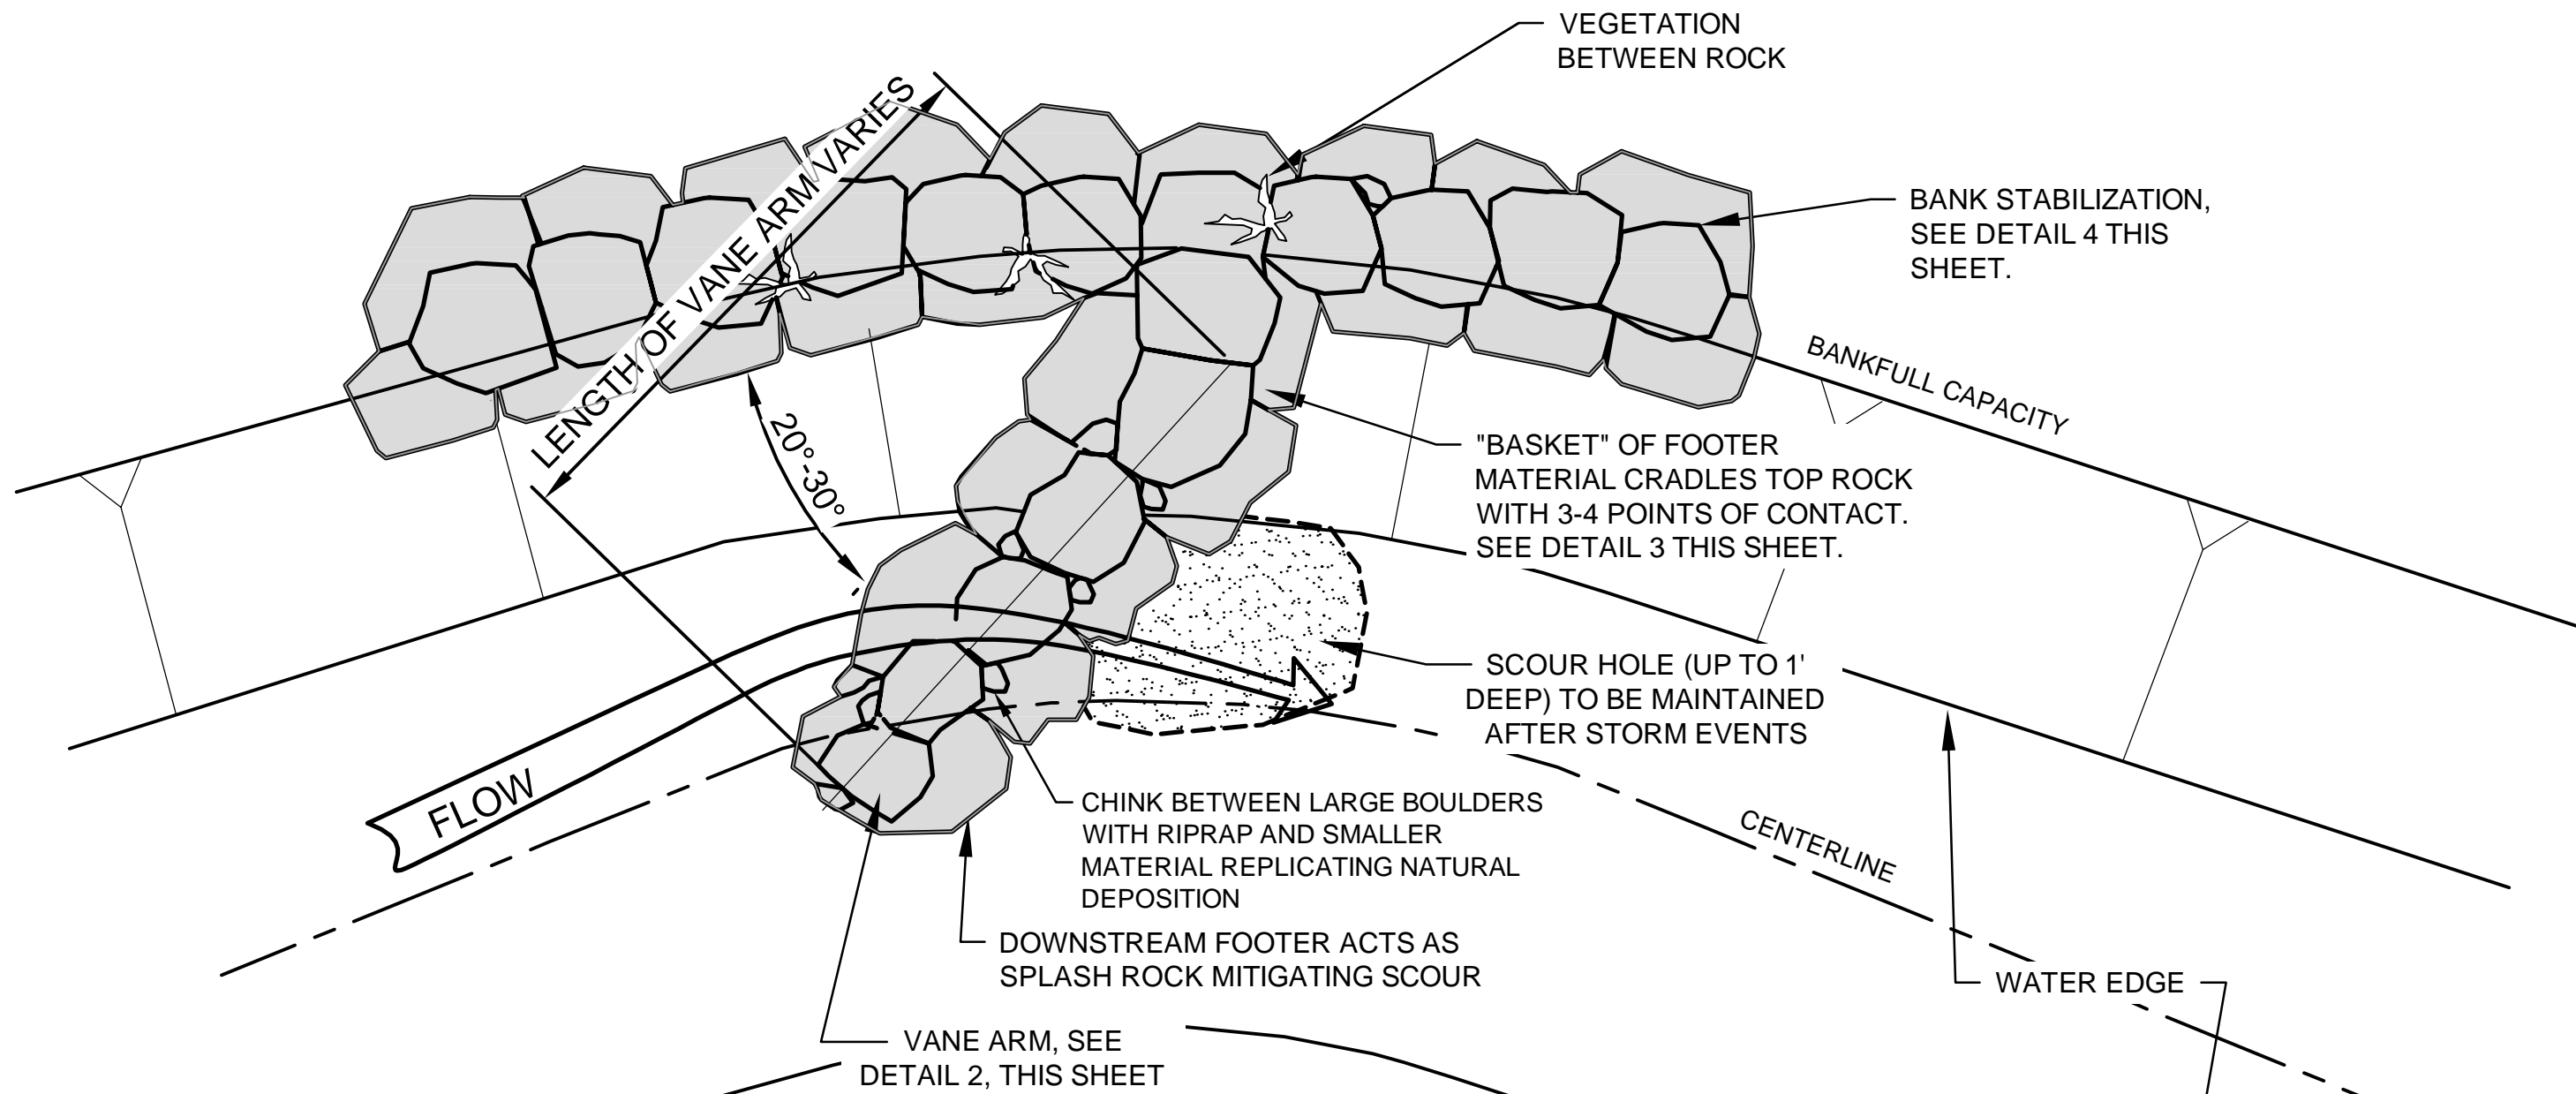
PLAN VIEW  
A  
D-2  
TYPICAL VANE ARM AND BANK STABILIZATION DETAIL  
NTS

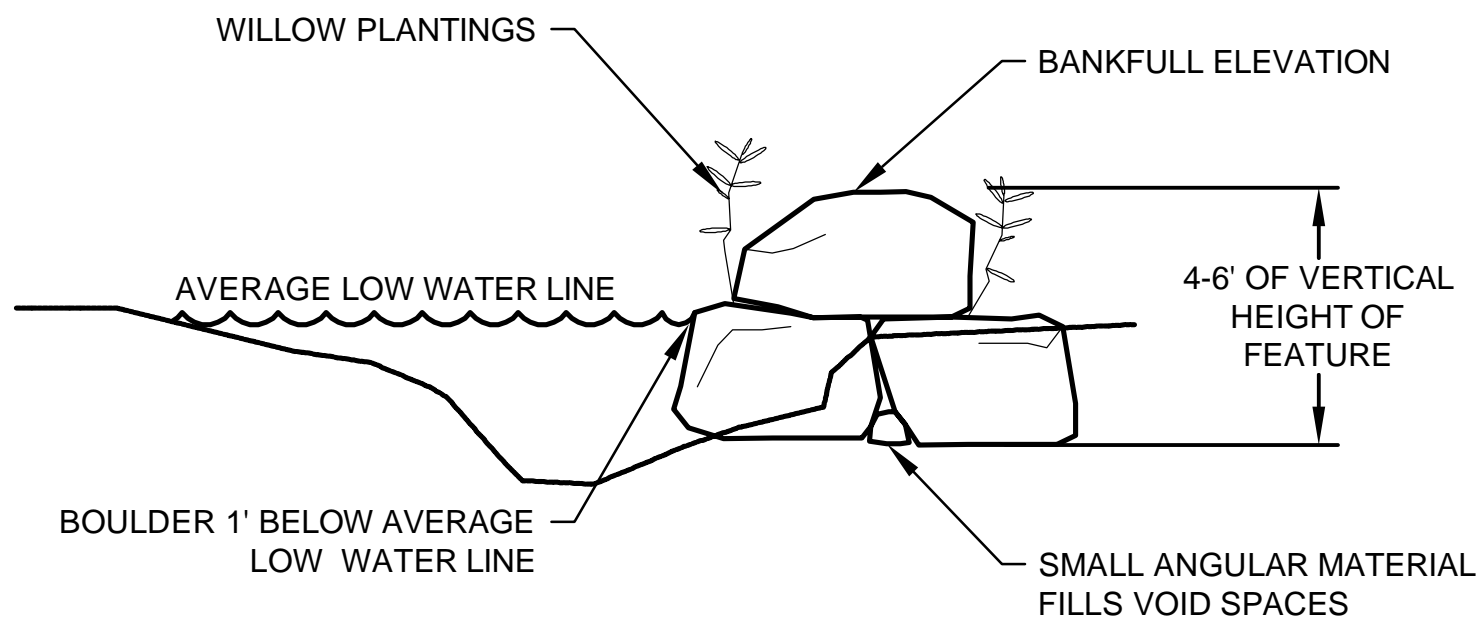
4  
D-2  
TYPICAL BANK STABILIZATION DETAIL  
NTS
