**Phase 1 Final Design Deliverable**  
**Camp Bird Removal Action**

**Site Name:** Camp Bird Mine

**Prepared by:** Mike Thompson, Project Coordinator, Caldera Mineral Resources, LLC

CAMP BIRD MINE RECLAMATION  
OURAY COUNTY, COLORADO

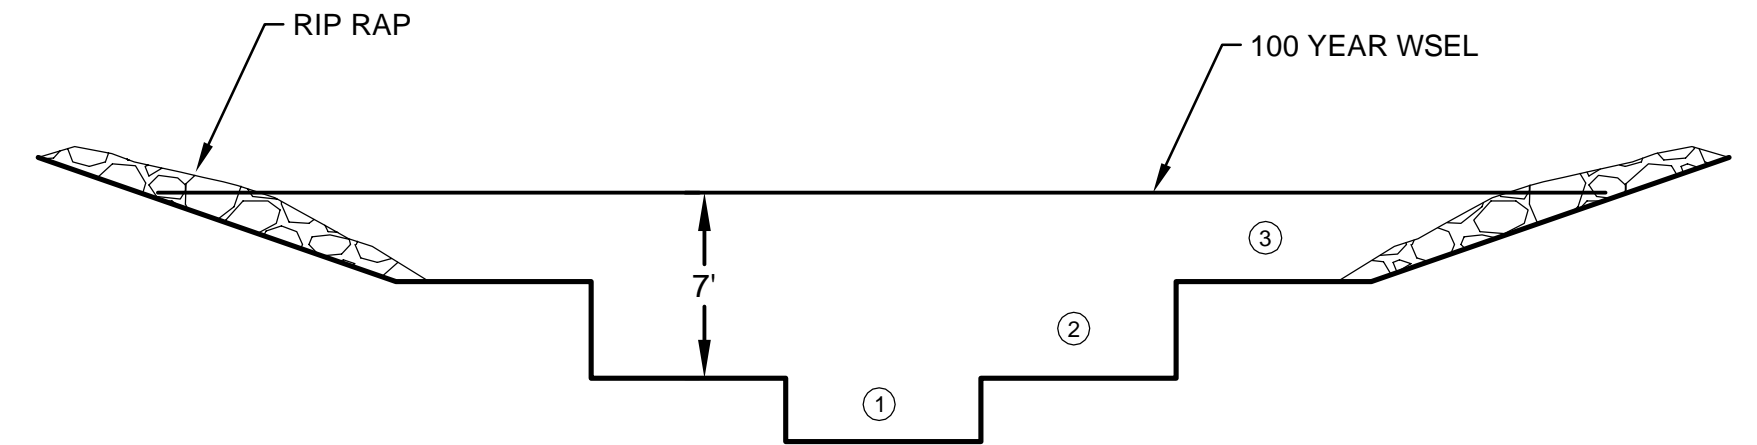
5  
D-2  
TYPICAL MULTI-STAGE CHANNEL CROSS SECTION  
NTS

ACTUAL CHANNEL SECTIONS FOR EACH STREAM  
BANK TO BE DETERMINED IN FIELD

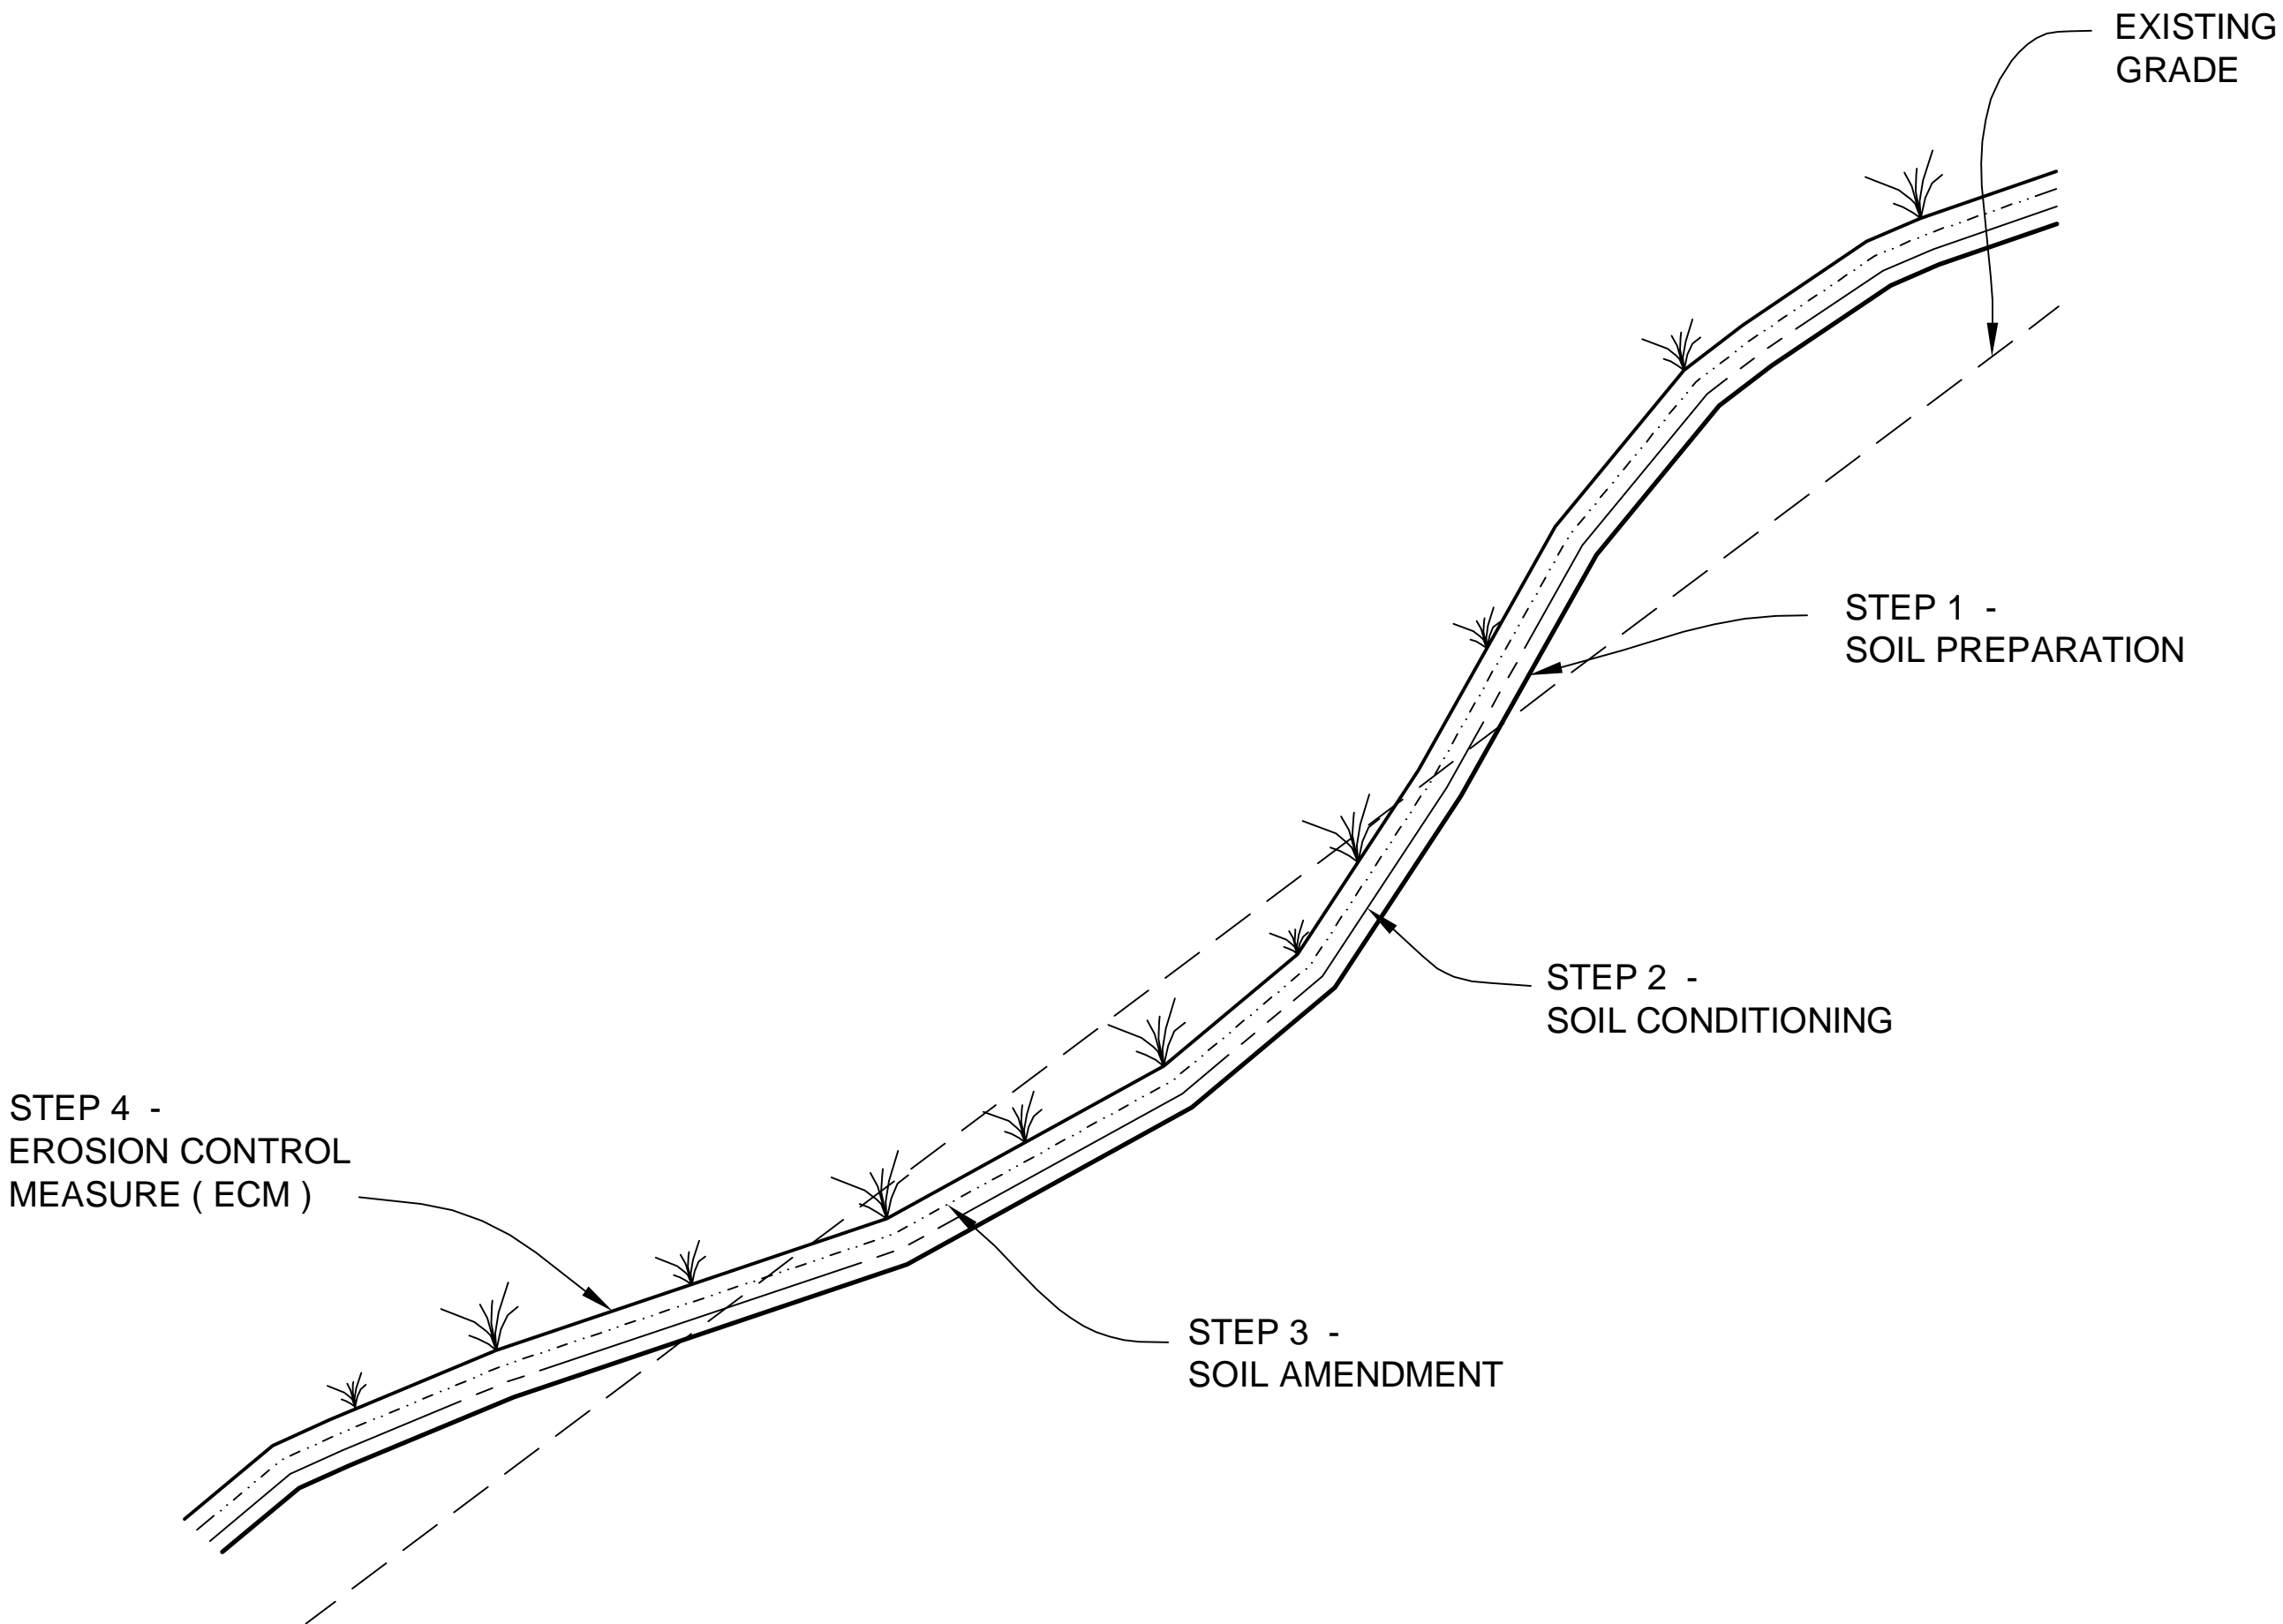
- STEP 1. Soil Preparation - Includes shaping, contouring, and furrowing
- STEP 2. Soil Conditioning - Hydraulic application of soil conditioners to neutralize pH. Sulfur for pH > 8.0, Agricultural lime for pH < 6.0
- STEP 3. Soil Amendment - Hydro-mulching of prepared/conditioned slopes with Proganics, Richlawn, QuantumGrow Lite and QuantumGrow VCS, seed mix ( see below )and tackifier as directed by Triton
- STEP 4. Erosion Control Measure ( ECM ) - Hydraulic application of ECOFlex HP ECM at rate prescribed by Triton

1 D-3 SCHEMATIC REVEGETATION DIAGRAM NTS

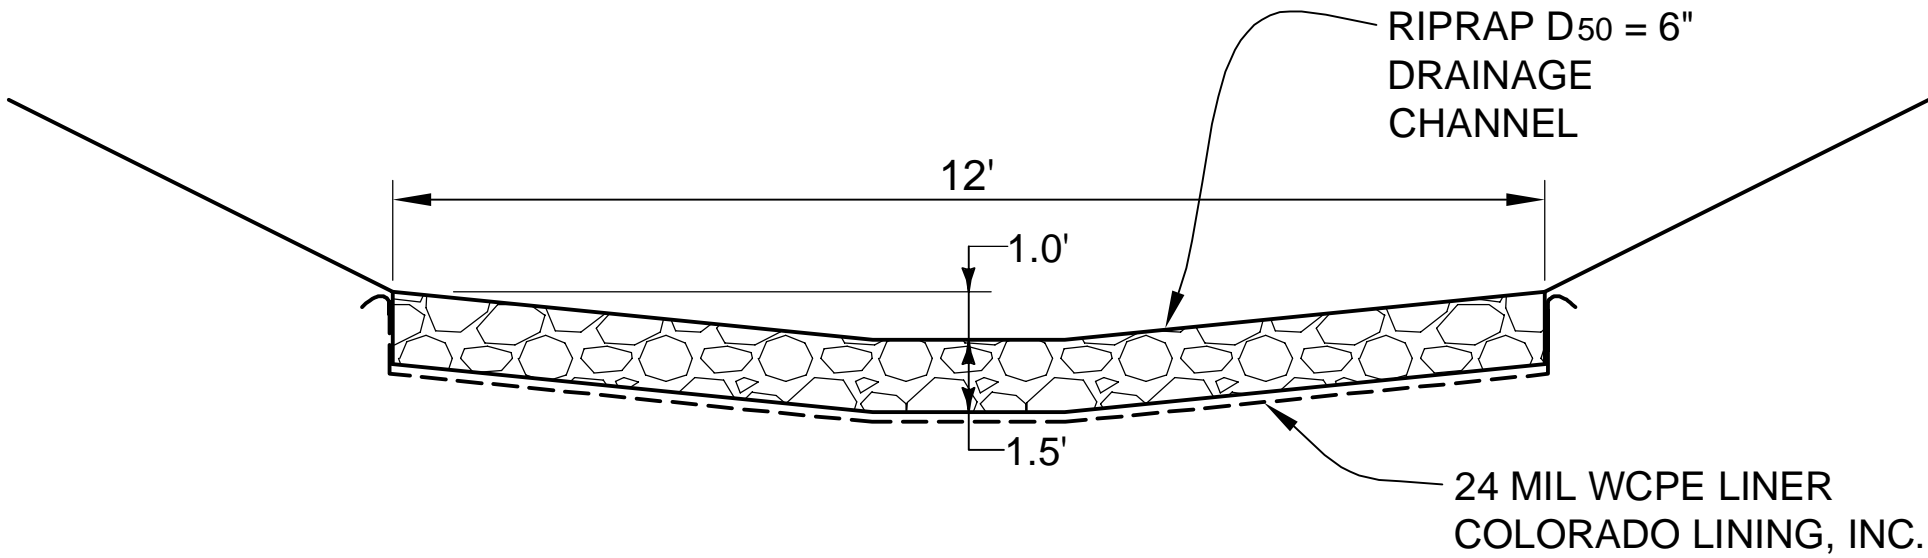
2 D-3 RIPRAP CHANNEL & OUTFALL DETAIL NTS
