**FINAL REPORT**

**OTSEGO TOWNSHIP DAM AREA  
TIME CRITICAL REMOVAL ACTION  
OPERABLE UNIT 5, AREA 3  
ALLIED PAPER, INC. / PORTAGE CREEK / KALAMAZOO RIVER SUPERFUND SITE  
Docket V-W-16-C-009**

**Allegan County  
Otsego Township, Michigan**

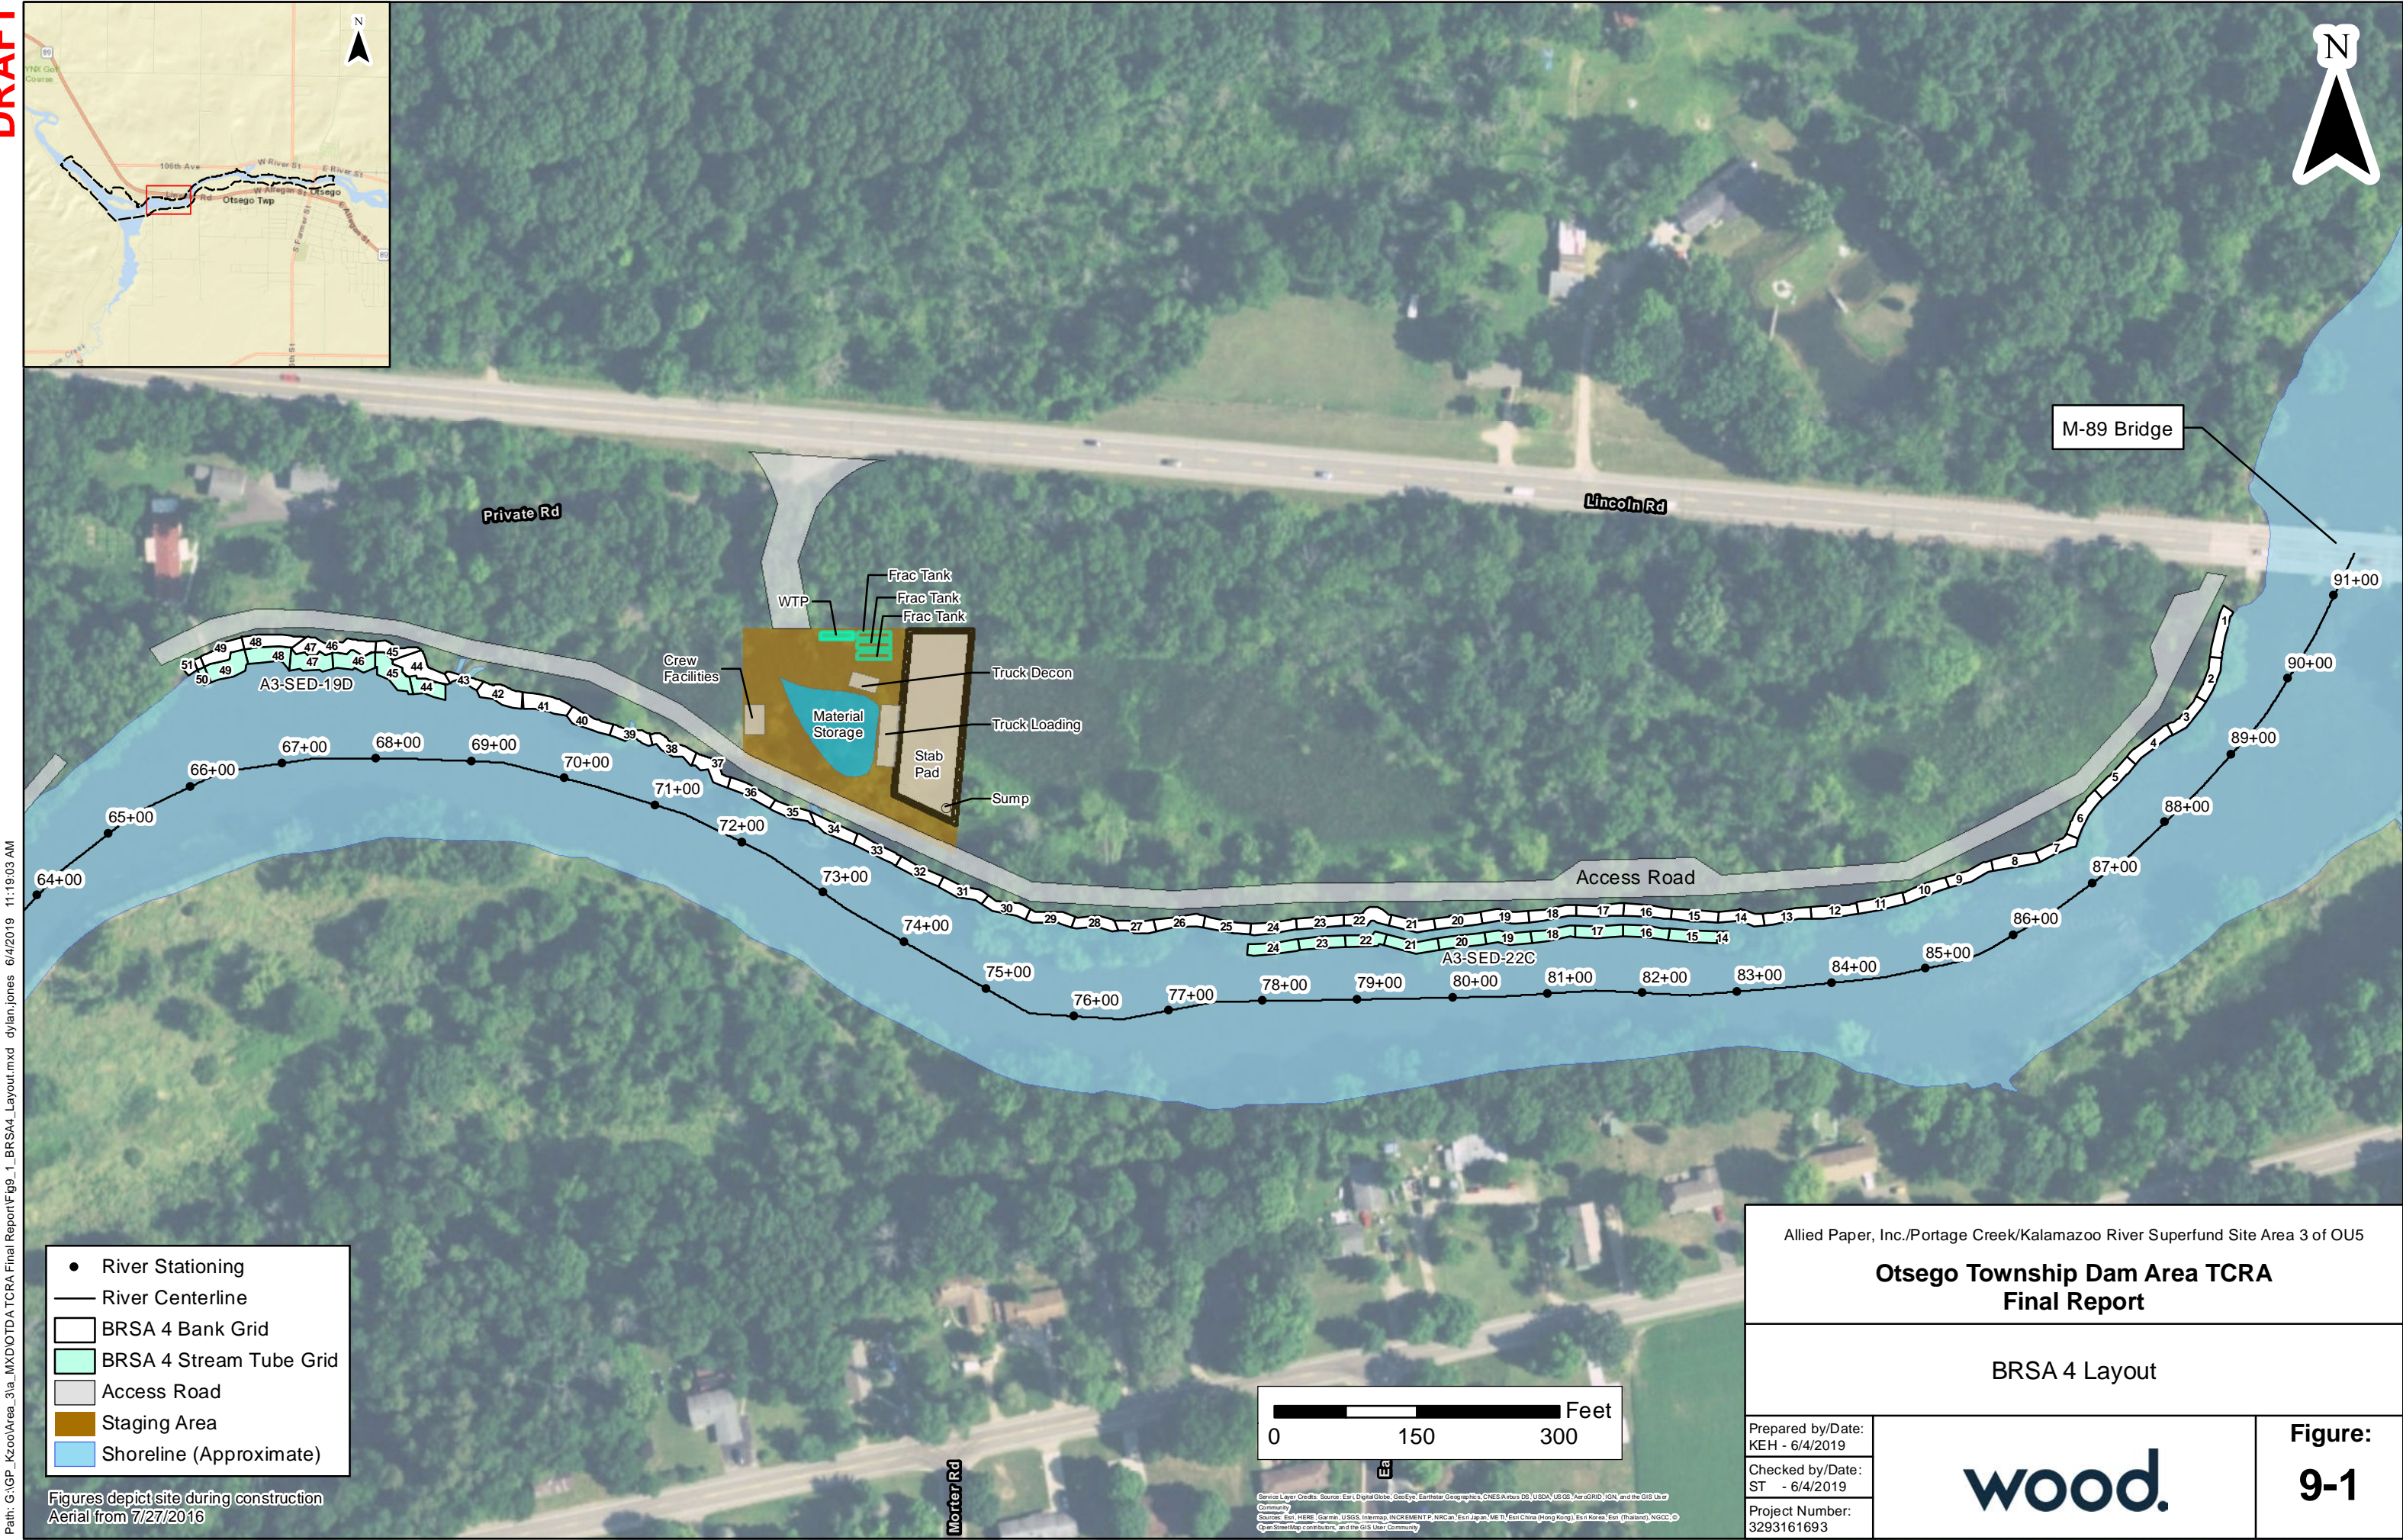
**Figure:  
9-1**

Figures depict site during construction  
Aerial from 7/27/2016

BRSA 4 is located on the RDB immediately downstream of the M-89 Bridge, extending approximately 2,500 feet from approximately RDB STA 12+50 to 36+50 (RS 66+50 to 90+50, [Figure 9-1](#)). BRSA 4 remediation and restoration activities were conducted between April and August 2017. This section summarizes those activities and documents USEPA-approved deviations from the design presented in the BRSA 4, 5, 6, and 9 TM, which can be found [here](#).

Removal work was required on banks at the downstream end of BRSA 4, between a privately-owned residential property and the river (see Figure 9-1 and Photo 26 in Attachment A). Due to the steep bank, access was limited in this area. A shelf was constructed through the steep bank to facilitate construction of an access road over the removal excavation area. The access road was constructed to the downstream end of BRSA 4 and removal excavation was completed in stages from downstream to upstream, removing the access road and completing restoration as work was completed.

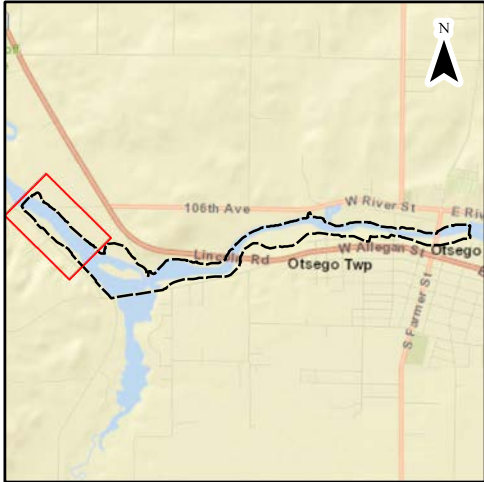
Figure:  
13-1

- River Stationing
- River Centerline
- BRSA 8 Bank Grid
- BRSA 8 Stream Tube Grid
- Access Road
- Staging
- Shoreline (Approximate)

Figure depicts site layout during construction  
Aerial from 7/27/2016

BRSA 8 extends approximately 3,259 feet from LDB STA 77+63 to 110+27 (RS 3+50 to 33+00, [Figure 13-1](#)). BRSA 8 is located downstream of BRSA 9 and upstream of former auxiliary spillway. BRSA 8 remediation and restoration activities were conducted between December 2017 and May 2018 (with a one-month winter shut down from February 12 to March 12, 2018). Restoration of the plunge pool area was completed between June and August 2018. This section summarizes these activities and documents USEPA-approved deviations from the design presented in the BRSA 7 and 8 TM, which can be found [here](#).

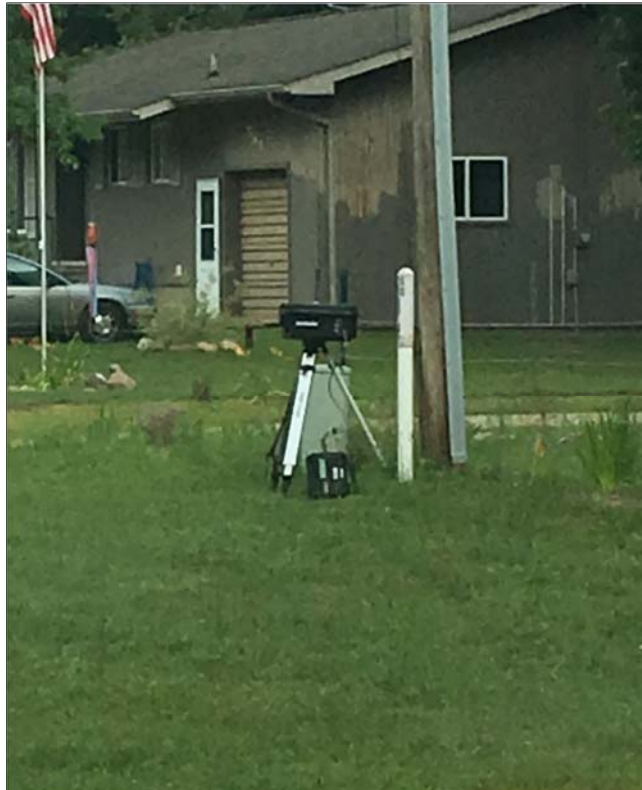
**Photo 1: Air monitor set up outside perimeter of work area (July 2017).**

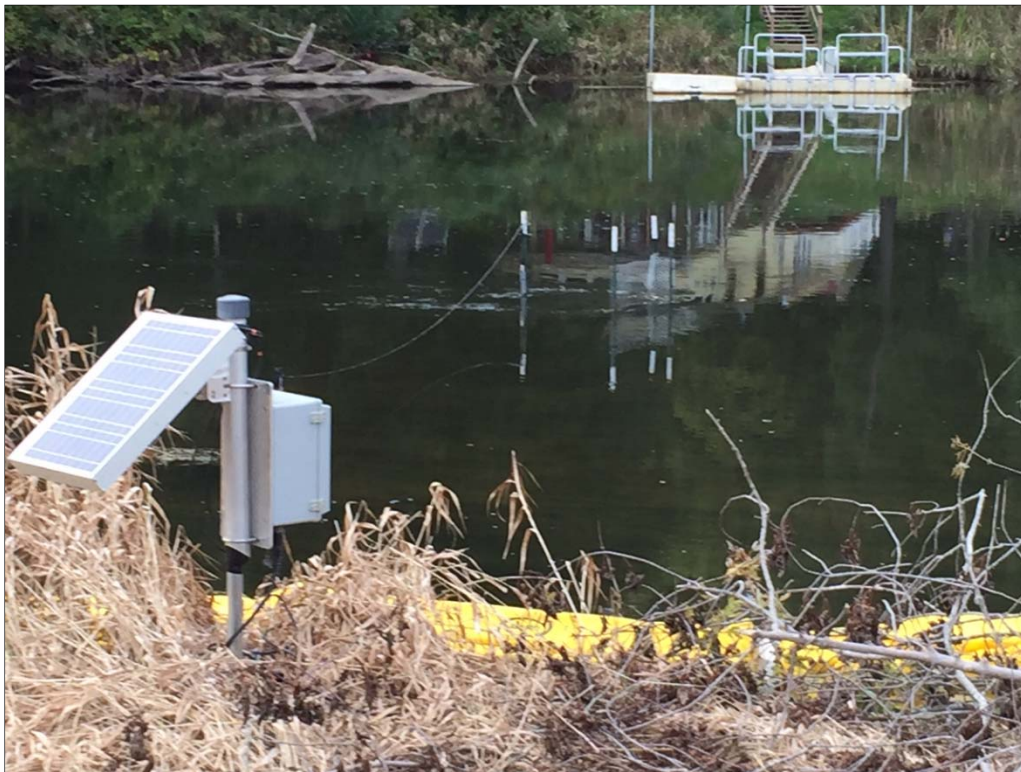
**Photo 2: Turbidity monitor set up downstream of work area (2016).**

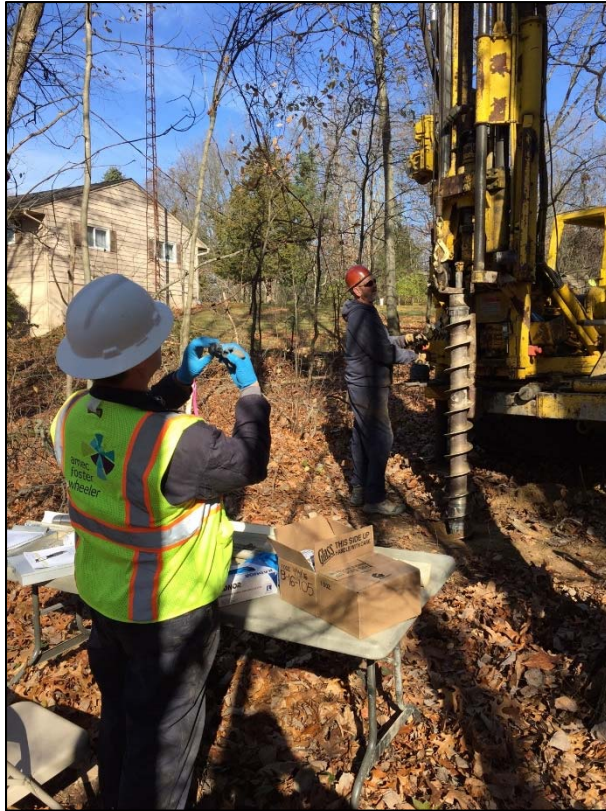
**Photo 3: Geotechnical boring (November 2016).**

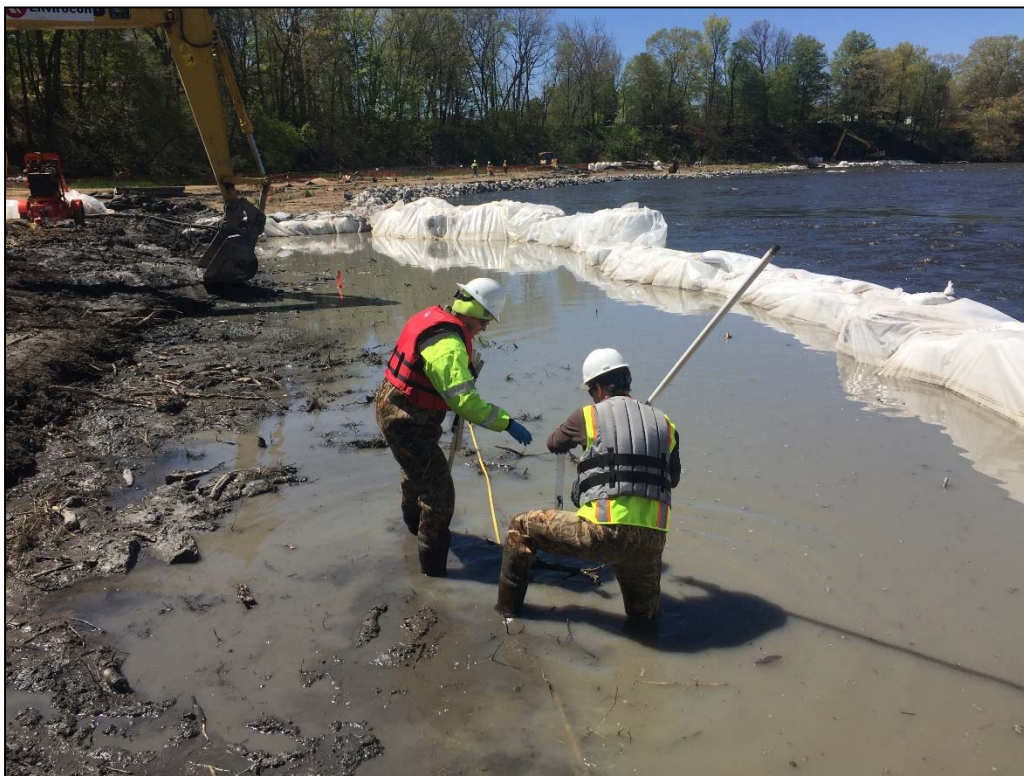
**Photo 4: Collecting post-excavation confirmation sample (May 2017)**

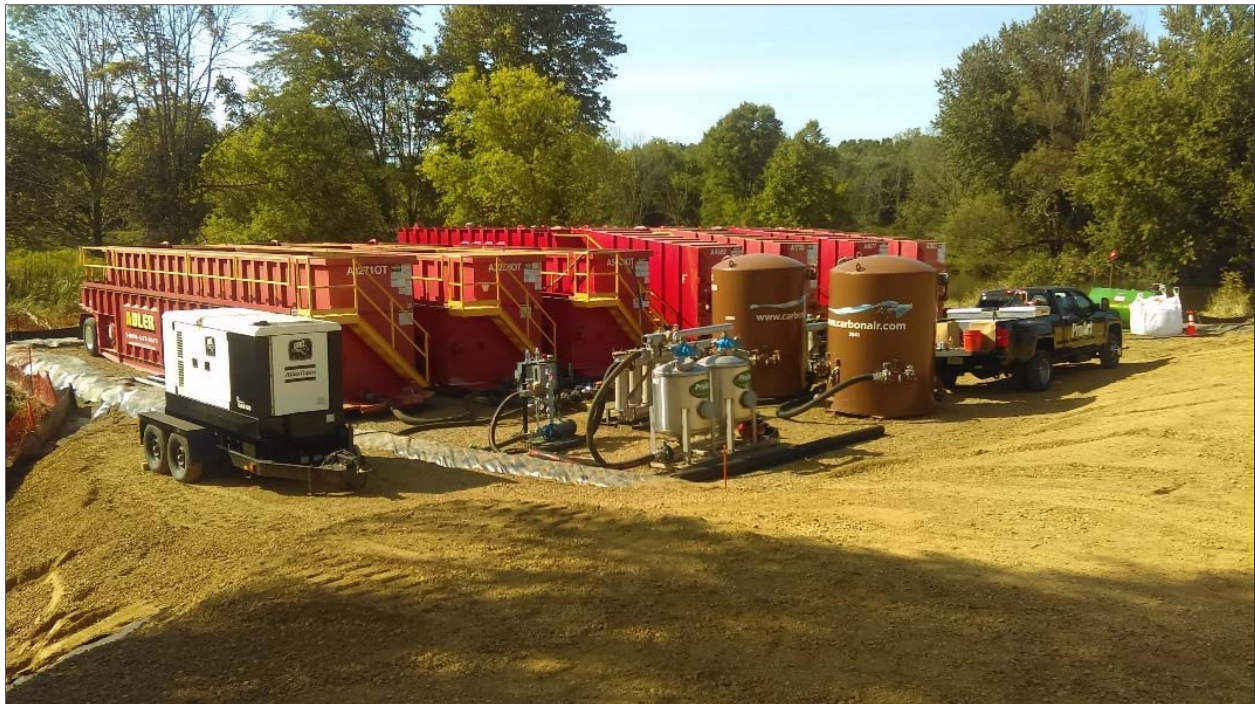
**Photo 5: BRSA 1 Water Treatment Plant (September 2016).**

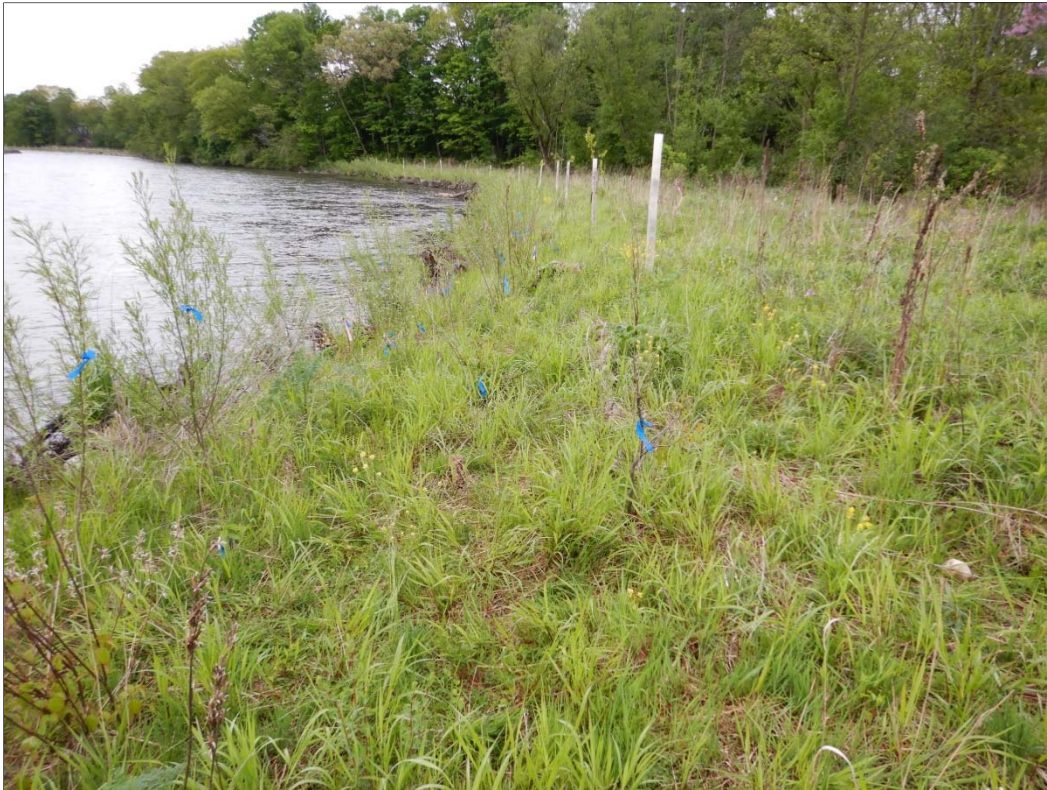
**Photo 9: Study plot established to monitor vegetative success (BRSA 1, May 2019).**

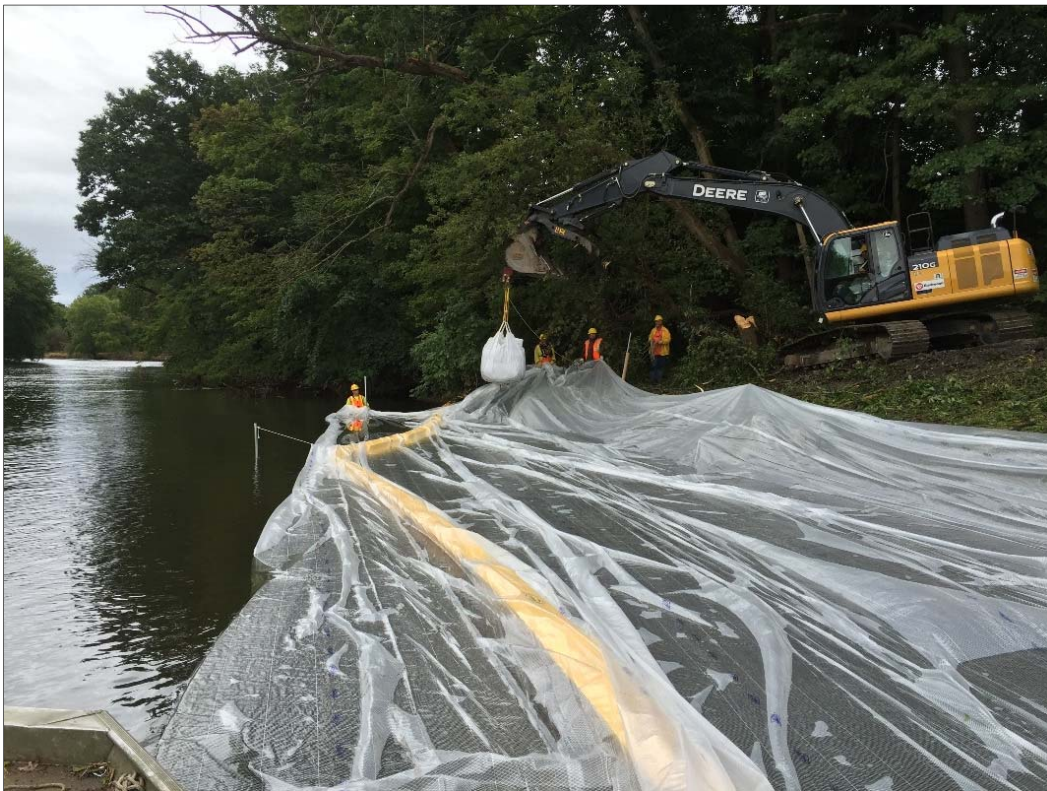
**Photo 10: Installation of sandbag cofferdam (BRSA 1, September 2016).**

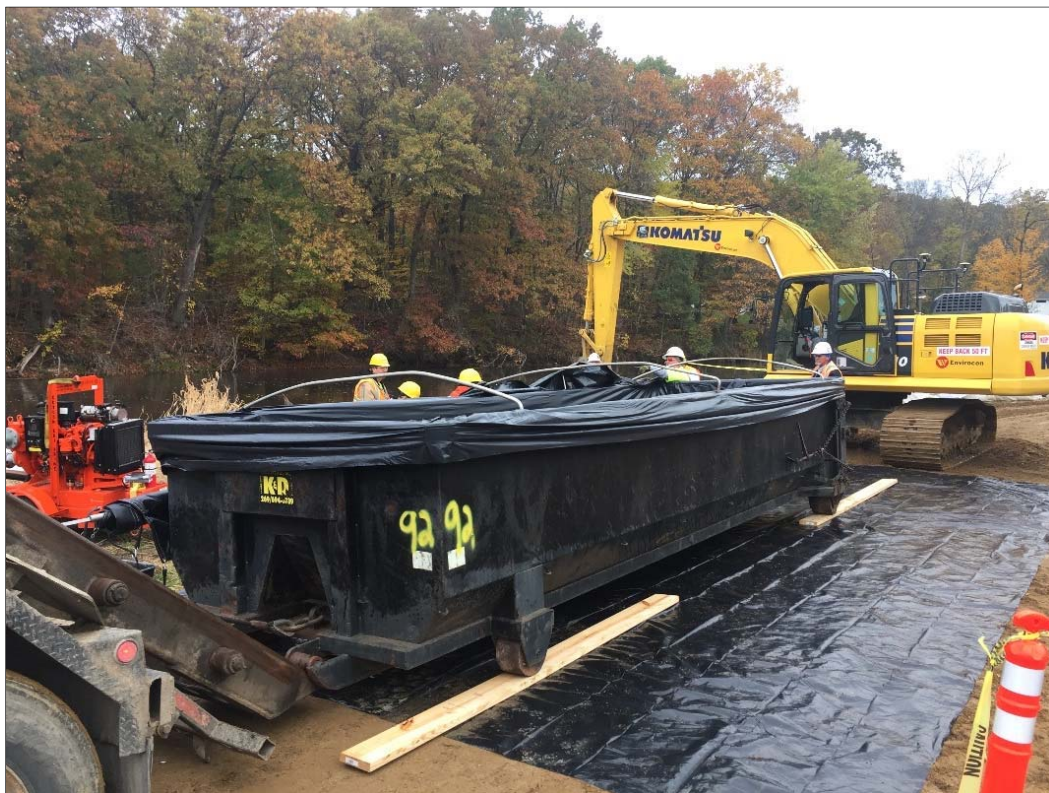
**Photo 12: TSCA roll-off setup (BRSA 1, October 2016).**

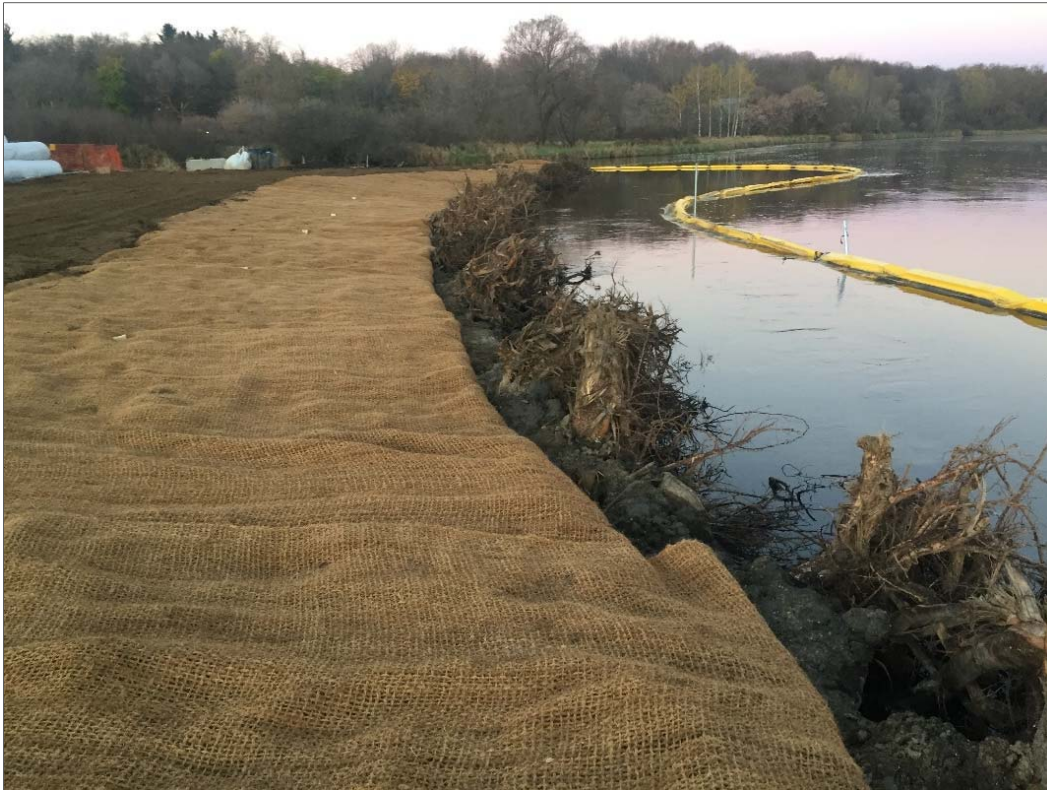
**Photo 13: Coir fabric installed over root wads (BRSA 1, October 2016).**

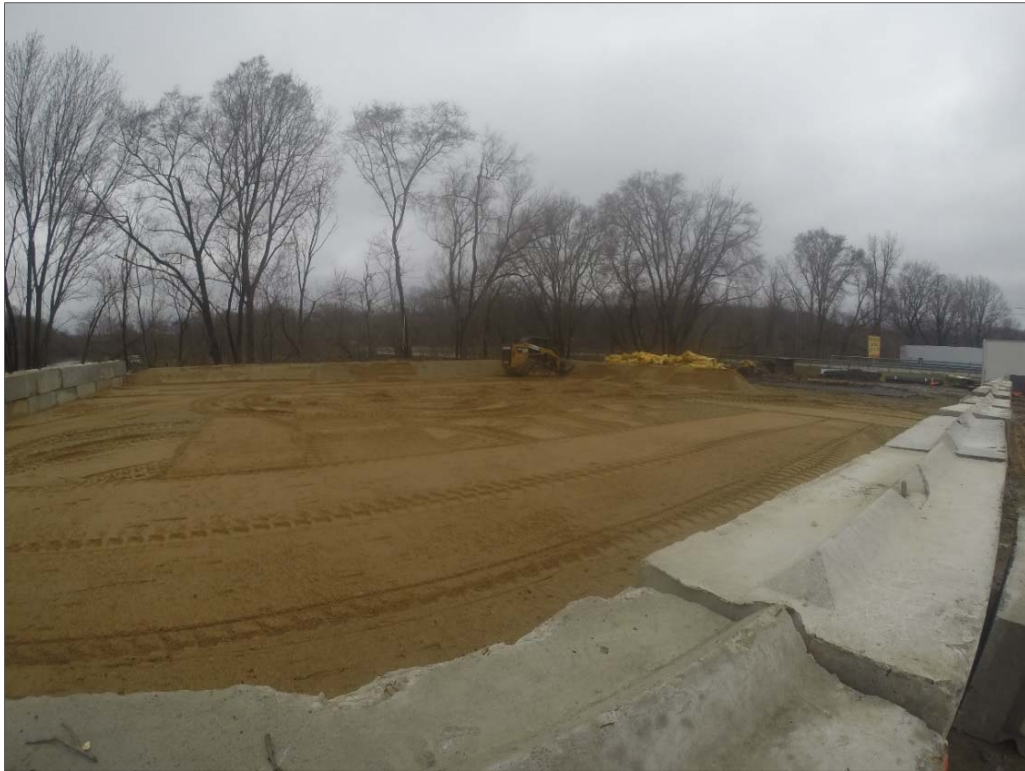
**Photo 15: Construction of BRSA 3 stabilization/loadout pad (March 2017).**

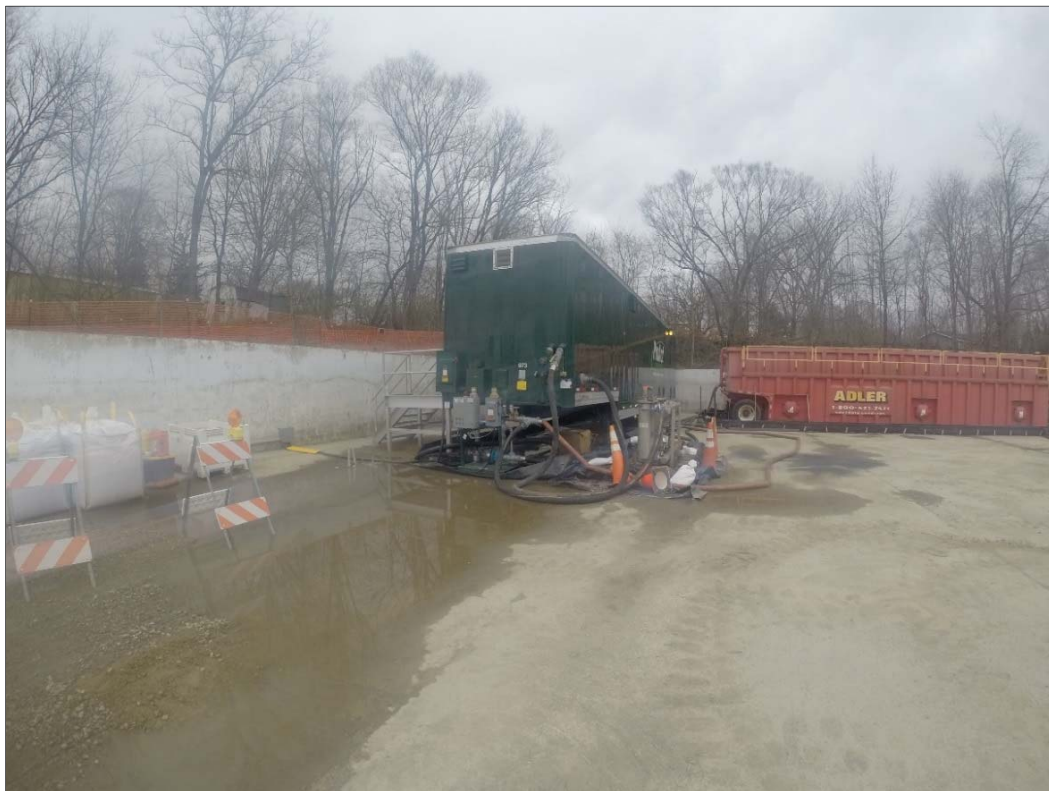
**Photo 16: BRSA 3 Water Treatment Plant (April 2017).**

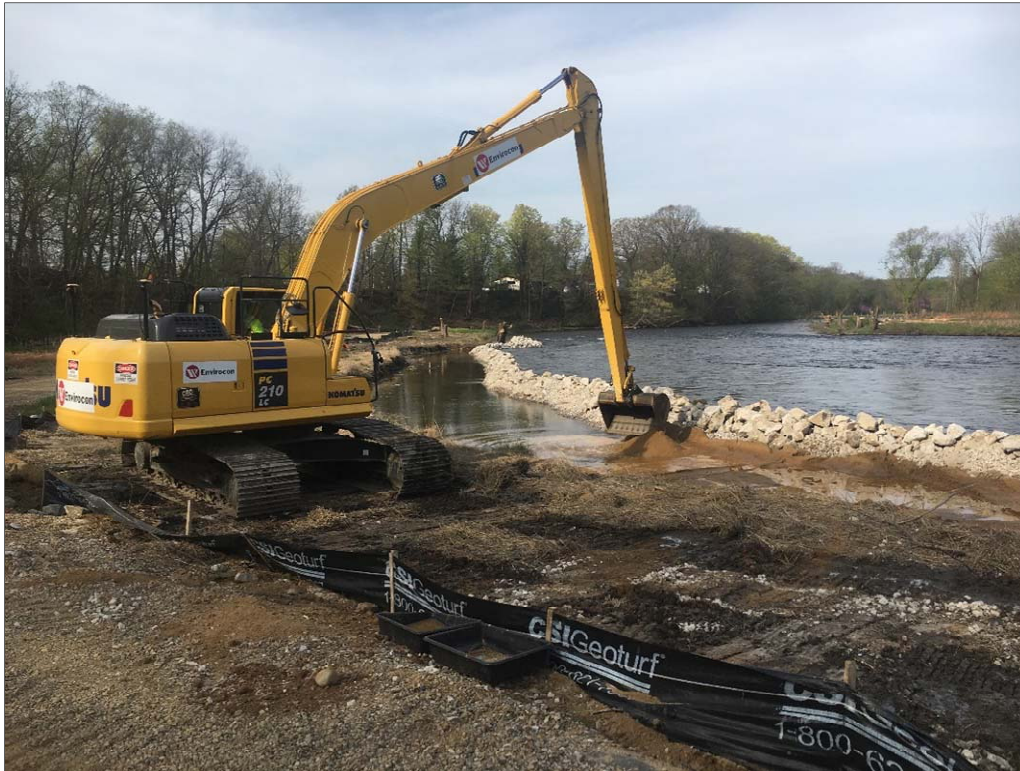
**Photo 17: BRSA 3 riprap cofferdam (April 2017).**

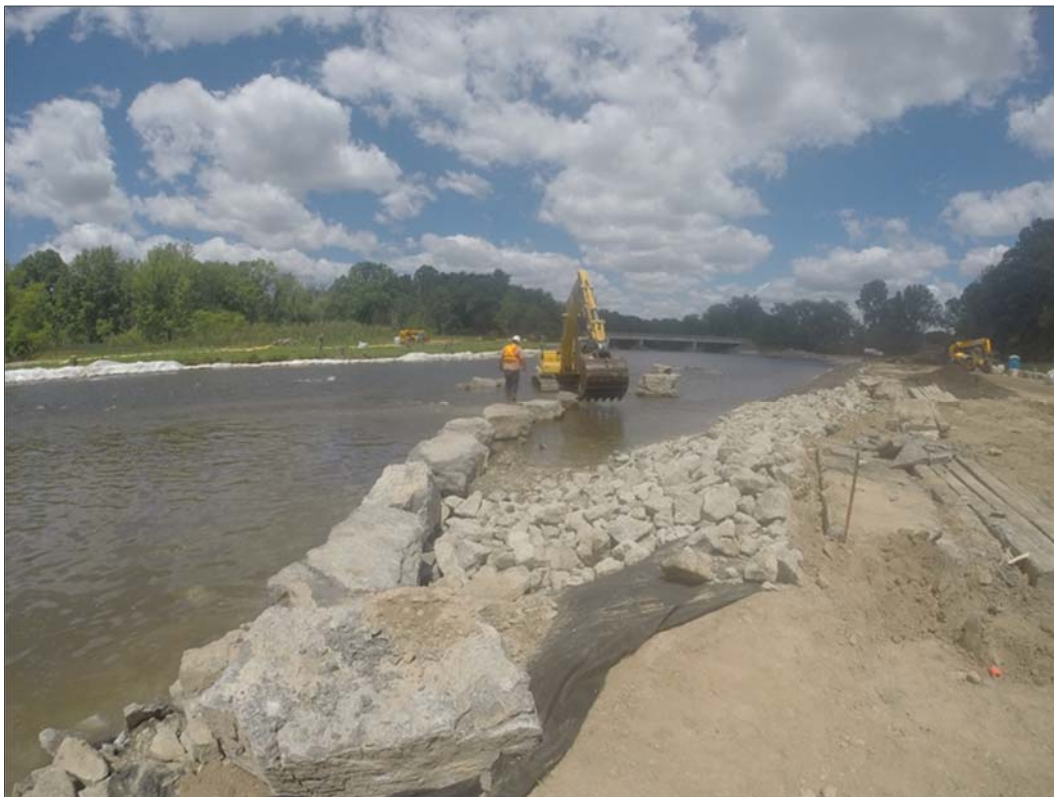
**Photo 18: Installation of BRSA 3 J-hook (June 2017).**

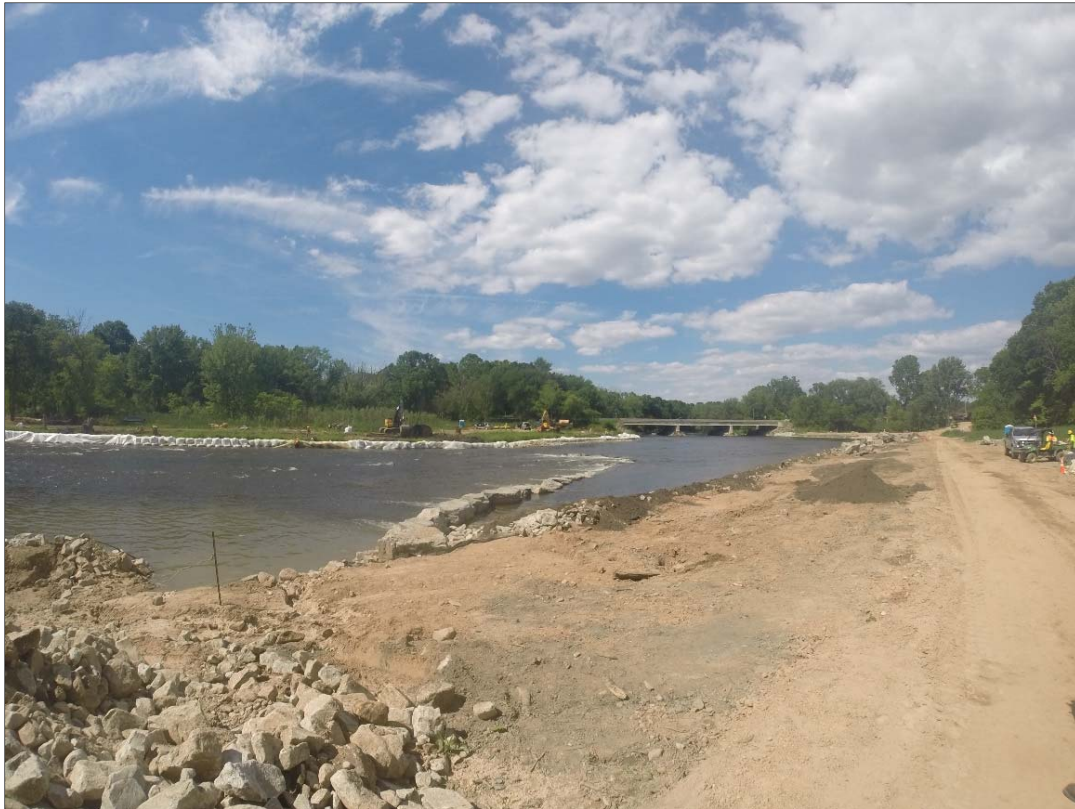
**Photo 19: BRSA 3 J-hook (June 2017).**

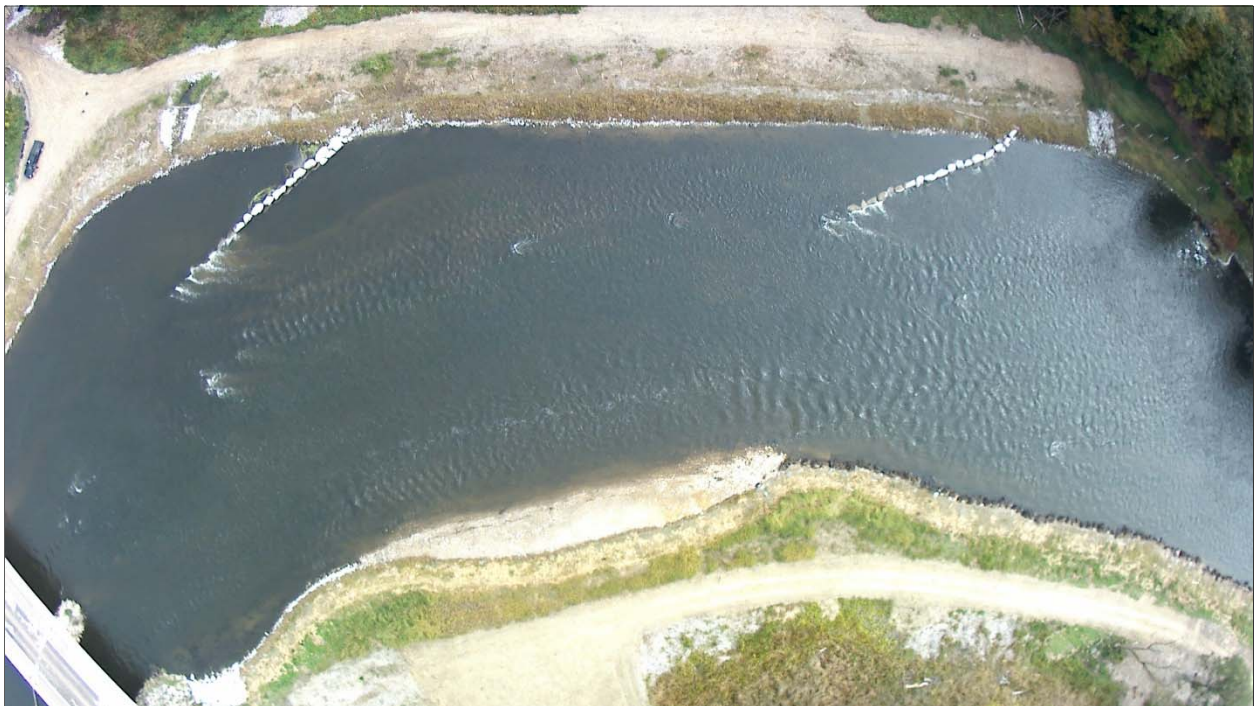
**Photo 20: Aerial view of J-hooks installed on BRSA 3 bank (October 2017).**

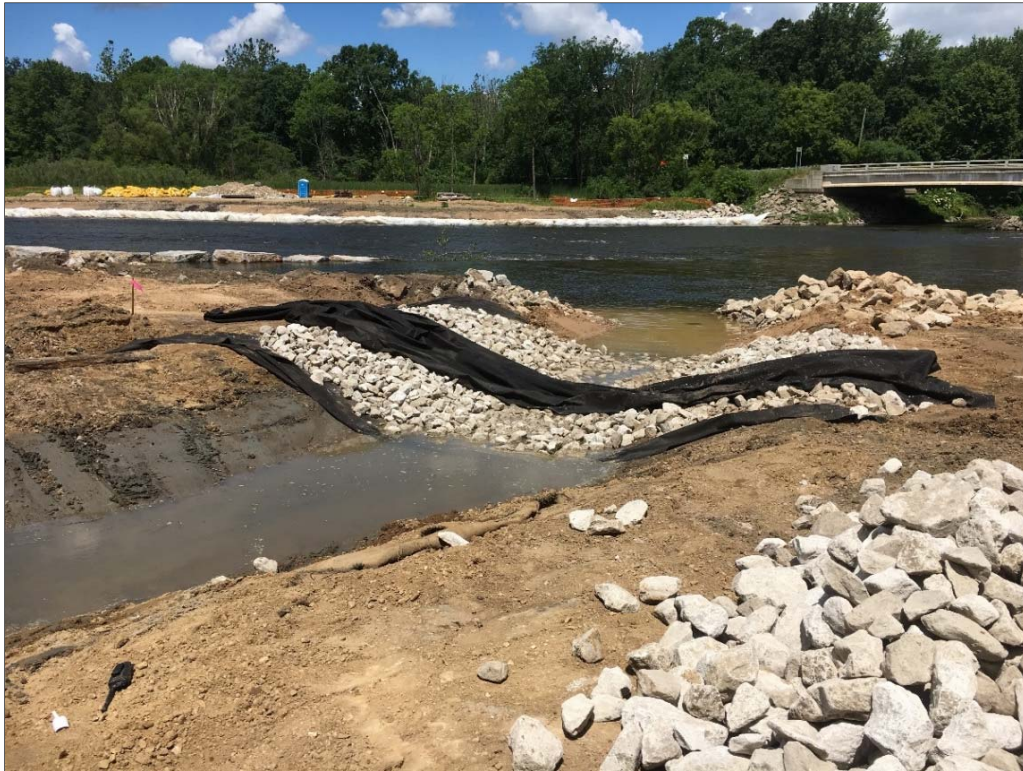
**Photo 21: Feeder stream restoration (BRSA 3, June 2017).**

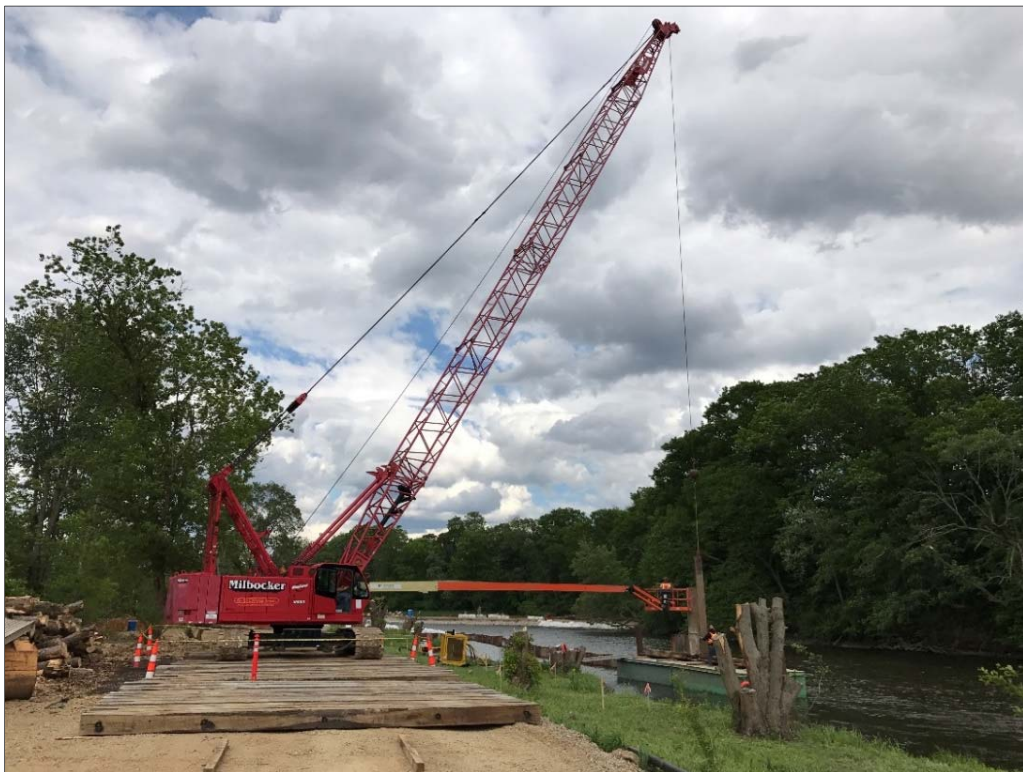
**Photo 22: Installing sheet pile cofferdam at stream tube 22C (BRSA 4, May 2017).**

Sediment in two BRSA 4 stream tubes required remediation: stream tube A3-SED-22C, extending from approximately RS 78+50 to 83+50, and stream tube A3-SED-19D, extending from approximately RS 67+00 to 69+25. To facilitate stream tube excavation, a temporary sheet pile cofferdam was installed around stream tube A3-SED-22C (see Photos 22 and 23 in Attachment A). Sand bags were placed inside the sheet piling to delineate grids and facilitate remediation and confirmation sampling. Contact water was pumped from inside the sheet piling and sent to the WTP.

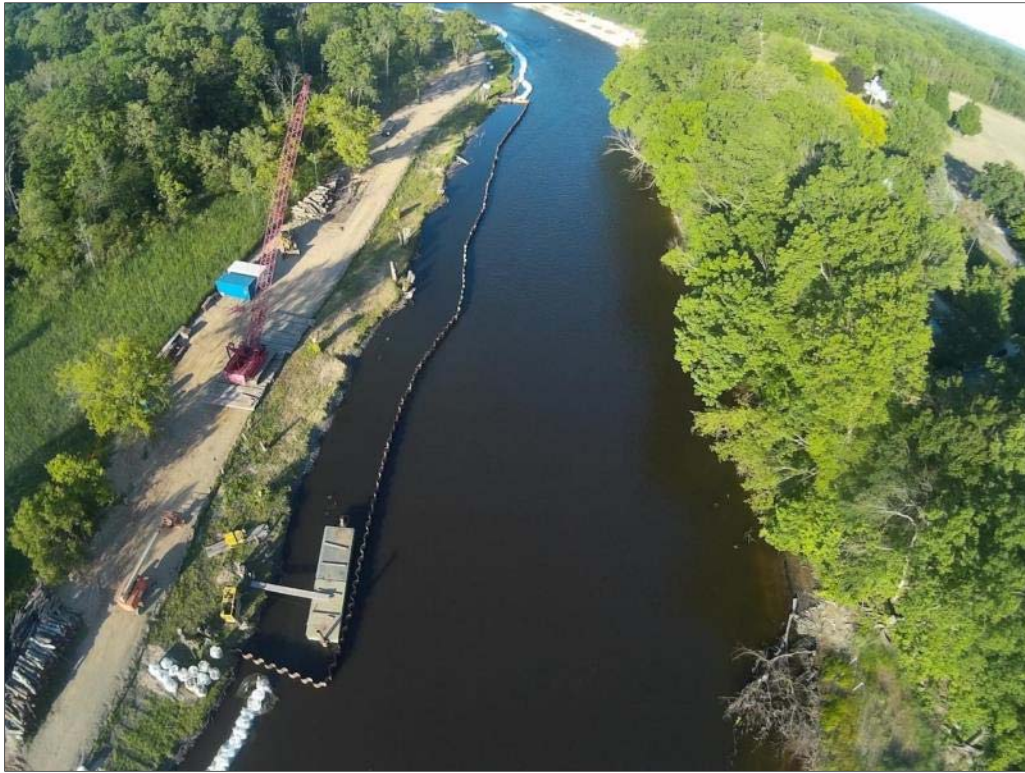
**Photo 23: Aerial view of BRSA 4 sheet pile cofferdam (June 2017).**

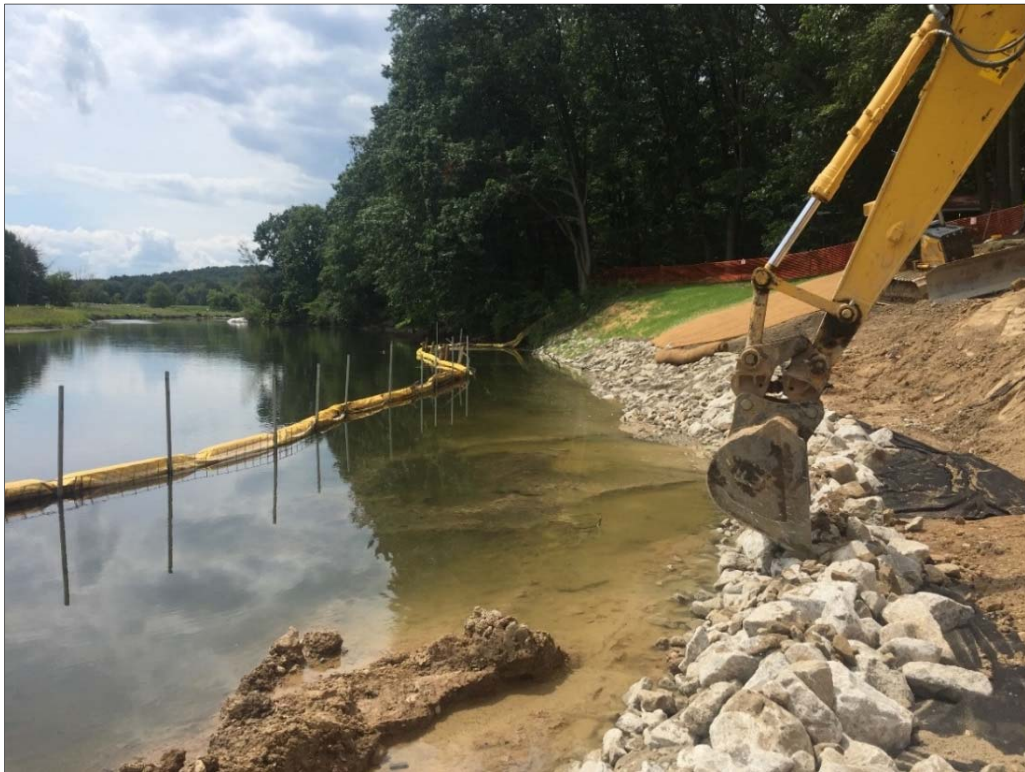
**Photo 24: Reinforced turbidity curtain at stream tube 17D (BRSA 4, August 2017).**

Deeper water and access restrictions at the downstream stream tube (A3-SED-19D) necessitated the use of a reinforced turbidity curtain, which was installed as described in Section 5.12. Pumping water from the excavation area on the bank-side of the reinforced turbidity curtain helped maintain negative pressure to minimize the potential for contact water to enter the river (see Photo 24 in Attachment A). Contact water was pumped to the WTP.

- As discussed above, deeper water and access restrictions at the downstream stream tube (A3-SED-19D) necessitated the use of a reinforced turbidity curtain (Photo 24, Attachment A), rather than the planned sandbag cofferdam.

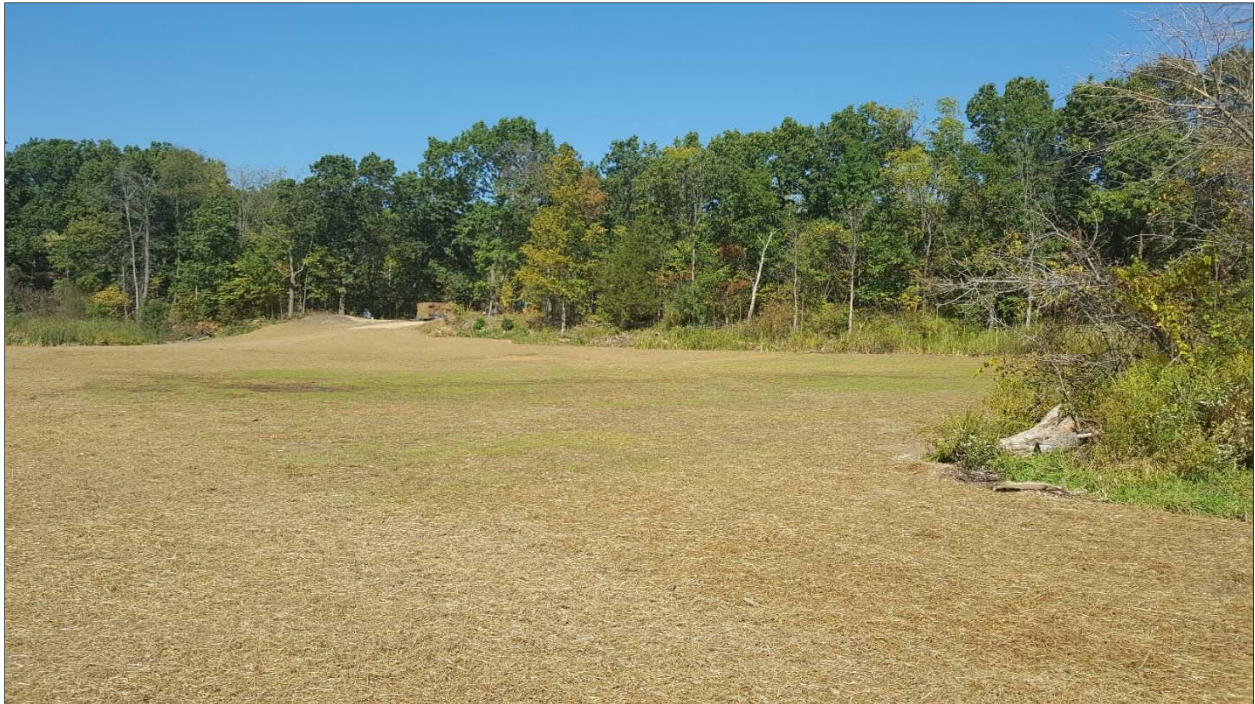
**Photo 25: Restored BRSA 4 staging area (September 2017).**

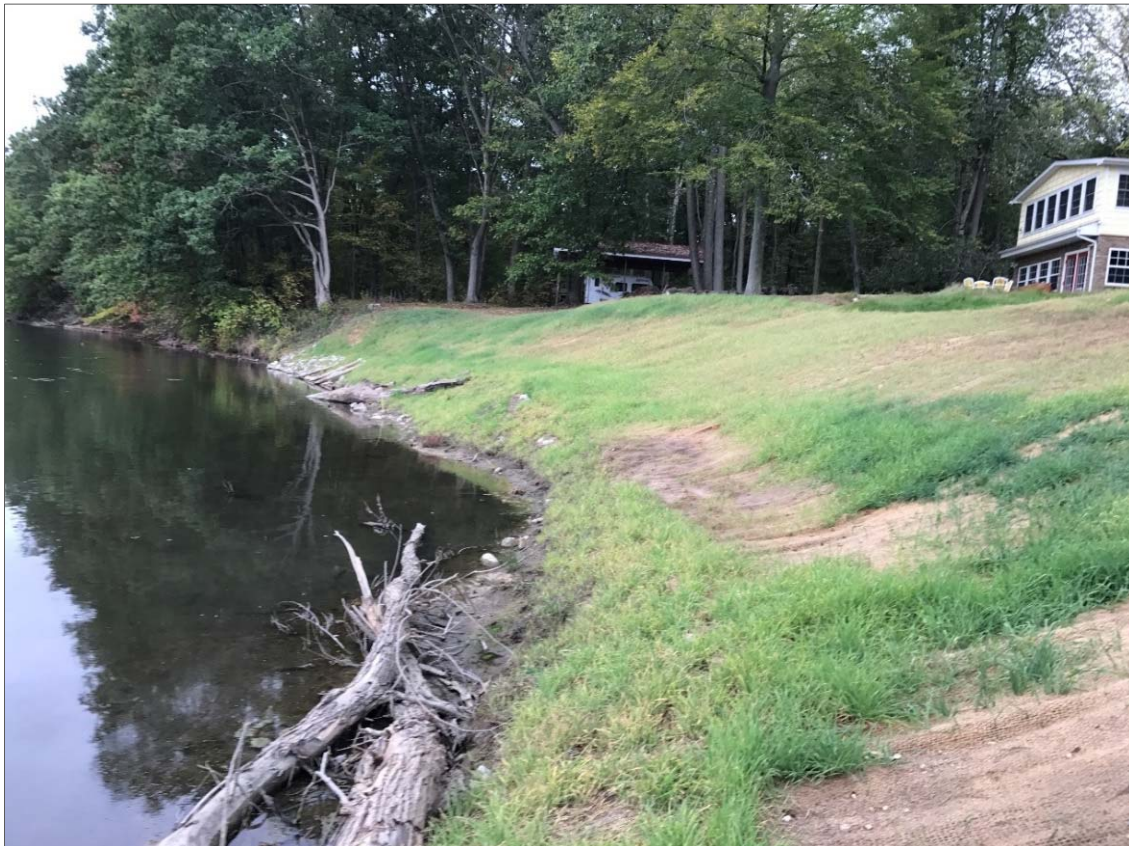
**Photo 26: Restoration of steep slope at downstream end of BRSA 4 (October 2017).**

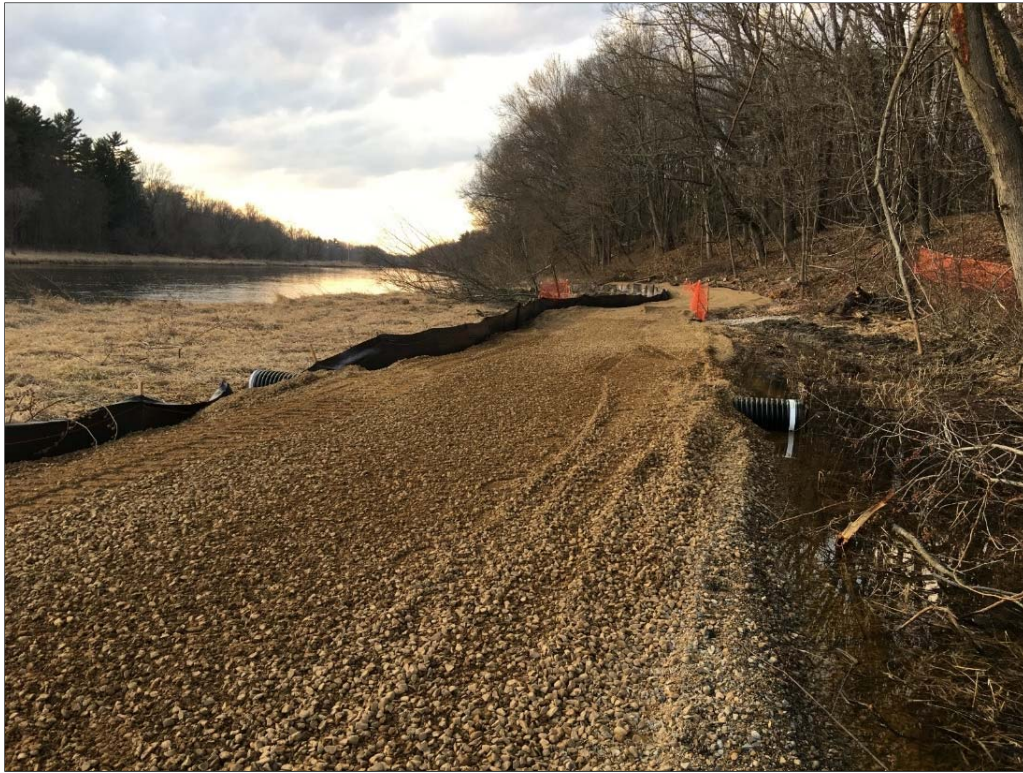
**Photo 27: Culvert installed beneath BRSA 6 access road for feeder stream flow (February 2017).**
