**FINAL REPORT**

**OTSEGO TOWNSHIP DAM AREA  
TIME CRITICAL REMOVAL ACTION  
OPERABLE UNIT 5, AREA 3  
ALLIED PAPER, INC. / PORTAGE CREEK / KALAMAZOO RIVER SUPERFUND SITE  
Docket V-W-16-C-009**

**Allegan County  
Otsego Township, Michigan**

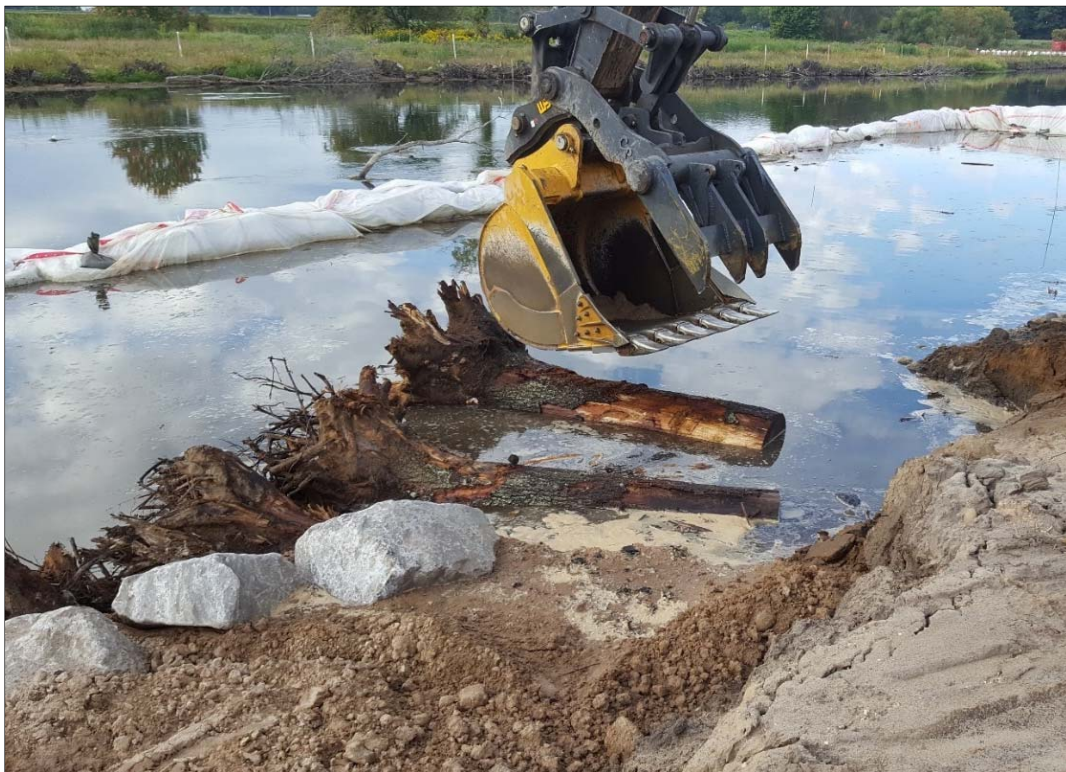
**Photo 28: BRSA 6 root wad restoration (September 2017).**

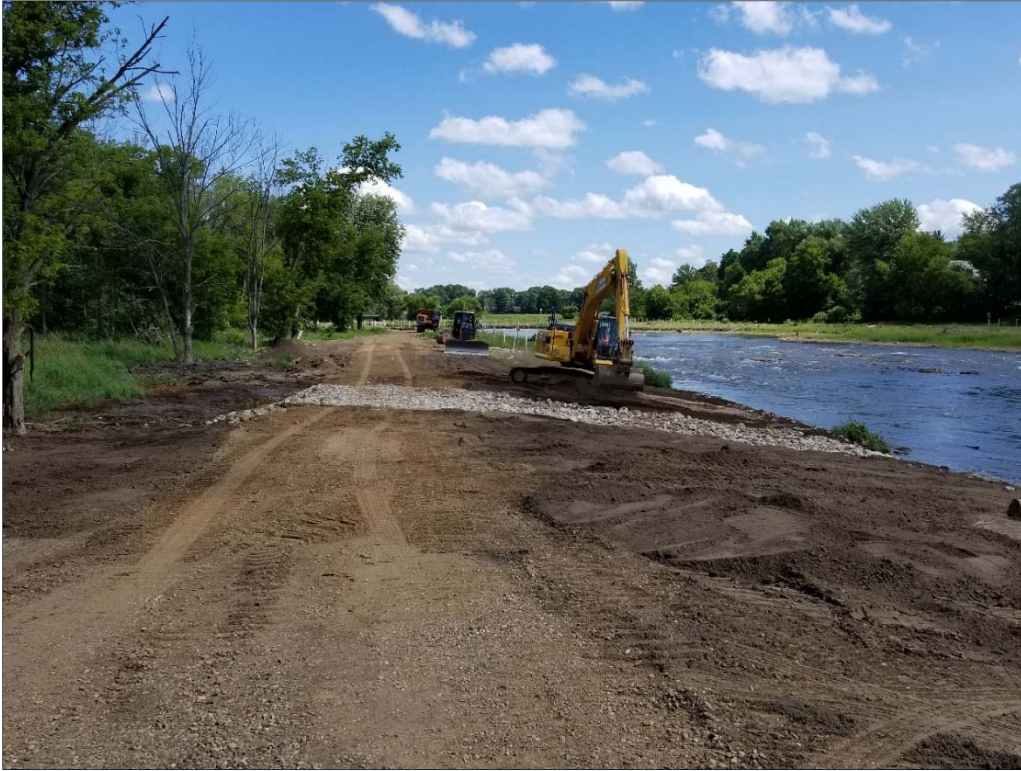
**Photo 29: Restoration of BRSA 6 floodplain discharge area near RDB STA 65+50 to 66+53 (October 2017).**

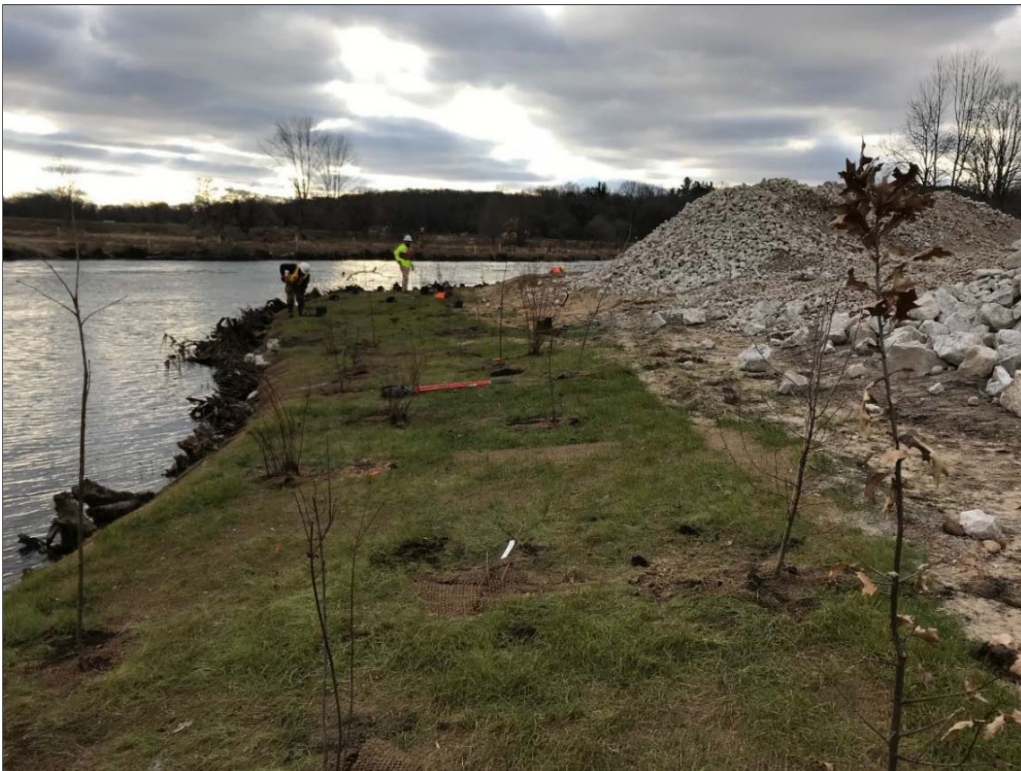
**Photo 30: Restoration planting in BRSA 6 grids 1 through 4 (December 2017).**

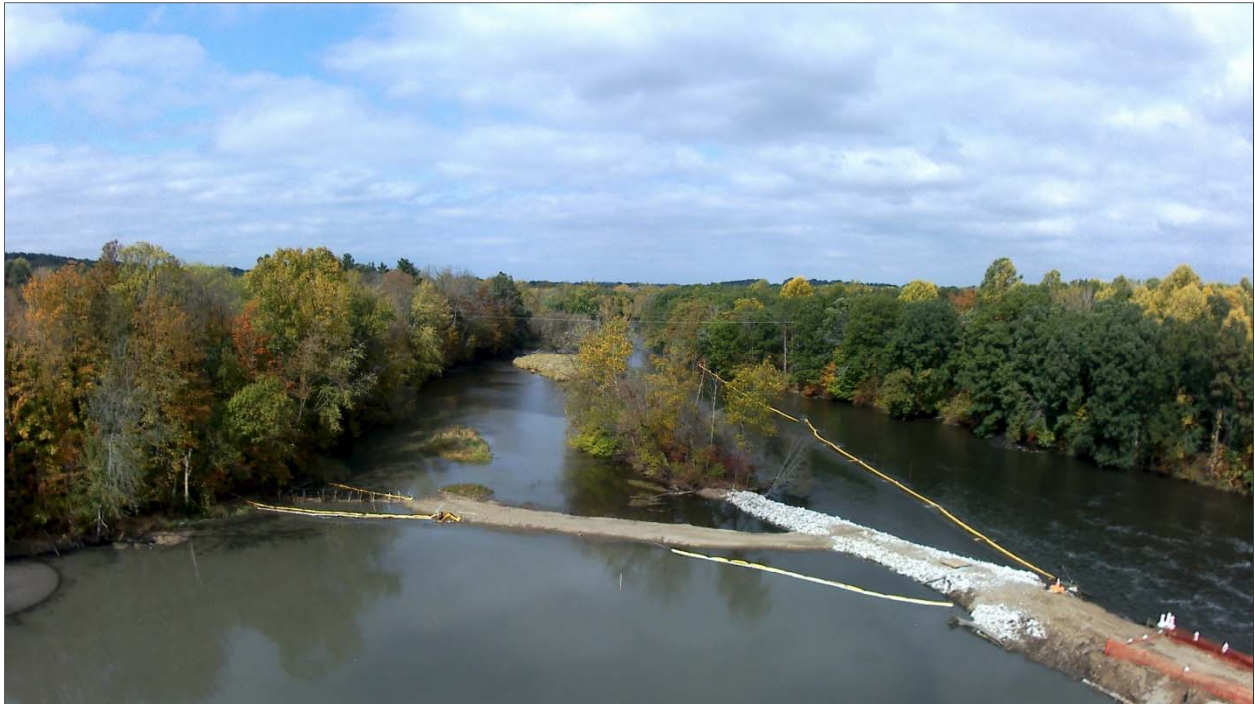
**Photo 31: Turbidity controls installed downstream of former WCS and plunge pool during pilot channel dredging (September 2017).**

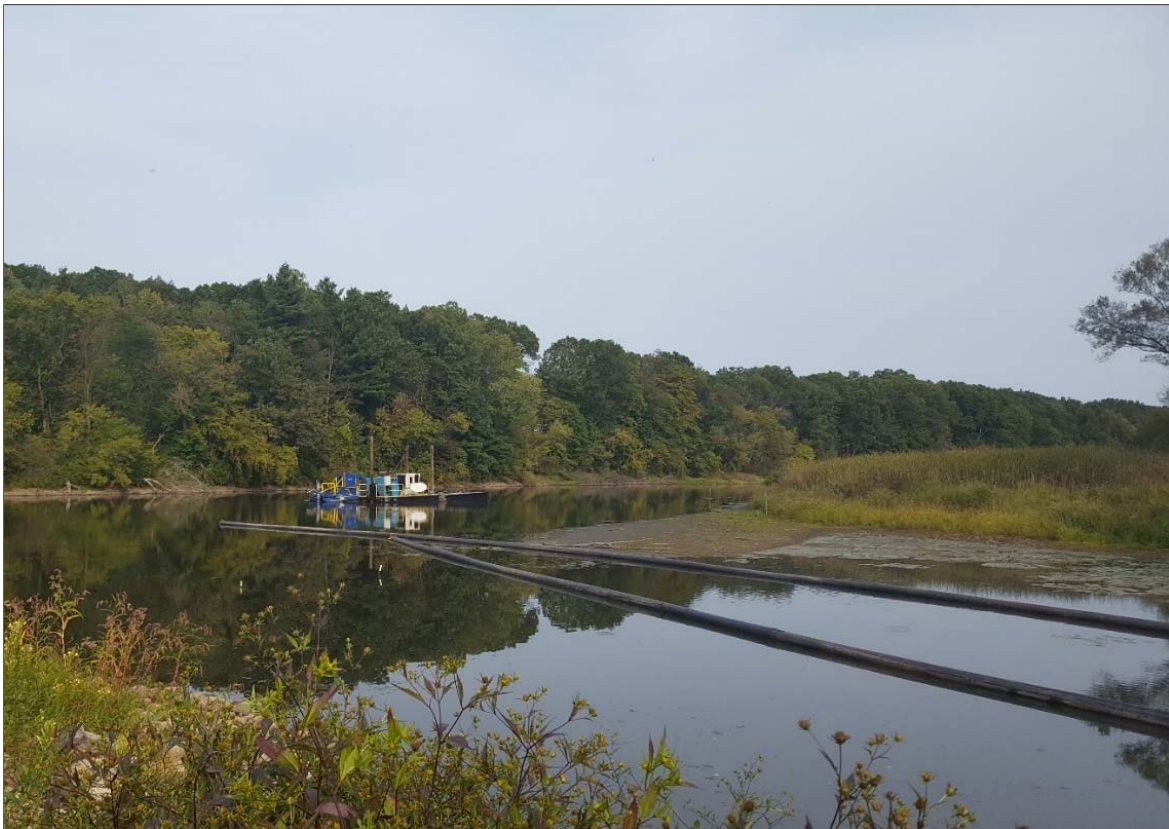
**Photo 32: Pilot channel dredge (September 2017).**

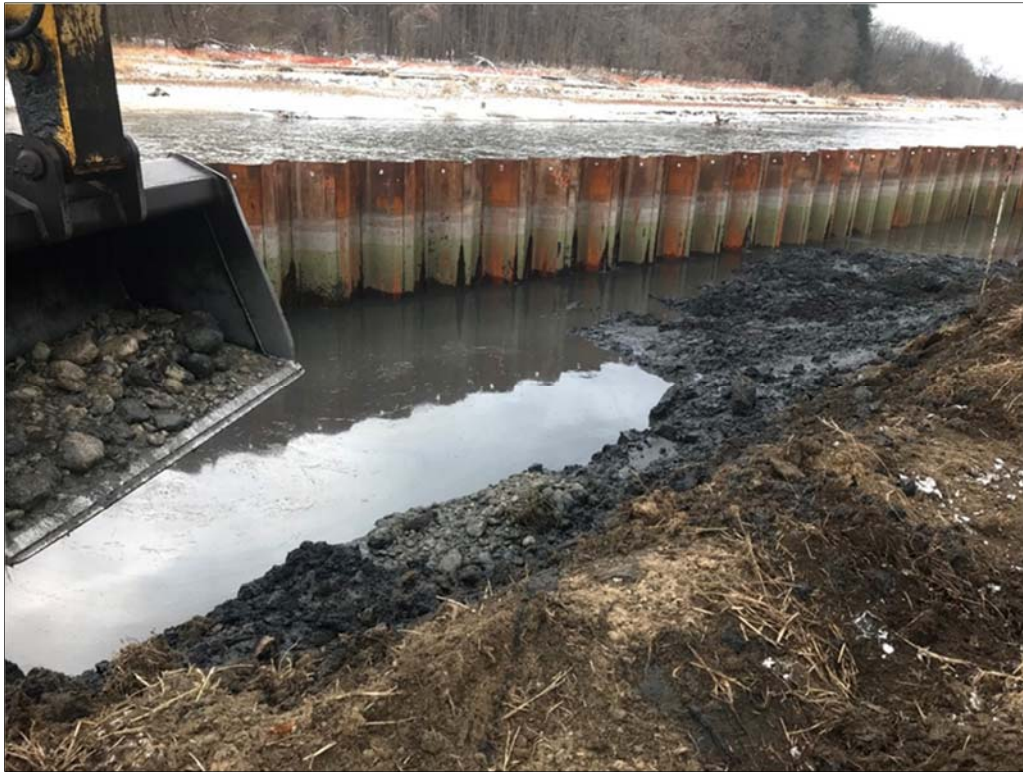
**Photo 33: BRSA 7 stream tube Grid 8 excavation inside sheet piling cofferdam (December 2017).**

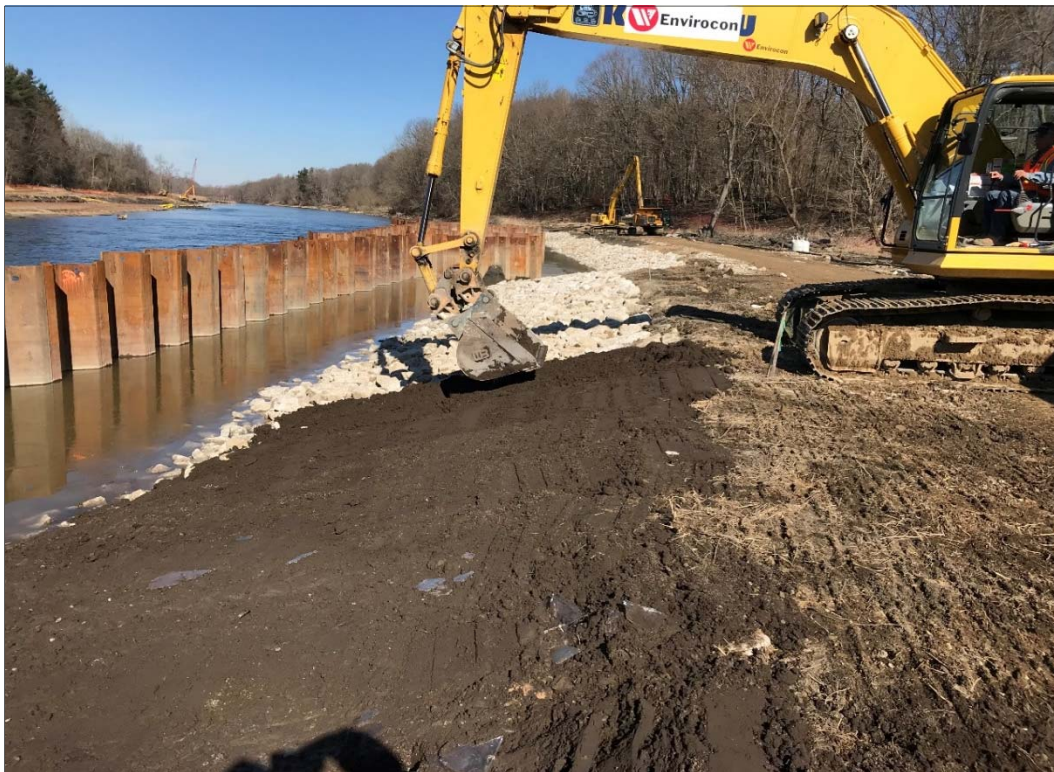
**Photo 34: Topsoil placed over joint planting rock during BRSA 7 restoration (March 2018).**

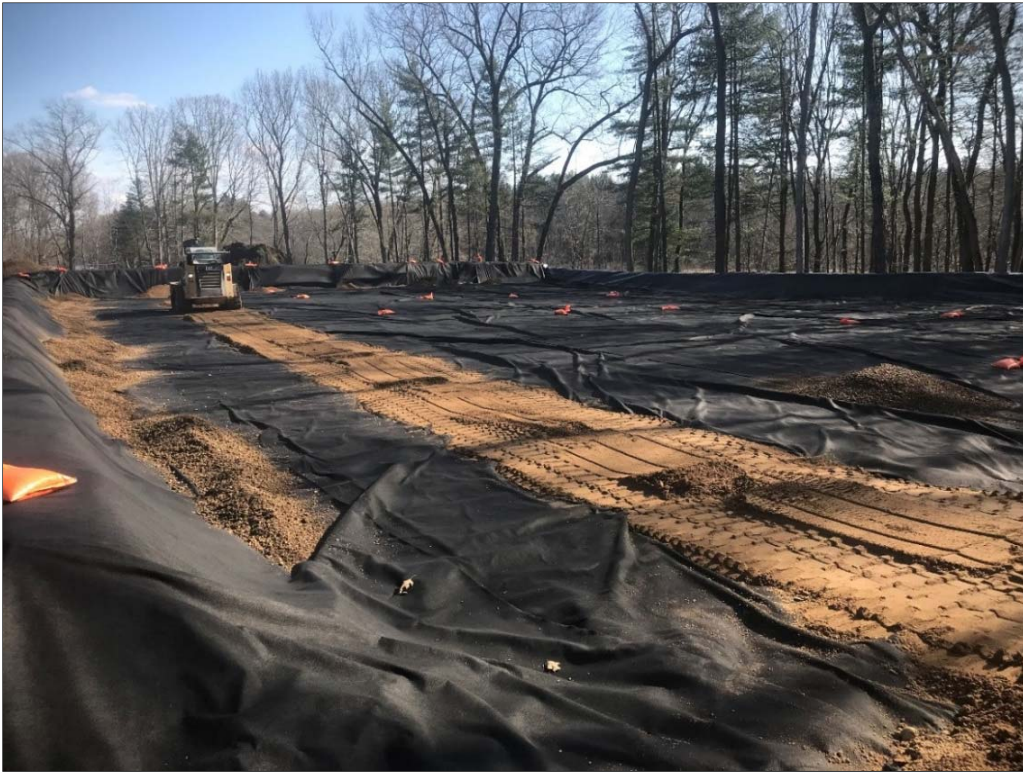
**Photo 35: Construction of BRSA 7 stabilization/load out pad at Command Center (April 2018).**

would need to be hauled, it was necessary to construct a stabilization/loadout pad at the Command Center for material excavated from grids downstream of (and including) grid 26 (refer to Photo 35 in Attachment A and [Figure 12-1](#)).

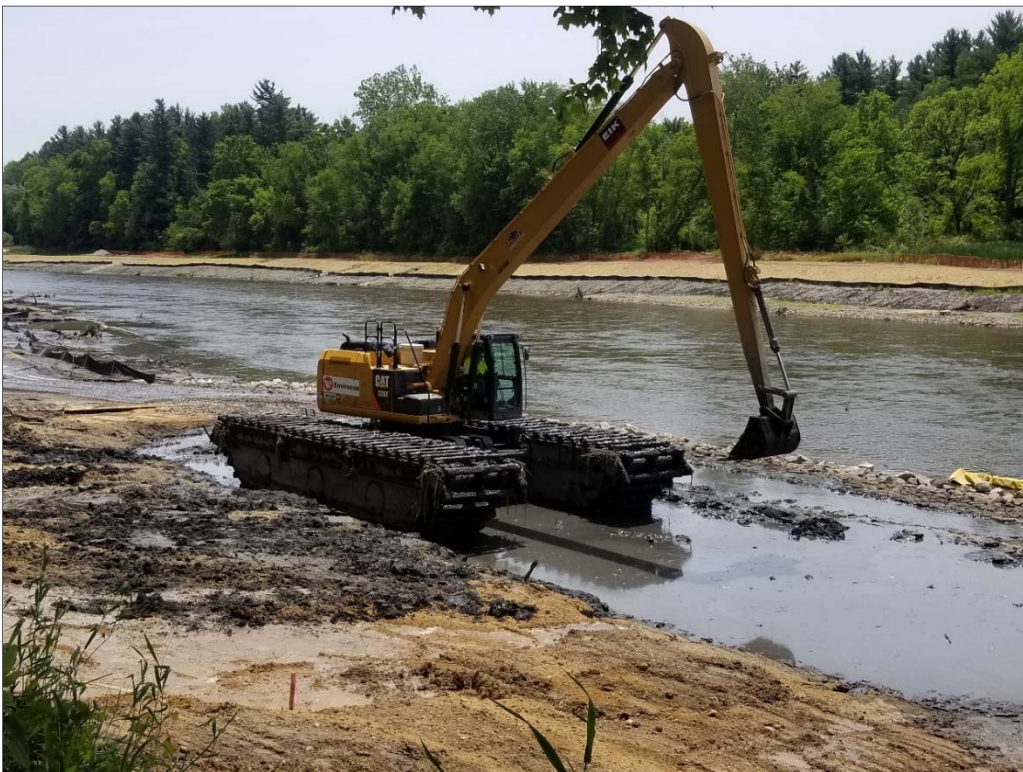
**Photo 36: Marsh excavator used during BRSA 7 and 8 construction (June 2018).**

Bank-based excavators, including the marsh excavator (Photo 36 in Attachment A), removed bank soil that exceeded the RAL of 5 mg/kg total PCBs to the design depth (or lower) and at least 10 feet perpendicular from the water's edge, creating the buffer zone mentioned in Section 1.1.

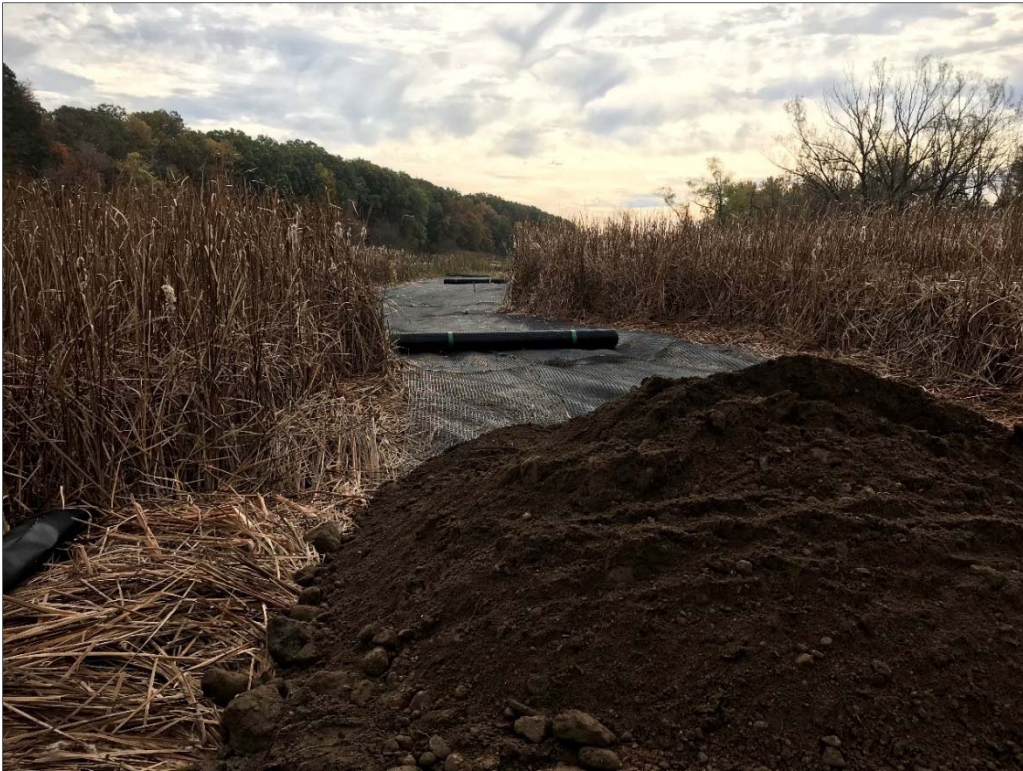
**Photo 37: BRSA 8 access road construction (October 2017).**

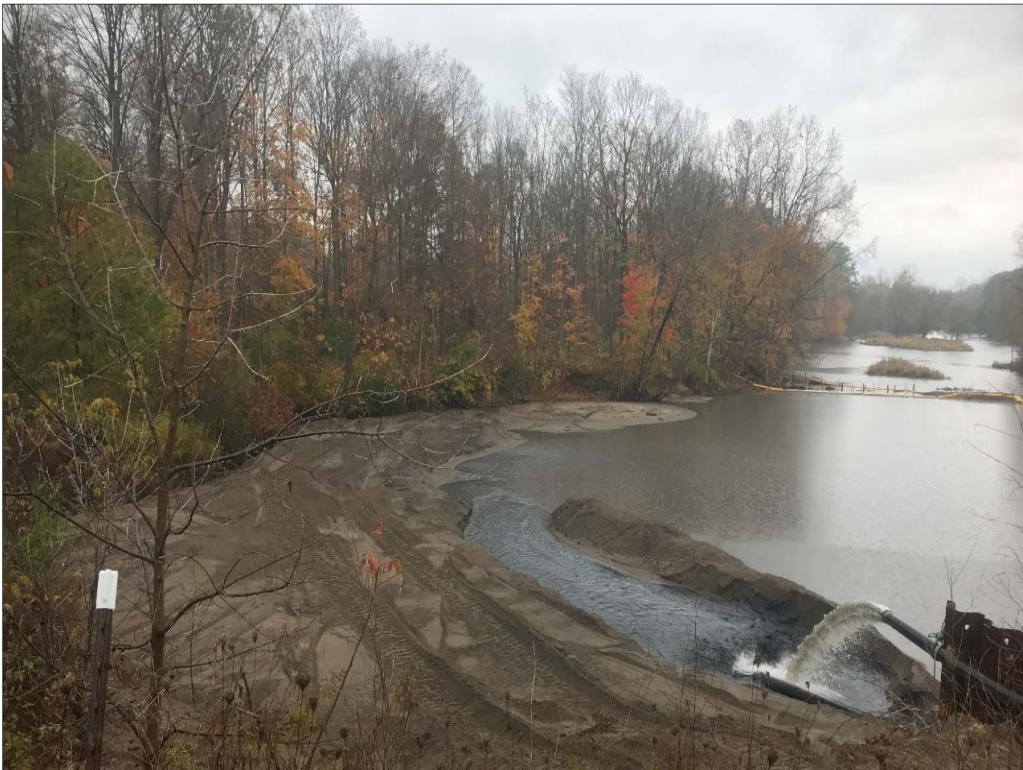
**Photo 38: Dredge material filling left descending bank of plunge pool (December 2017).**

The former WCS superstructure spanned approximately 180 feet. Prior to its removal, water levels were drawn down in coordination with MDNR by removing stop logs (Photo 38 in Attachment A). Stop logs were removed from the WCS from October 12 through November 9, 2017, lowering water levels a maximum of 6 inches per day. After completion of the drawdown, the superstructure was removed in two approximately 90-foot sections: first the northern half followed by the southern half (which was removed in three approximately 30-foot sections) (Photo 52 in Attachment A).

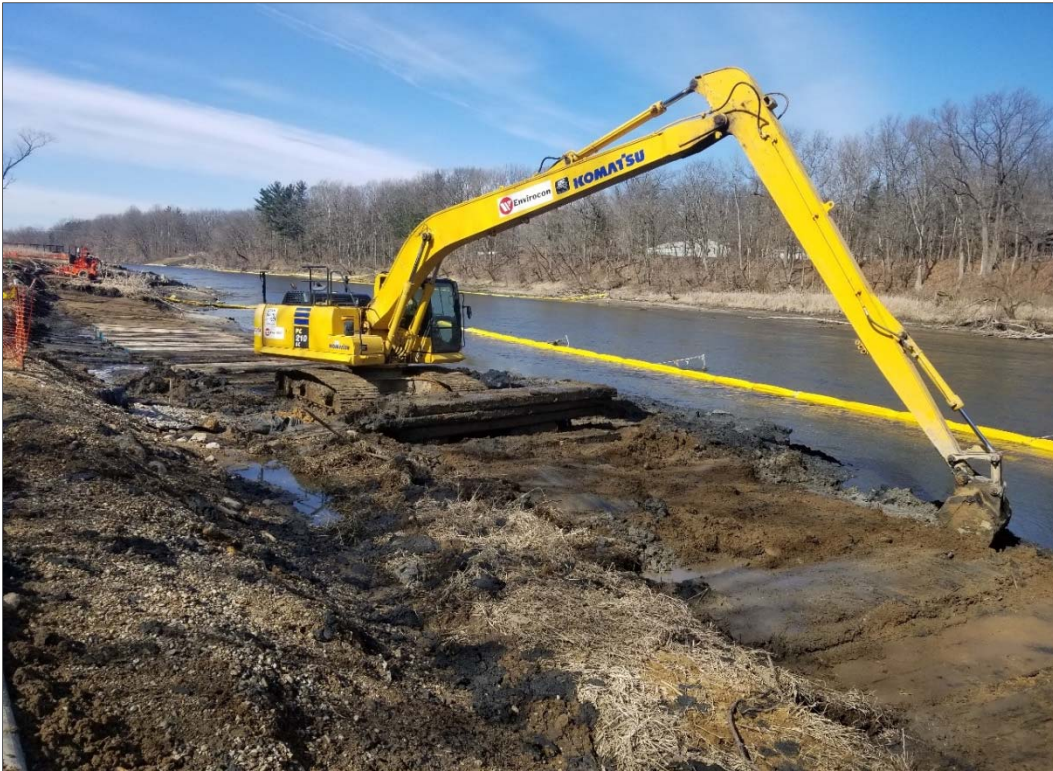
**Photo 39: Constructing BRSA 8 bank buildout (March 2018).**

- Remediation and restoration on the bank was completed from the access road; however, due to restricted access, a portion of the bank slope toe and near-shore sediment could not be reached. A marsh excavator was used to excavate the hard-to-access toe of slope and near-shore sediment (Photo 39 in Attachment A). Sediment that was excavated was used to fill void spaces in riprap associated with joint planting bank treatments.

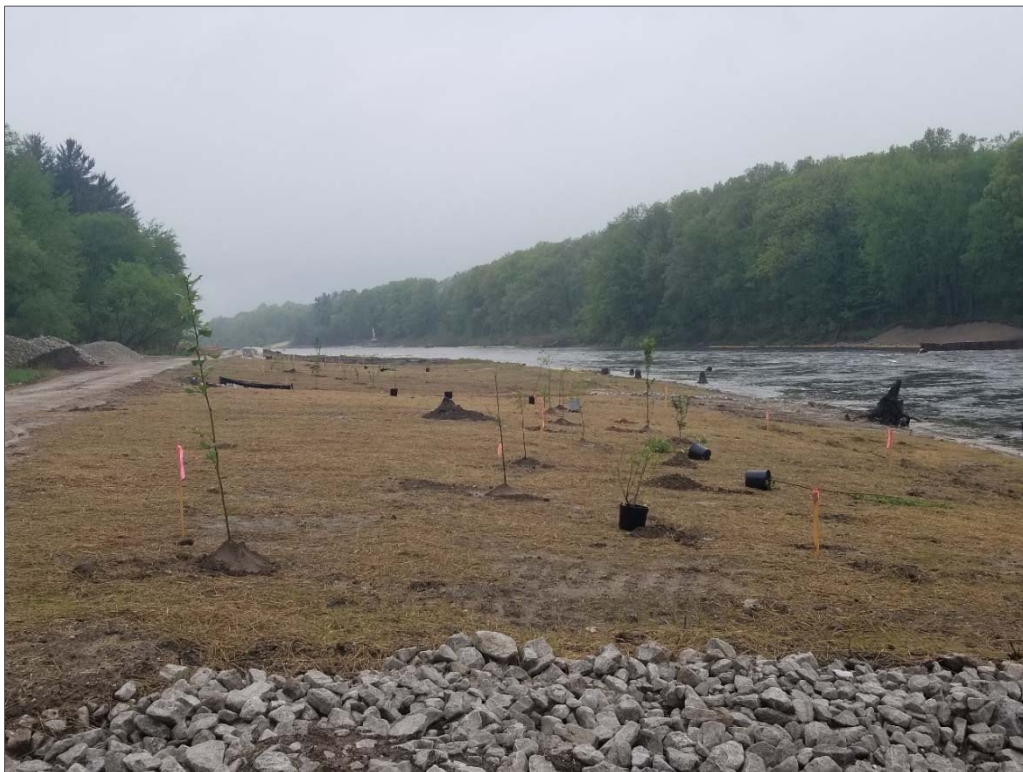
**Photo 40: BRSA 8 restoration planting (May 2018).**

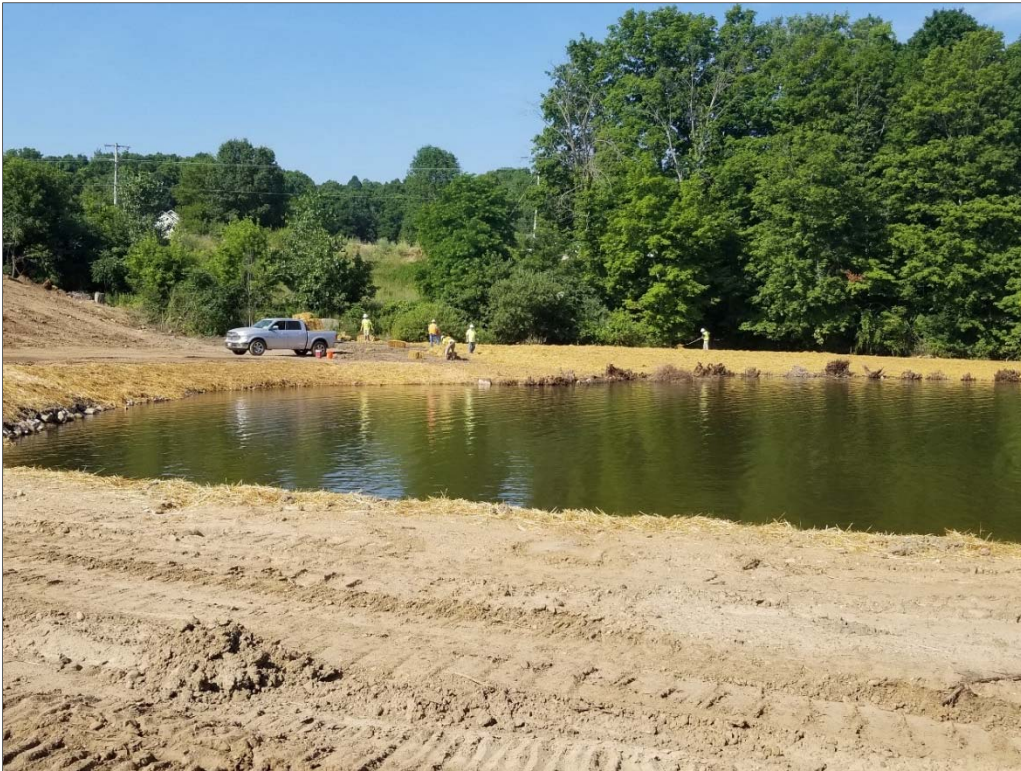
**Photo 41: Restoration of plunge pool area (July 2018).**

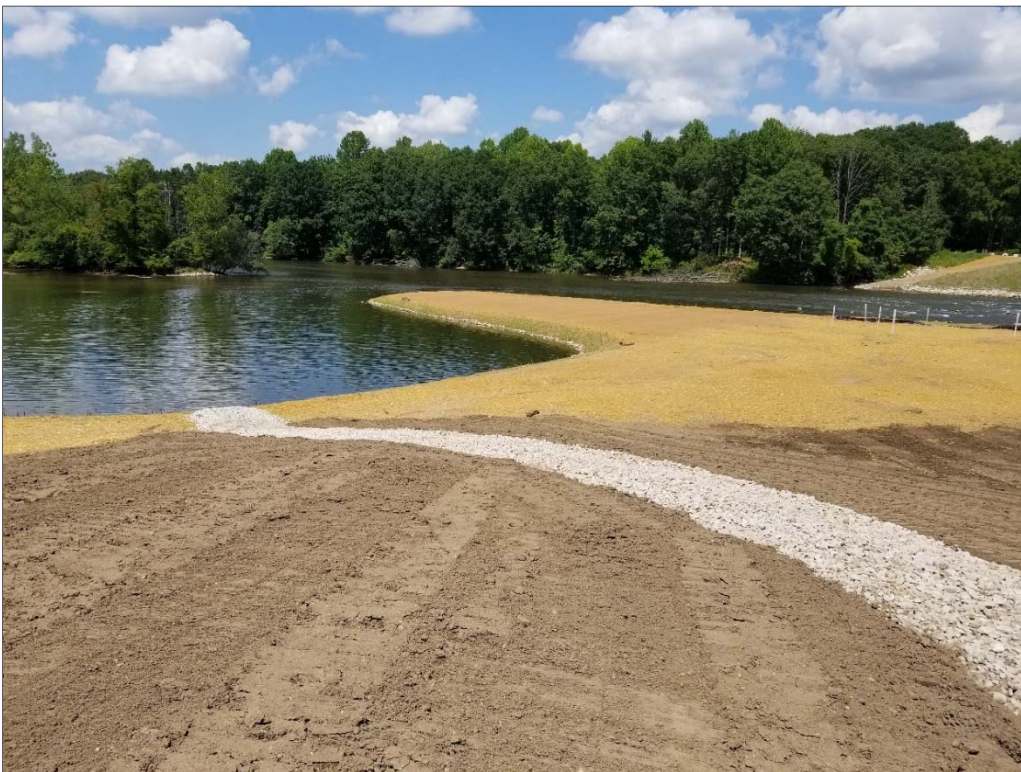
**Photo 42: Plunge pool area restoration (July 2018).**

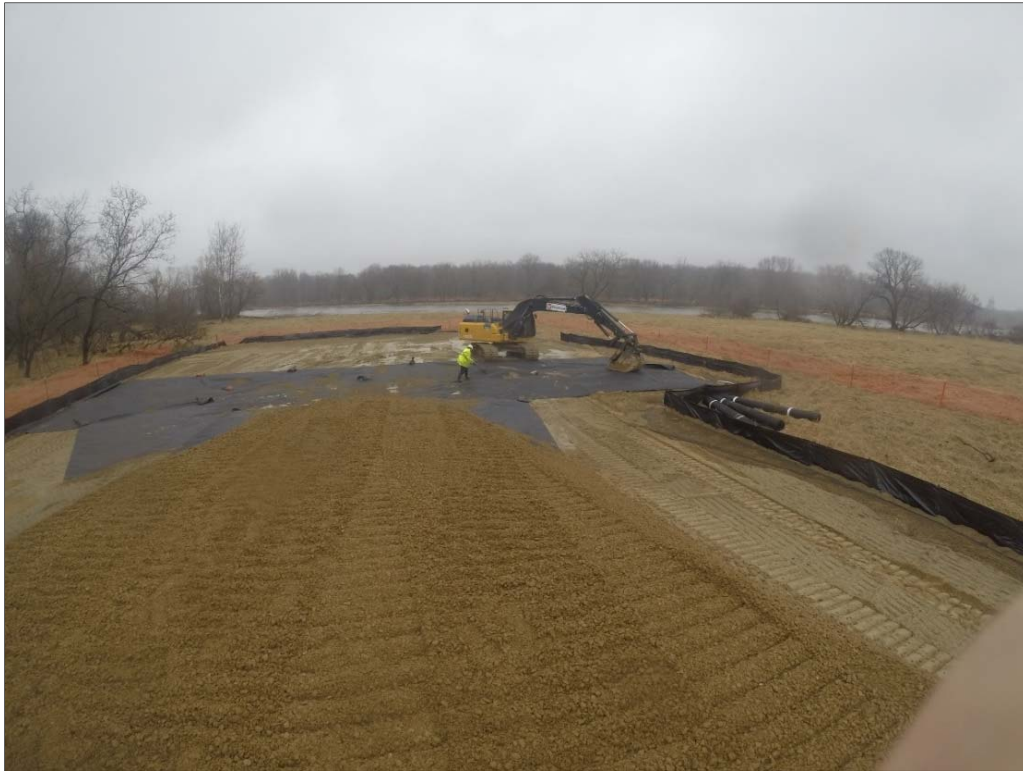
**Photo 43: Construction of BRSA 9 staging area (February 2017).**

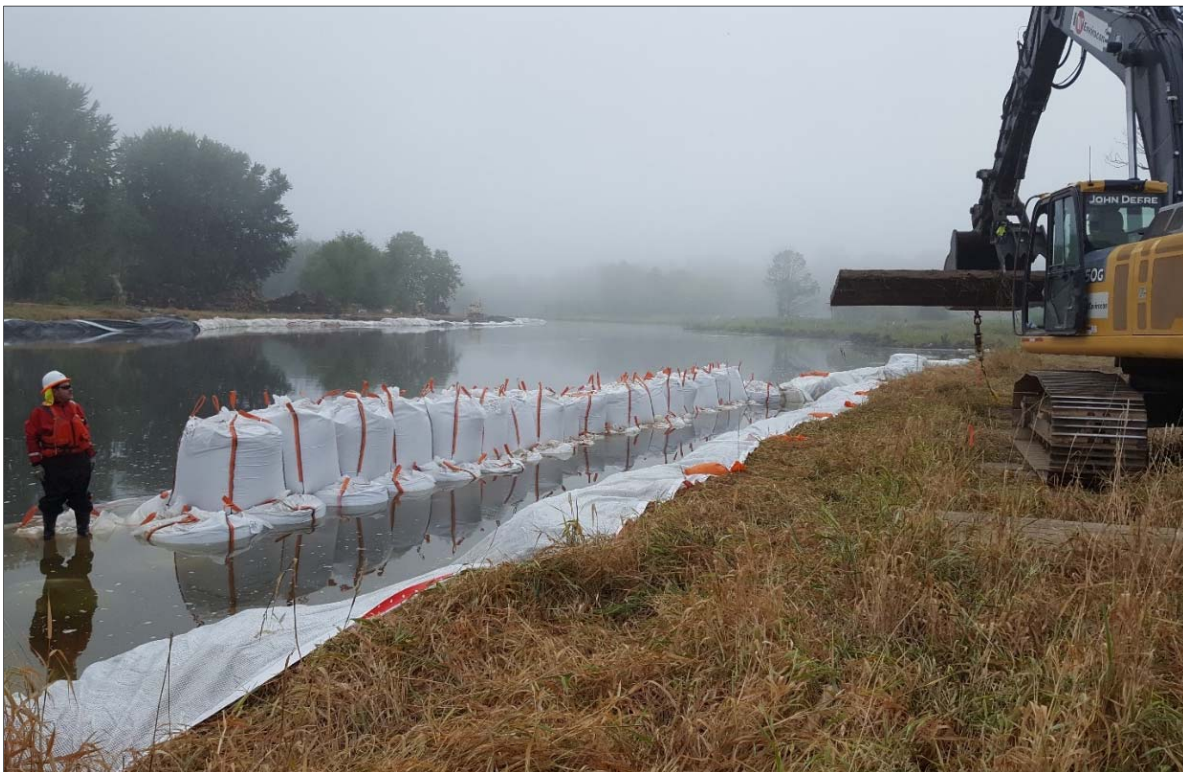
**Photo 44: BRSA 9 sand bag coffer dam installation (August 2017).**

BRSA 9 removal work began with installation of a sand bag cofferdam system as described in Section 5.12 (Photo 44 in Attachment A). Bank soil that exceeded the RAL of 5 mg/kg total PCBs was removed to the design depth (or lower) and at least 10 feet perpendicular from the water's edge, creating the buffer zone mentioned in Section 1.1. Bank-based excavators removed bank soil to the required design depths, including an overcut of approximately 6 inches. Pre-design sample results indicated that over half of the BRSA 9 bank did not require remediation excavation (bank grids 1-9, 16-29, and 36-38). In these grids, a 6-inch overcut of bank soil was removed and confirmation samples were collected.

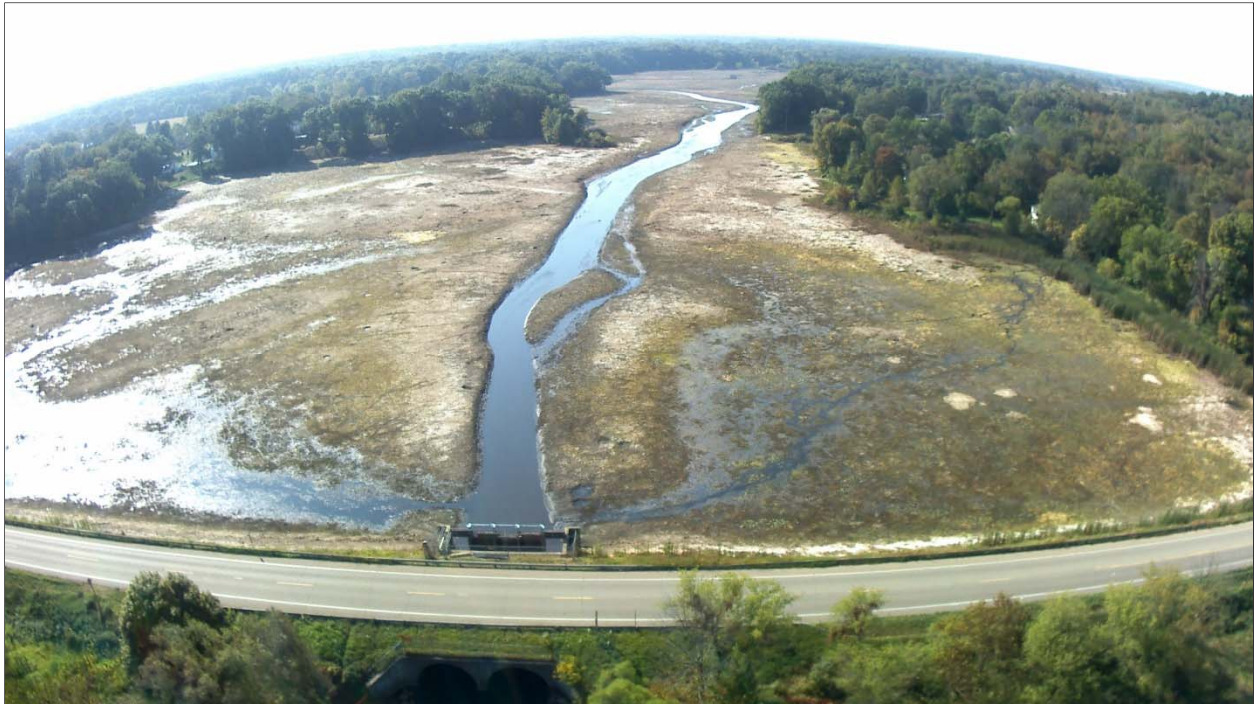
**Photo 45: Aerial view of Pine Creek reservoir during drawdown (September 2017).**

To facilitate removal of the Pine Creek stream tubes the Pine Creek Reservoir was drawn down over a period of 15 days (September 5 to 20, 2017, see Photo 45 in Attachment A). A scope of work for the Pine Creek WCS drawdown (located [here](#)) was submitted to and accepted by the Allegan County Drain Commissioner. The USEPA and START notified Pine Creek area property owners about the drawdown. During this initial drawdown, a fortified turbidity curtain was installed around the Pine Creek stream tubes and sediment was excavated to the design depths. A temporary bridge constructed of riprap overlying three 36-inch diameter culverts was installed at the end of Pine Creek between BRSAs 9 and 1 to facilitate access to the Pine Creek stream tubes. The Pine Creek drawdown was managed through coordination between USEPA, MDNR, EGLE, and Allegan County Drain Commissioner. As discussed in Section 5.6, pre-and post-construction inspections of the Pine Creek WCS were conducted (report located [here](#)).

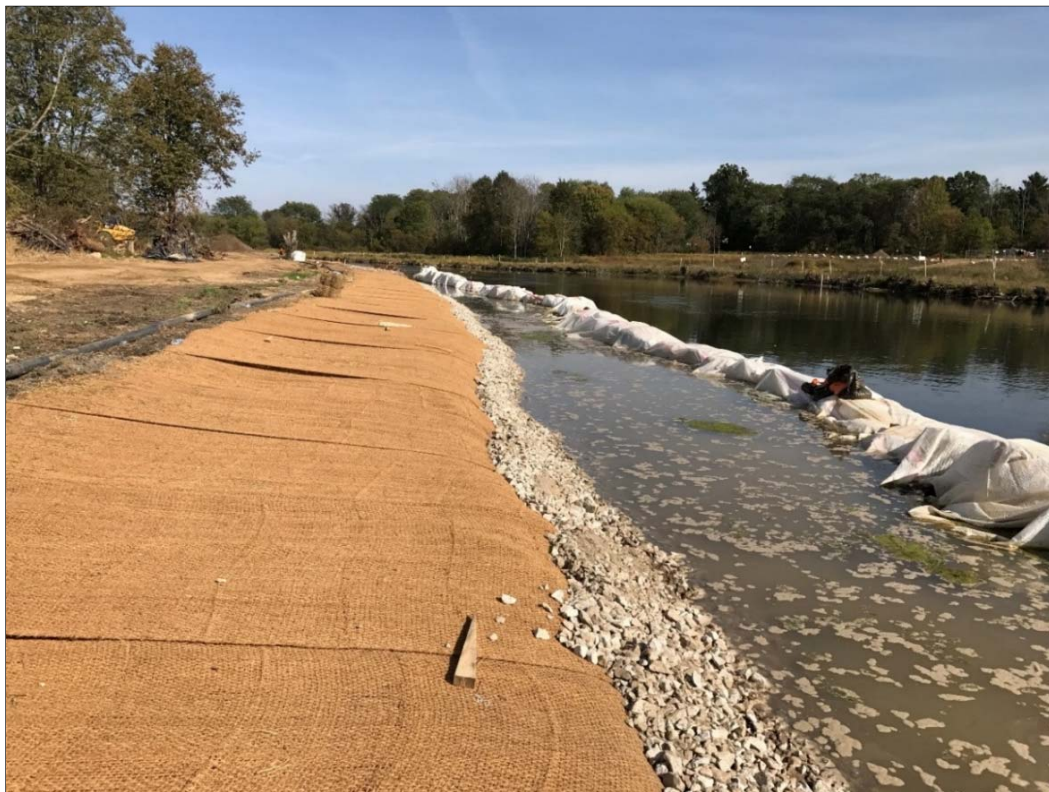
**Photo 46: BRSA 9 coir fabric restoration (October 2017).**

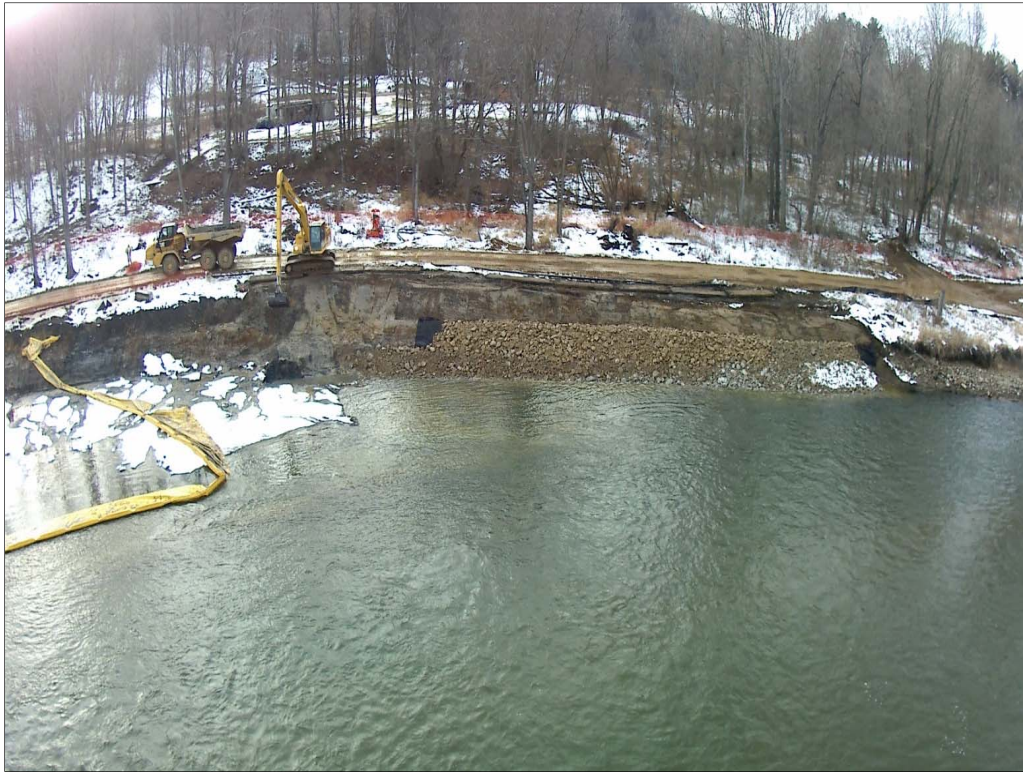
**Photo 47: BRSA 9 bank restoration (December 2017).**

The banks of BRSA 9 and the Pine Creek confluence were restored as described in Section 5.7 and stabilized using a combination of rootwads, coir fabric, and joint planting (Photos 47 and 48 in Attachment A). Table 14.1, below, outlines the restoration techniques used and Table 14.2 summarizes the imported materials (see Section 5.9 for sources). A final as-built survey was completed following restoration and is presented on the BRSA 9 Record Drawings, included as Attachment B (drawings C-144 to C-145).

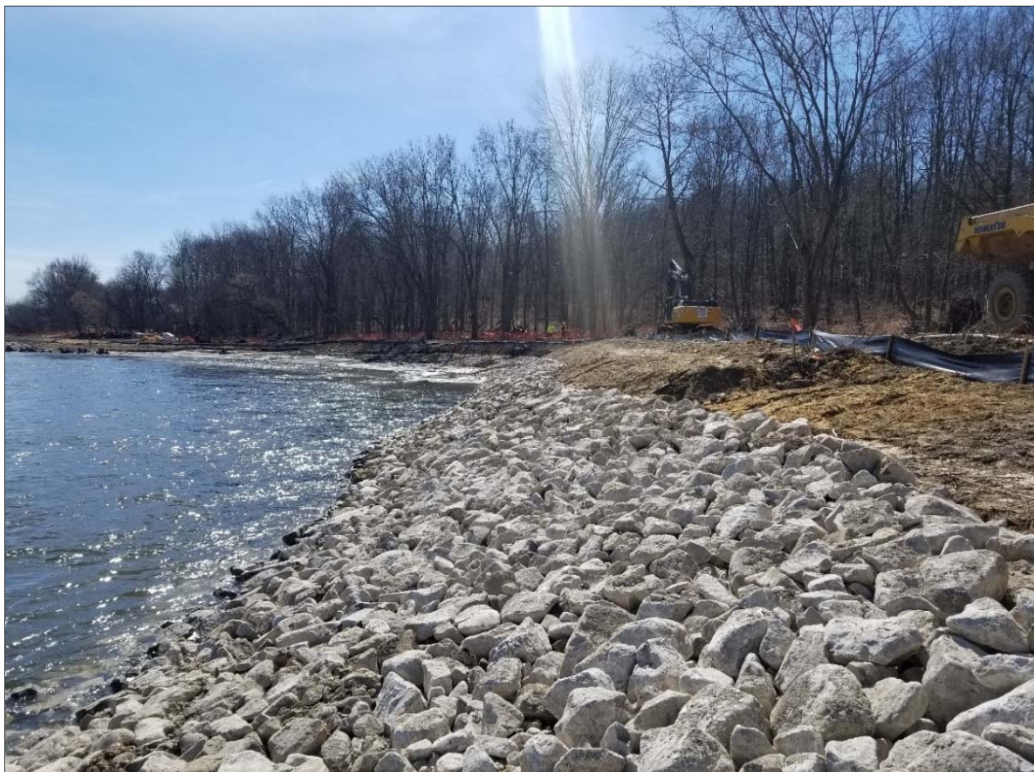
**Photo 48: BRSA 9 joint planting riprap (March 2018).**

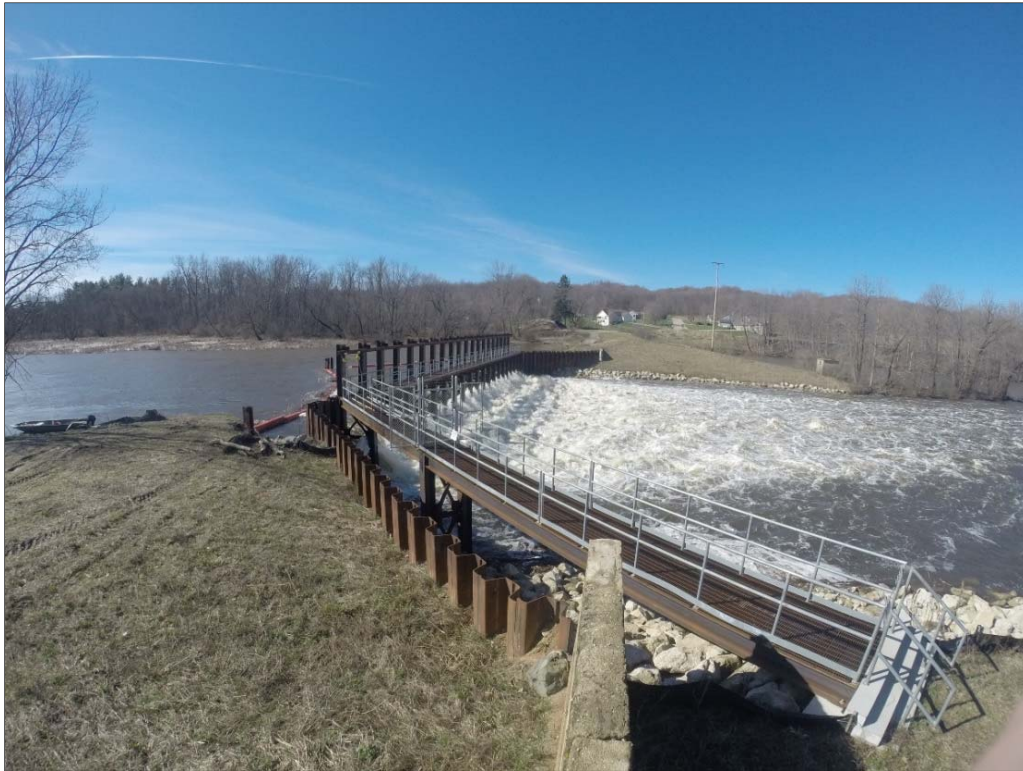
**Photo 49: View of former WCS before drawdown (April 2017).**

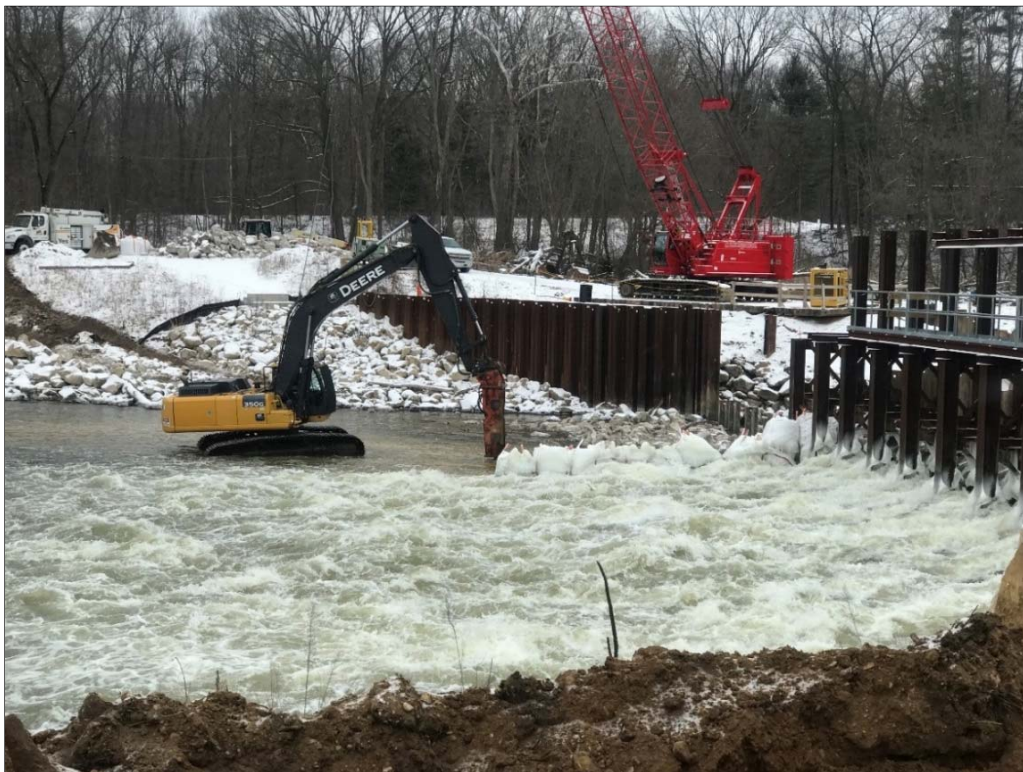
**Photo 50: Demolition of grouted riprap during removal of northern half of former WCS (January 2018).**

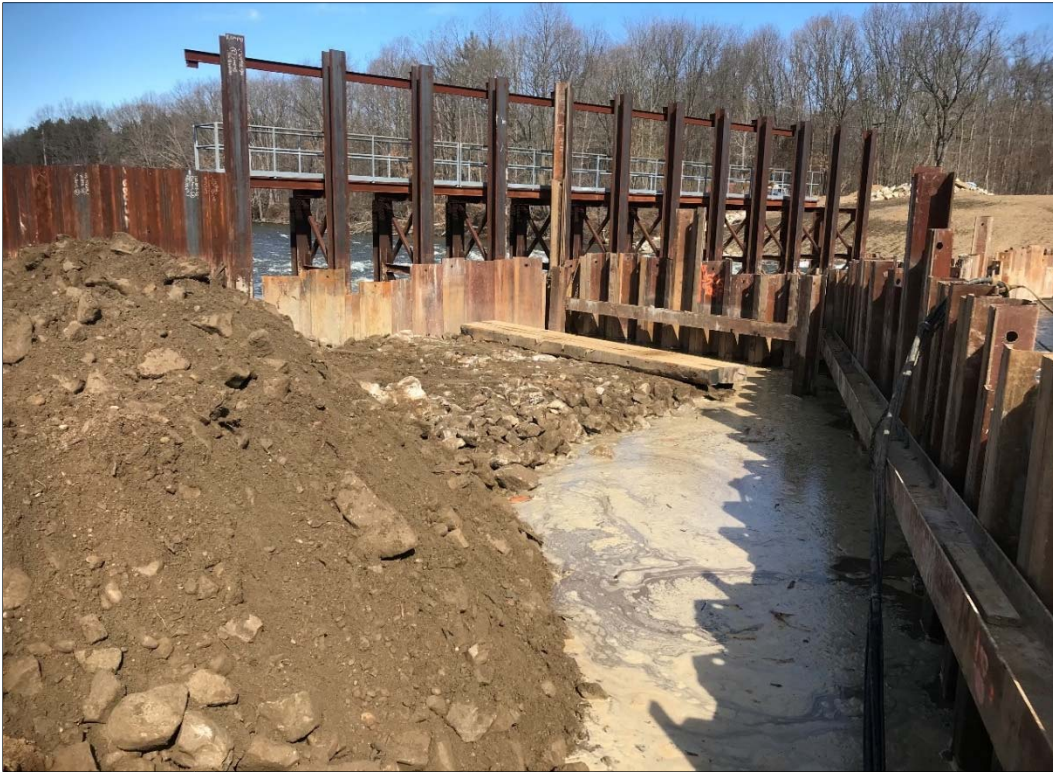
**Photo 51: Construction of crane pad for removal of southern portion former WCS (March 2018).**

approximately 672 feet amsl to facilitate removal and restoration of the WCS corridor. The southern half of the WCS was to be removed in a similar manner; however, a temporary cofferdam was installed from the center of the channel toward the bank due to limited crane access/reach from the south (Photo 51 in Attachment A). Sheeting was left in place from the northern temporary cofferdam and extended to the south. As the sheeting approached the LDB, a scour pool developed. The scour pool was filled with riprap and removal of the southern half of the WCS was modified to occur in three approximately 30-foot sections. This modification allowed for a larger portion of the river to remain open, helping to mitigate higher velocity and shear stress on the banks and along the temporary sheet pile cofferdam. Demolition of the WCS, removal of the core wall, installation of the leading-edge transition, breaking up the grouted riprap, construction of the 2 percent slope and trailing edge armoring was completed similar to the northern portion described above. Refer to the construction sequencing figures, [here](#), for further details.

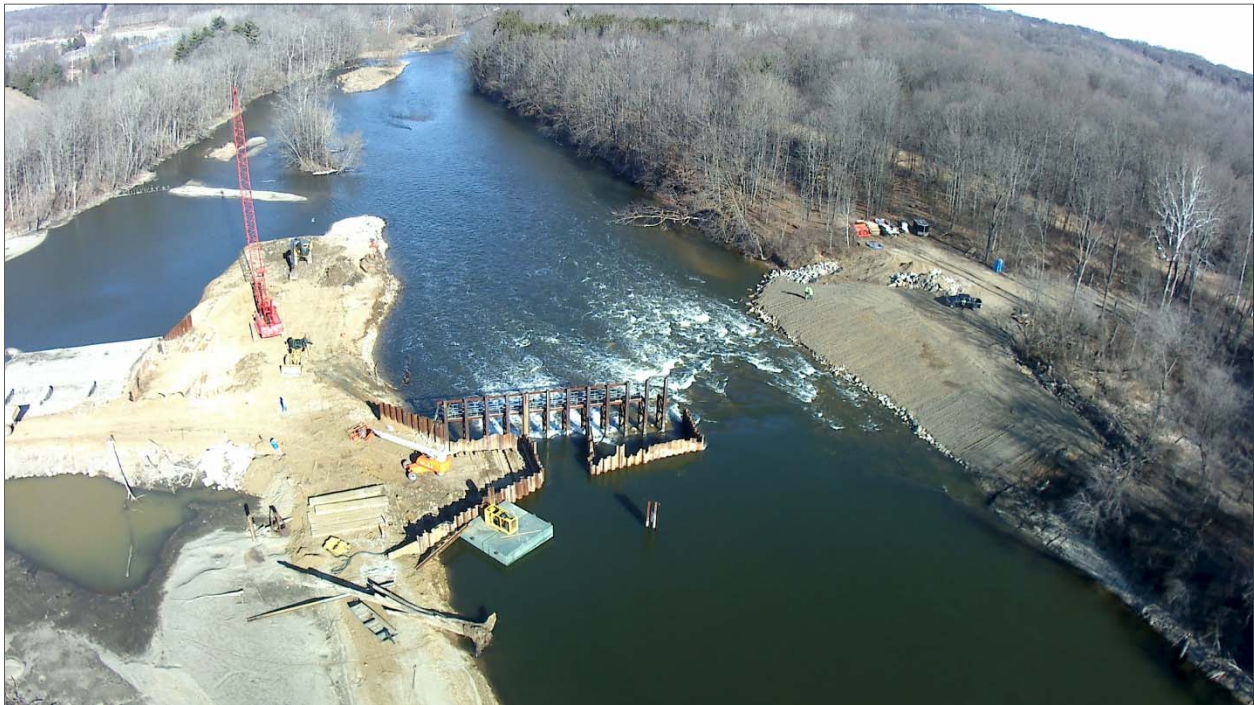
**Photo 52: Aerial view during removal of former WCS (April 2018).**

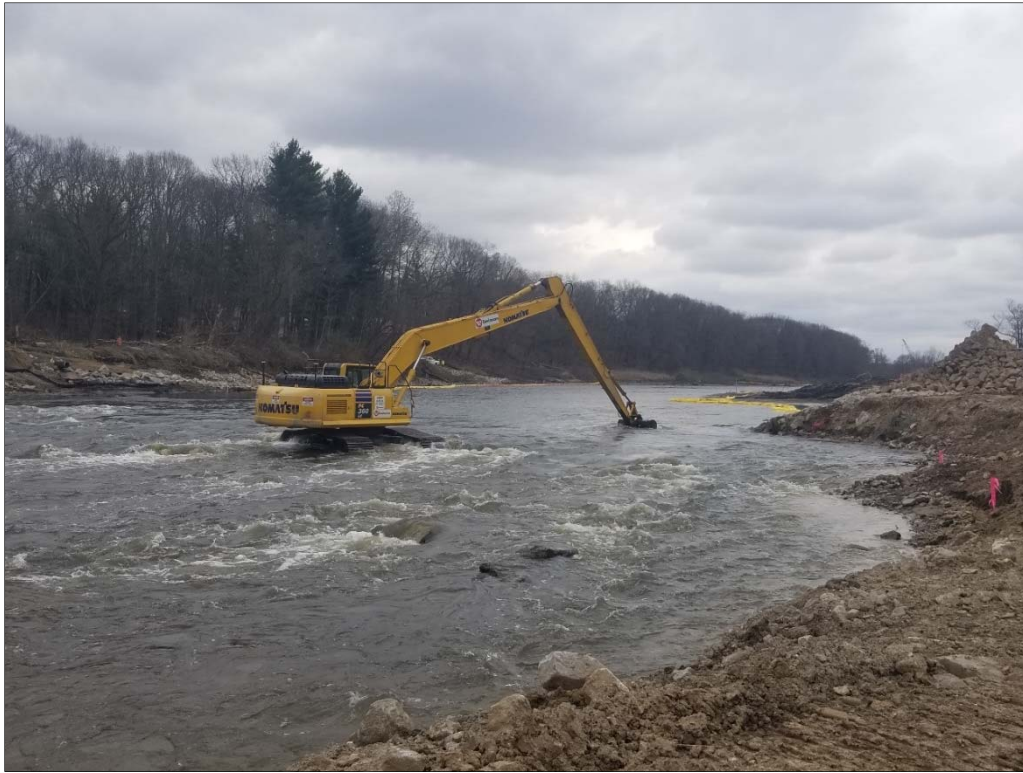
**Photo 53: Excavator grading 2% riverbed slope (former WCS corridor restoration, April 2018).**
