**FINAL REPORT**

**OTSEGO TOWNSHIP DAM AREA  
TIME CRITICAL REMOVAL ACTION  
OPERABLE UNIT 5, AREA 3  
ALLIED PAPER, INC. / PORTAGE CREEK / KALAMAZOO RIVER SUPERFUND SITE  
Docket V-W-16-C-009**

**Allegan County  
Otsego Township, Michigan**

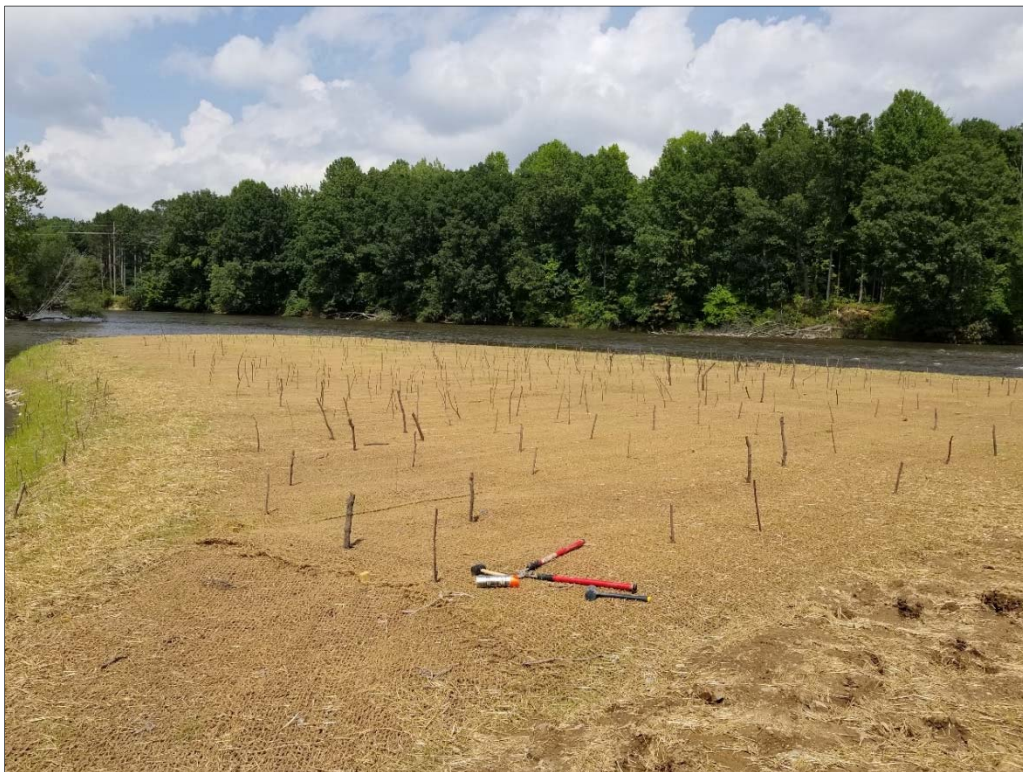
**Photo 54: Live stake planting (peninsula between former WCS corridor and plunge pool, August 2018).**

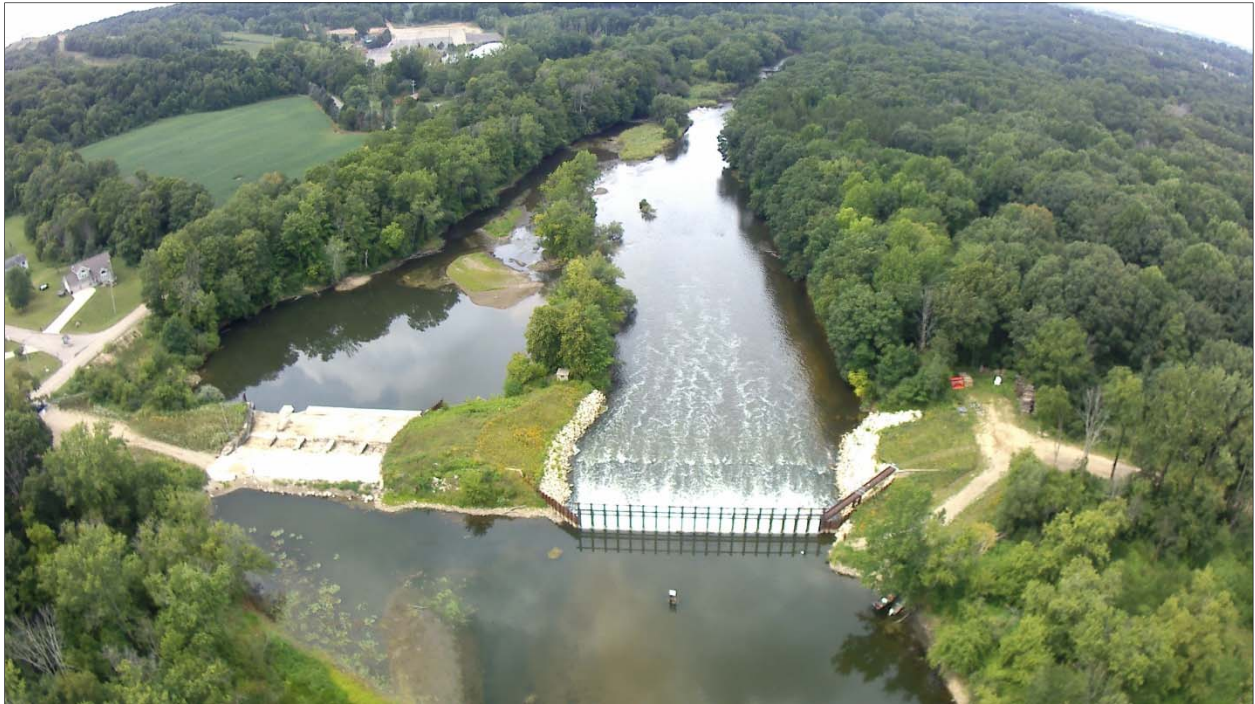
**Photo 55: View of former WCS and former auxiliary spillway prior to removal, looking downstream.**

Joint planting was installed along both banks of the former WCS corridor, and included reuse of existing WCS material. A 20-foot wide low-flow bench was constructed with riprap along the LDB as described in the PRSCP. The north side of the WCS corridor, upslope of the joint planting restoration, was restored using erosion blankets and planted with an upland seed mix. A boat access ramp was constructed to facilitate access to the river for M&M activities. The entire peninsula on the south side of the WCS corridor was regraded to an upstream elevation of 672 feet amsl and a downstream elevation of 666 feet amsl to provide connection with the former auxiliary spillway area and to reduce velocities associated with higher flow events (Photo 53, Attachment A). Excess material from removal of the peninsula was used to establish proper grades and restoration upstream of the former auxiliary spillway. The peninsula was restored with top soil, seed, core fabric and live stakes (Photos 42 and 54 in Attachment A). Restoration techniques used in the WCS corridor are shown on [Figure 13-2](#). A final as-built survey was completed following remediation. The as-built survey is presented on the WCS Records Drawings, which is included as Attachment B of the PRSCP ([here](#)). Photo 55 in Attachment A shows the WCS corridor prior to removal of the WCS, and Photo 56 shows the WCS corridor after removal and restoration

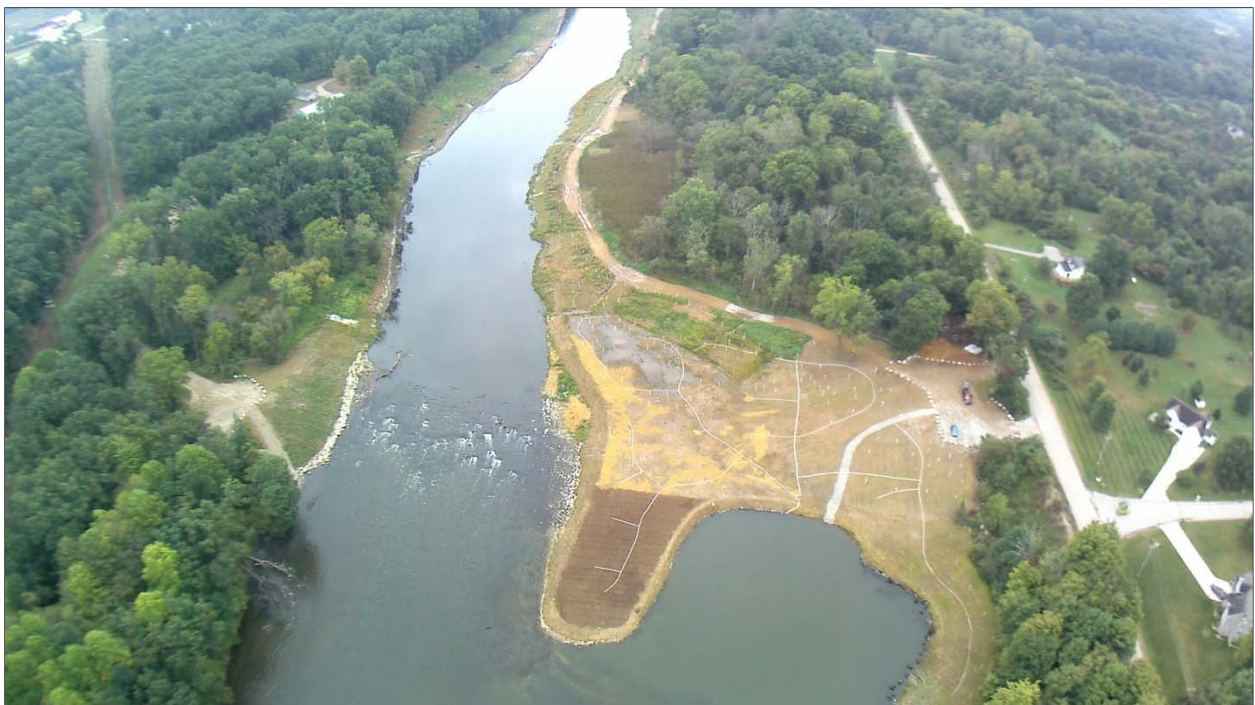
**Photo 56: View after removal of former WCS and restoration of former WCS corridor and plunge pool area, looking upstream.**
