**Incident Briefing
US Environmental Protection Agency
Report as of July 26, 2017**

Carribeau Mill Site

Site Description: The EPA Region 8 Removal Program is conducting a Time Critical Removal Action (TCRA) at the Carribeau Mill Area in the Iron Springs Mining District. This action began the week of July 17th.

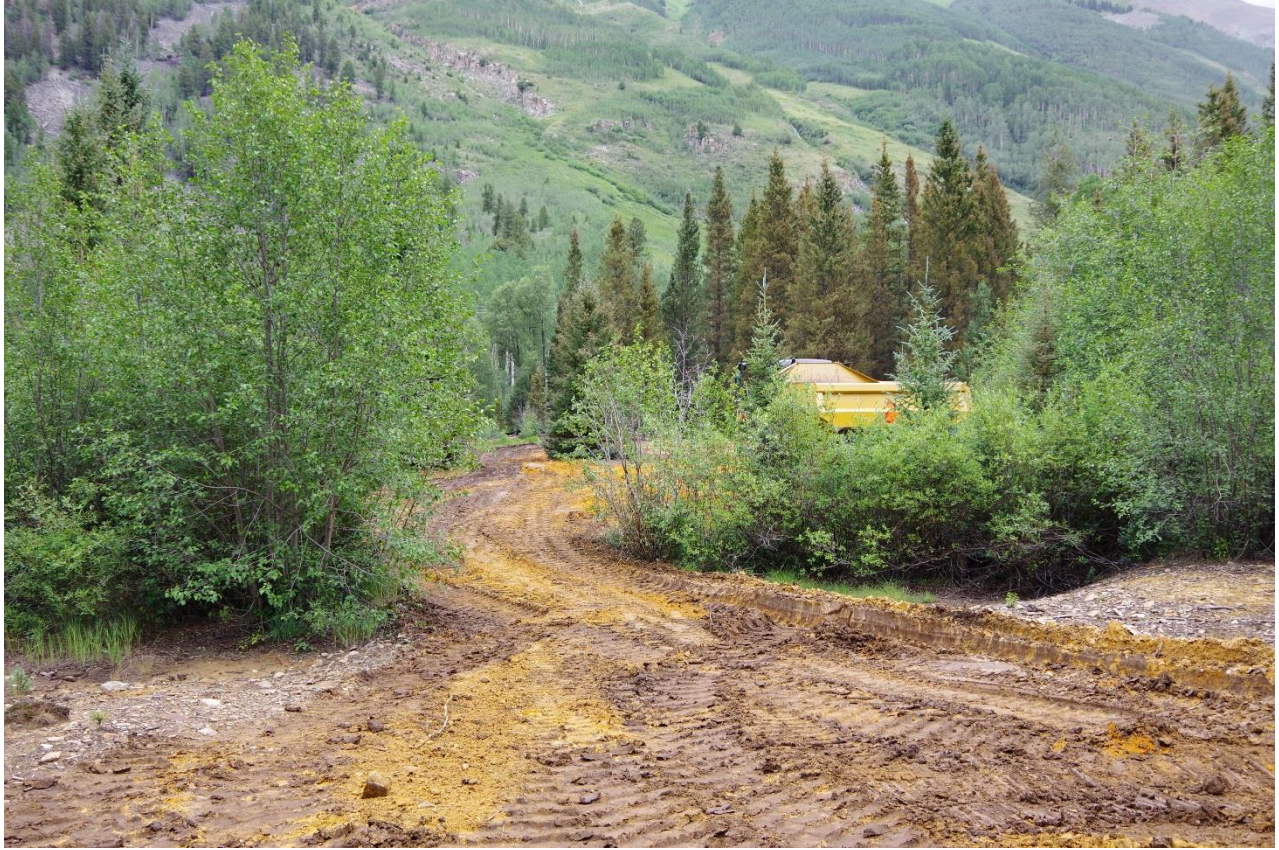
Scraping of clean soil and exposing tailings.

Set up office space, equipment mobilization, clearing and grubbing of vegetation, scraping of clean soil for repository.

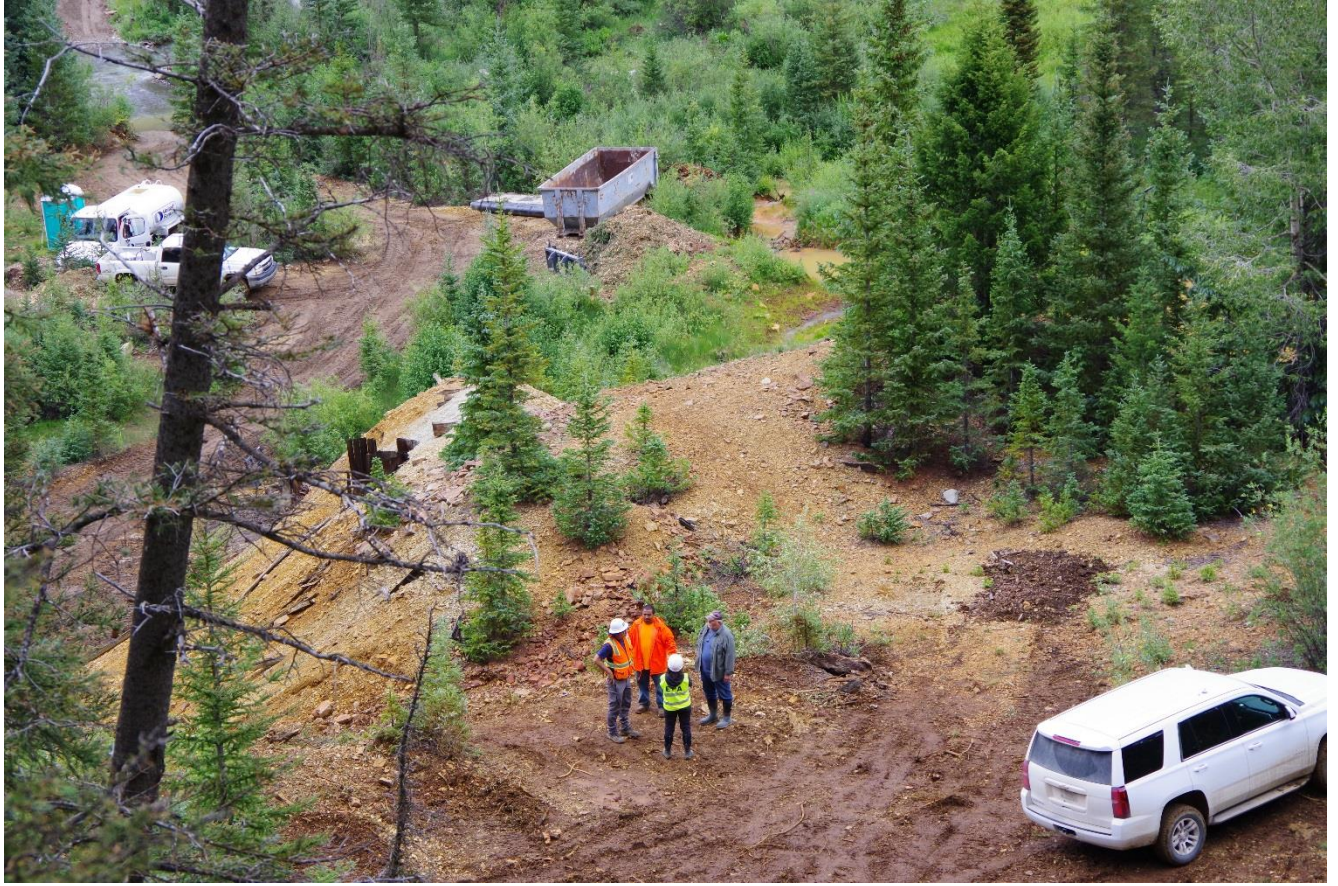
Engineering consult for repository design on 7/25/17.

On July 25, 2017, Deere & Ault's mining engineer, Christoph Goss, conducted site walk and peer review on Hays Griswold's repository design. He ensured the design was technically sound as well as provided guidance on stability sloping, avoiding groundwater tables, etc.
