Work Plan
Camp Bird Removal Action
07/07/2017

Site Name: Camp Bird Mine
Site ID: A8H9

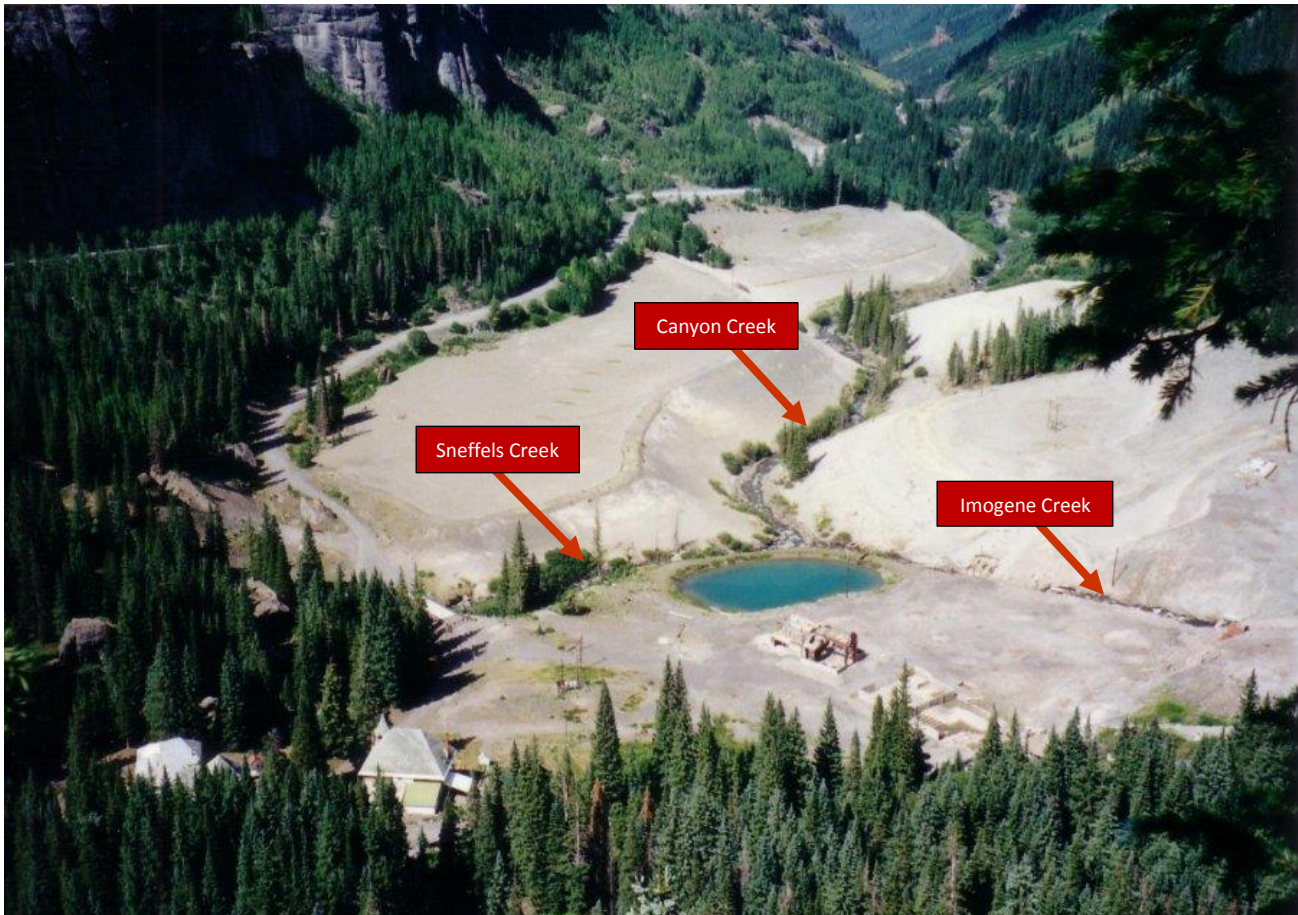
Aerial View of the Camp Bird Mine at the Entrance to Level 14 in 2002¹

The Camp Bird Mine is an underground mine, located 6 miles south of Ouray, Colorado. The Site subject to this Work Plan consists of three cells of tailings that are located near the entrance to the 14-Level of the mine. These tailings rest in direct proximity to Sneffels, Imogene and Canyon Creeks (see attached Site Map). Sneffels and Imogene Creeks enter the Site upstream and combine near the center of the tailings to form Canyon Creek. Canyon Creek flows downstream to Ouray.

The two tailings cells located on the south side of Canyon Creek are referred to as the “historic tailings” and are associated with milling activities believed to date back to the early 1900s. The third and largest tailings cell located on the north side of Canyon Creek is referred to as the “modern tailings” and was last used for disposal in the late 1990s. The modern tailings occur within the boundary of an active mining permit that is administered by the Colorado Division of Reclamation, Mining and Safety (DRMS).
