Work Plan
Camp Bird Removal Action
05/30/2017

Site Name: Camp Bird Mine

Site ID: A8H9

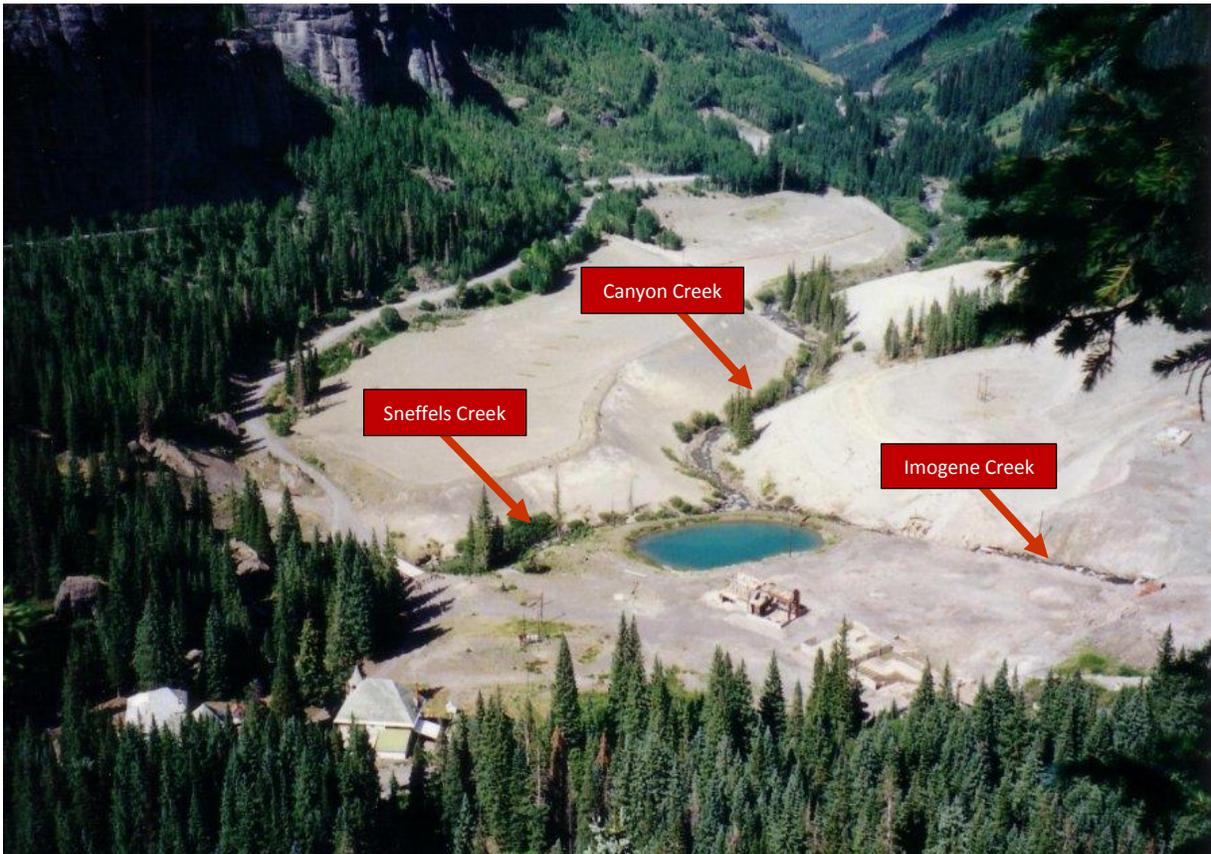
Aerial View of the Camp Bird Mine at the Entrance to Level 14 in 2002¹
