**Work Plan**  
Camp Bird Removal Action  
Revised 08/22/2017

**Site Name:** Camp Bird Mine  
**Site ID:** A8H9

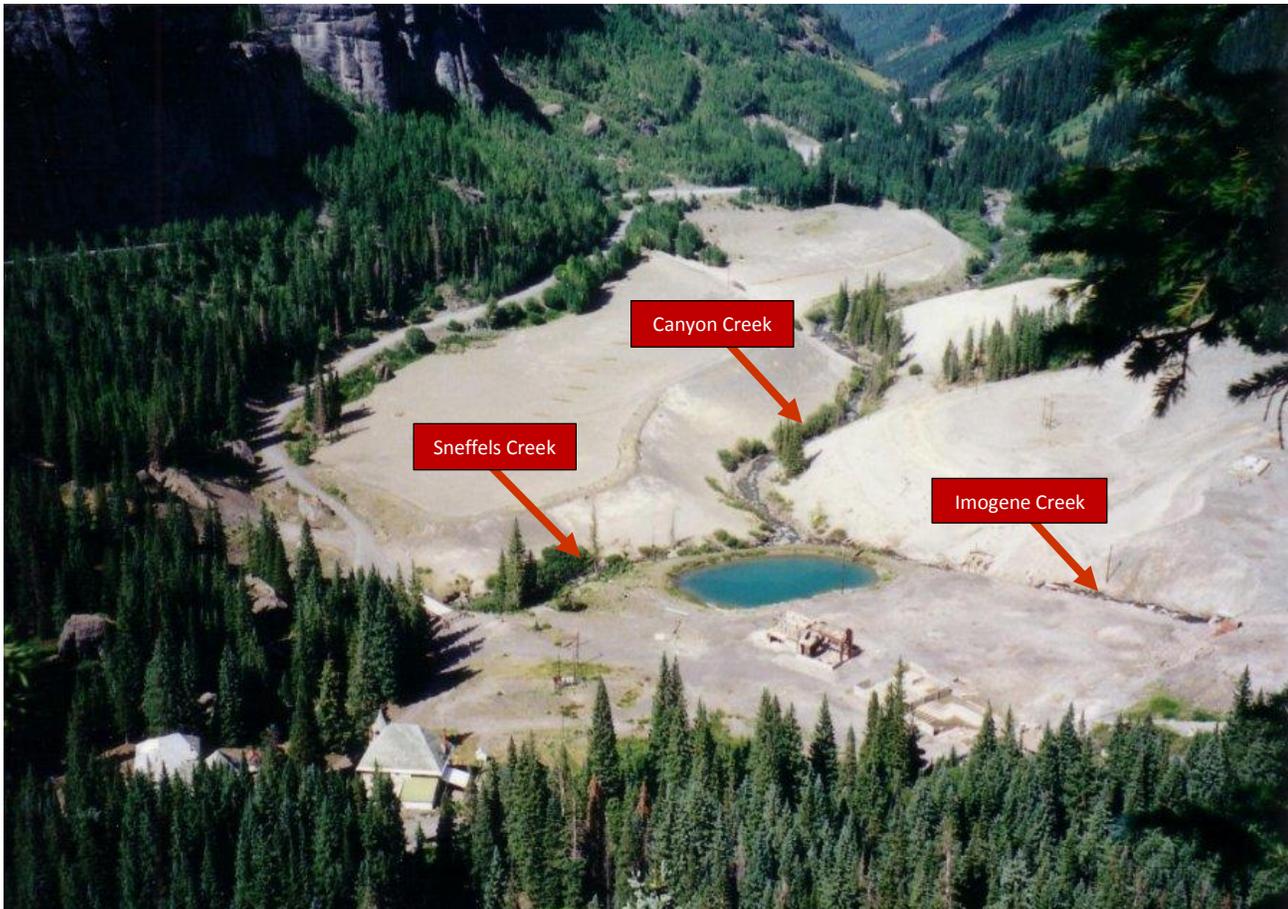
*Aerial View of the Camp Bird Mine at the Entrance to Level 14 in 2002<sup>1</sup>*

The Camp Bird Mine is an underground mine located 6 miles south of Ouray, Colorado. The Site subject to this Work Plan consists of three cells of tailings that are located near the entrance to the 14-Level of the mine. These tailings rest in direct proximity to Sneffels, Imogene and Canyon Creeks. Sneffels and Imogene Creeks enter the Site upstream and combine near the center of the tailings to form Canyon Creek. Canyon Creek flows downstream to Ouray.

The two tailings cells located on the south side of Canyon Creek are referred to as the “historic tailings” and are associated with milling activities believed to date back to the early 1900s. The third and largest tailings cell located on the north side of Canyon Creek is referred to as the “modern tailings” and was last used for disposal in the late 1990s. The modern tailings occur within the boundary of an active mining permit that is administered by the Colorado Division of Reclamation, Mining and Safety (DRMS).
