1. Site Name	2. Operational Period	Incident Briefing
Reilly Tar and Chemical (A8Q9)	November 2017	
3. Site Description		
<p>The Site is an abandoned coal tar distillery that operated from 1924 to 2002. The Site has been in bankruptcy since 2016. It is located south of Provo, Utah in unincorporated Utah County. Land use in the area is largely industrial. The Ironton Canal constitutes the northern boundary of the Site and this waterway discharges into Spring Creek and Utah Lake’s Provo Bay a few miles west of the Site. The southern part of the Site is now a seasonal wetland and groundwater tends to flow westward beneath a nearby industrial facility.</p>

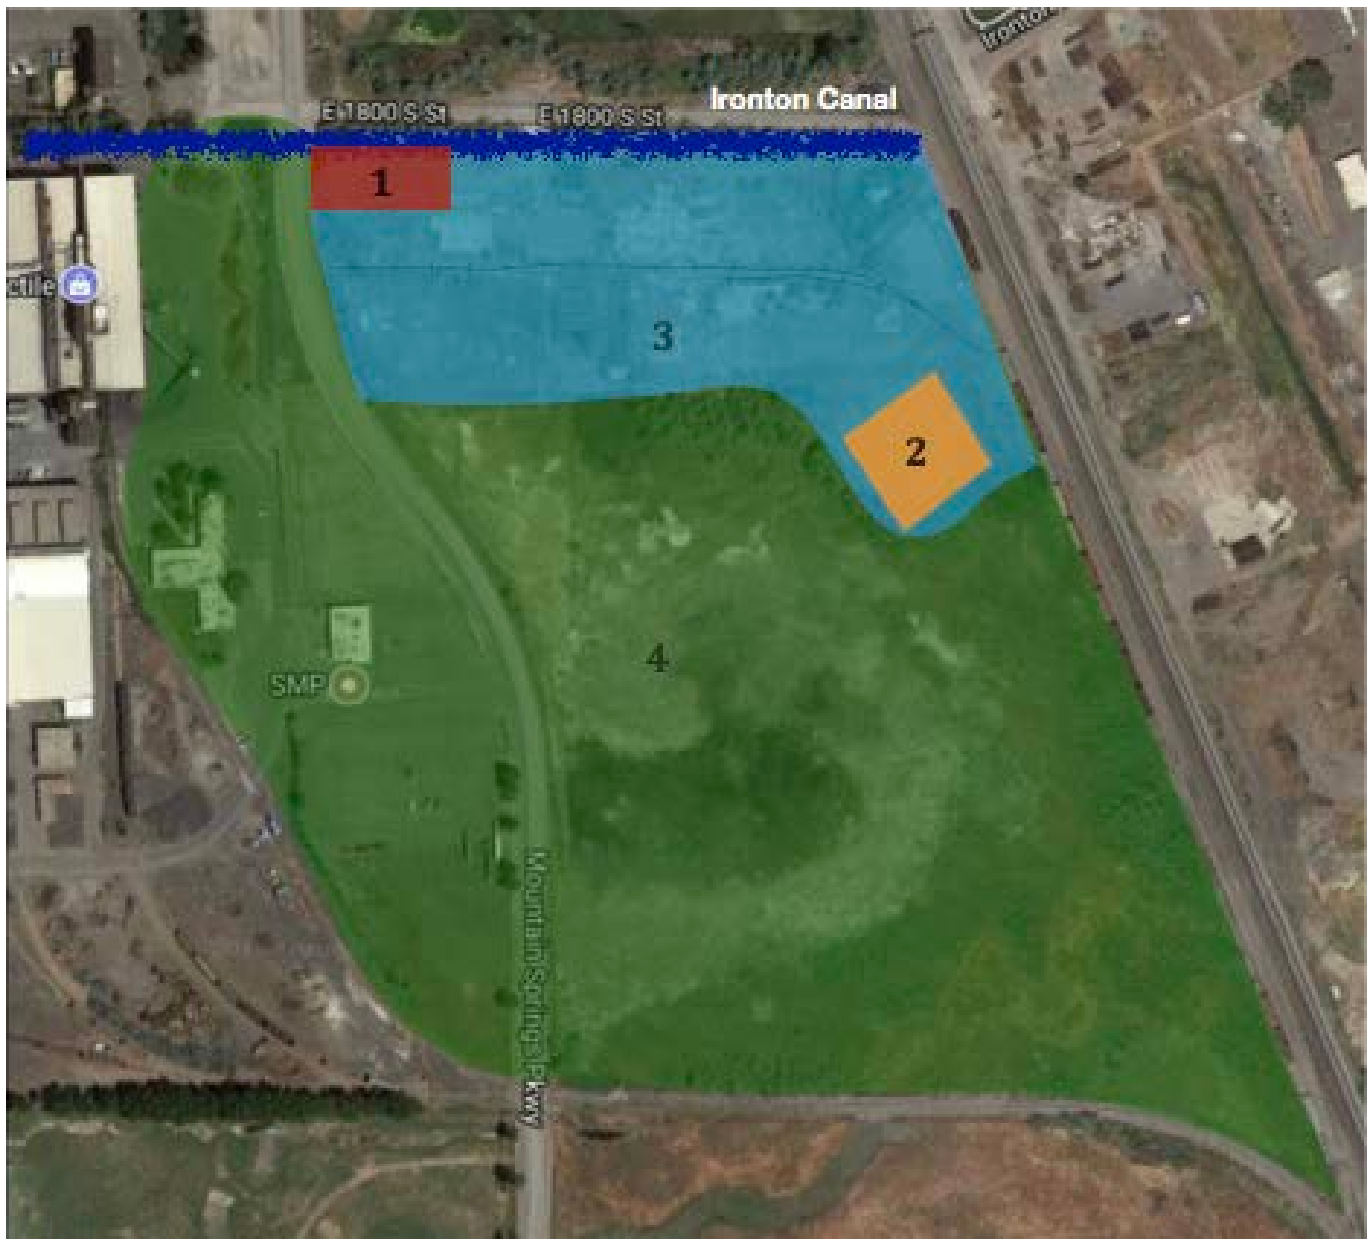
MAP

5. Response Operations		
<p>EPA is partnering with UDEQ to perform a Time Critical Removal Action and conduct additional assessment activities at the Site. The Removal Action involves:</p> <p>1: Approximately 2000 cubic yards of contaminated material have been excavated from along the Ironton Canal at the northwest corner of the Site where the historic outfall was located (Map Area 1). A flood-resistant liner between the Site and the Ironton Canal has been installed and the area has been backfilled with uncontaminated soil harvested on-site and uncontaminated rock from off-site.</p> <p>2: The eastern perimeter of the Site (Map Area 2) is being graded and appropriate runoff control berms have been established. Soil excavated from along the Ironton Canal has been moved to this location and spread evenly across this area as preparation for tilling projected to occur in May, July and September 2018.</p> <p>3: Less than 1 cubic yard of asbestos containing tiles in the industrial core of the Site (Map Area 3) have been collected, bagged and will be disposed of at an appropriate disposal facility. On-site grading to insure surface run-off drains to the south and away from the canal is on-going. Reseeding and installing erosion control features across the disturbed areas of the Site will be conducted as appropriate.</p> <p>The additional assessment activities will involve a complete characterization of the Site and development of a comprehensive plan and budget to remediate the Site (Map Area 4).</p>
