**Final Removal Action Report for
Black Butte Mine
Cottage Grove, Oregon**

**Prepared by Kathy Parker, On-Scene Coordinator
United States Environmental Protection Agency**

**REMOVAL ACTION REPORT
BLACK BUTTE MINE SITE
COTTAGE GROVE, OREGON**

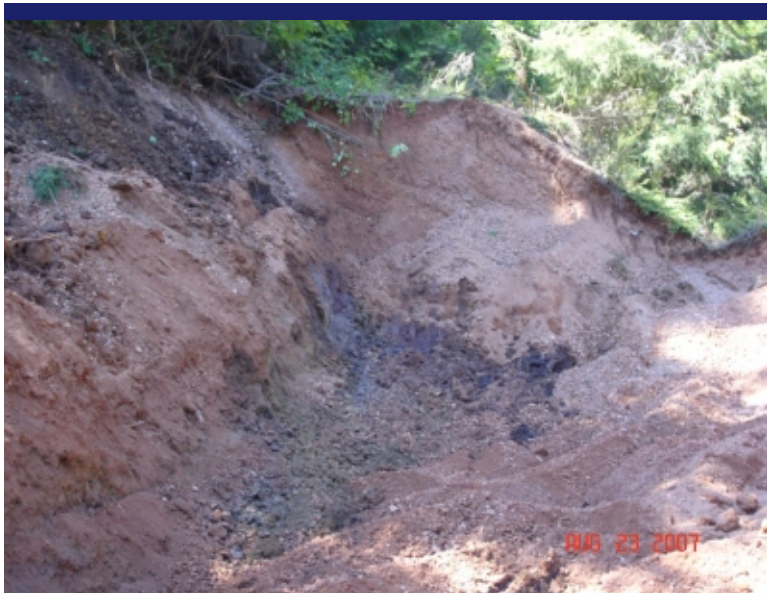
Photo 3 Native soil under tailings on Main Tailings Pile - West slope.

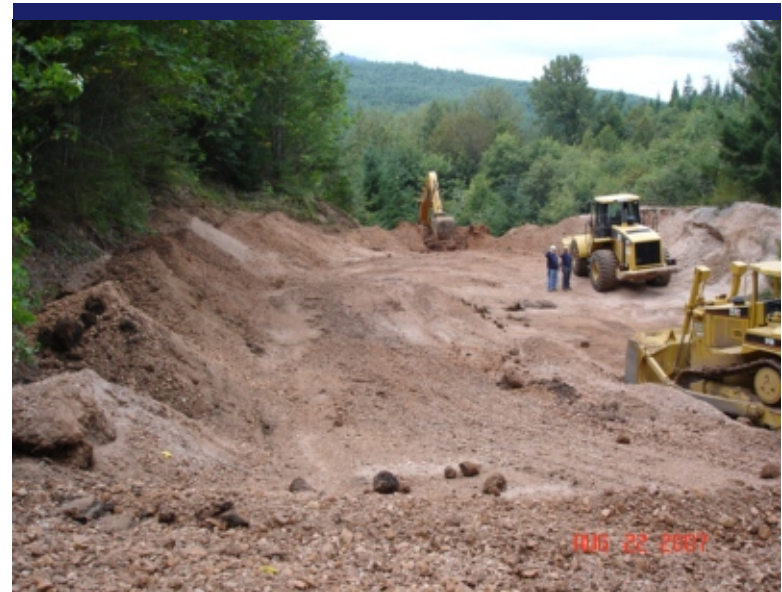
Photo 2 Moving tailings from Main Tailings Pile - West slope up slope.

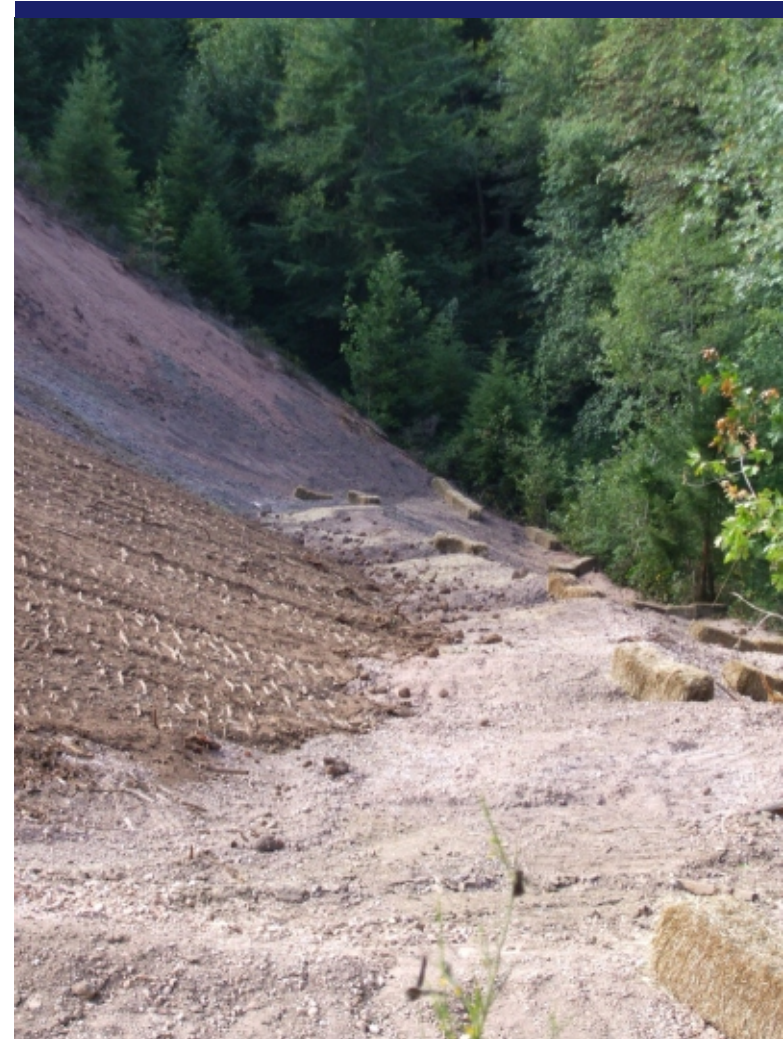
Photo 6 Main Tailings Pile - West slope showing soil cap and water bar.

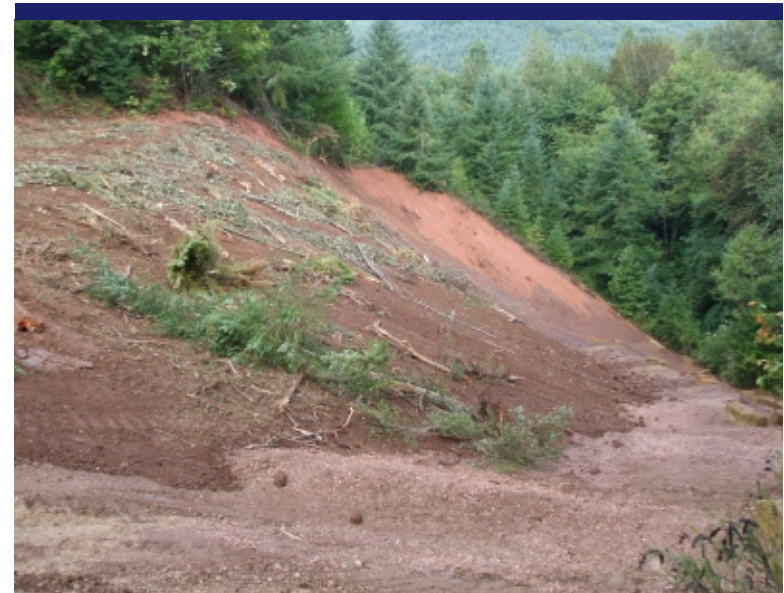
Photo 11 Main Tailing Pile - West slope showing soil cap with woody debris on surface.

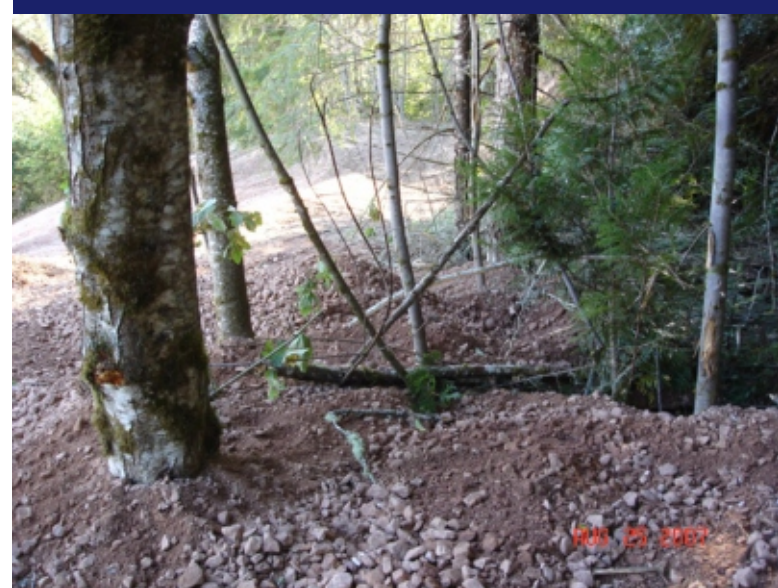
Photo 19 Keying tailings into top of Main Tailings Pile - East slope.

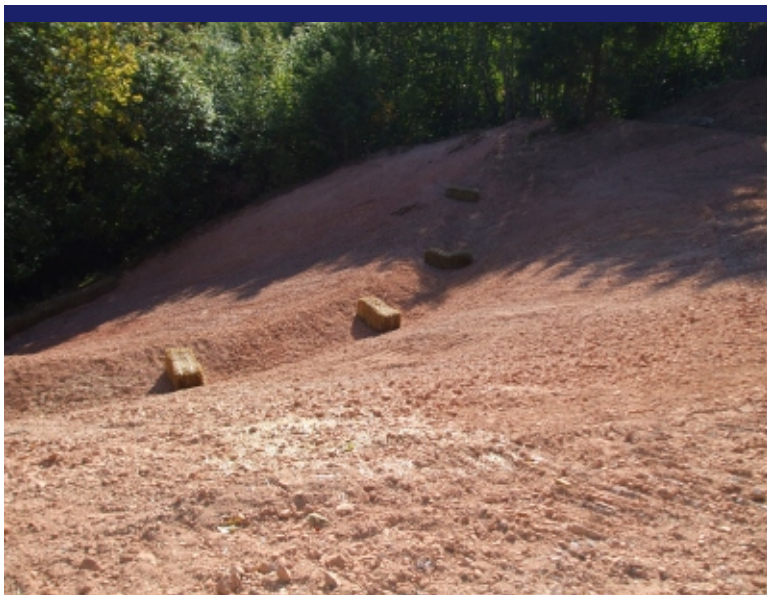
Photo 20 Main Tailings Pile - East slope prior to topsoil and hydroseed.

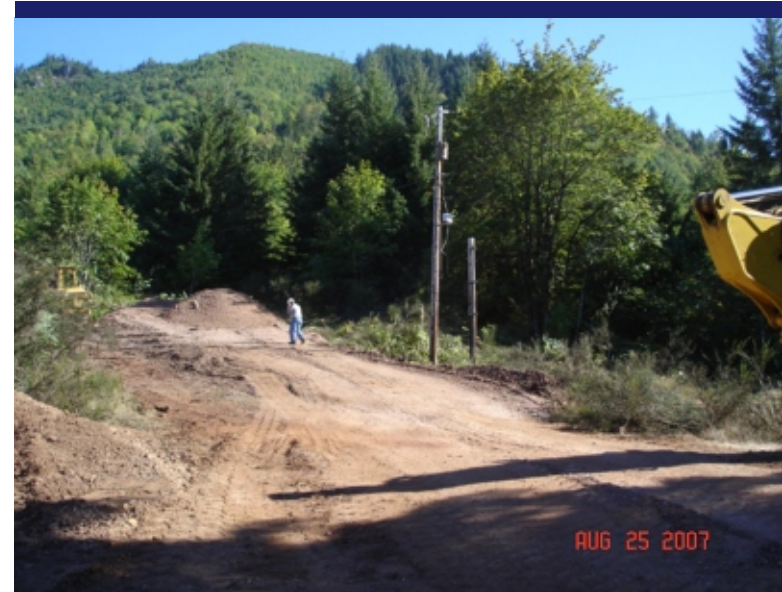
Photo 29 Starting to cap Old Ore Furnace Area.

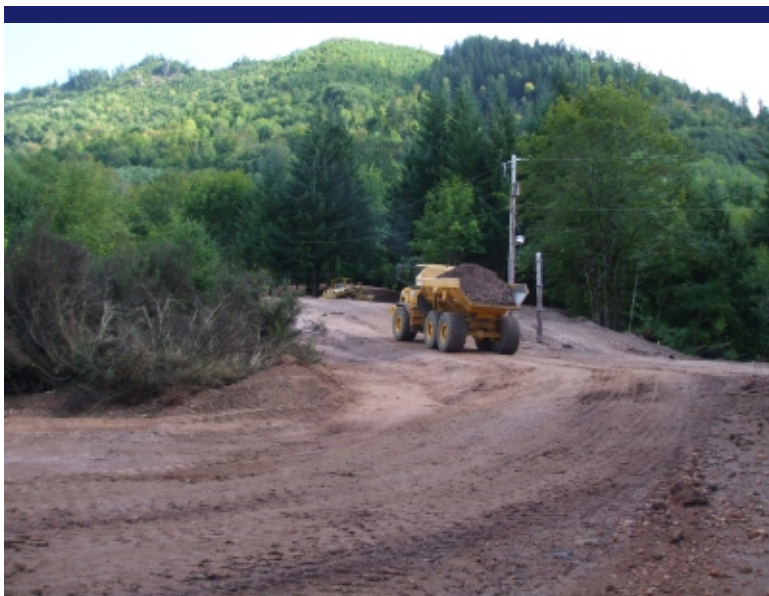
Photo 34 Hauler taking capping materials to Old Ore Furnace for capping.

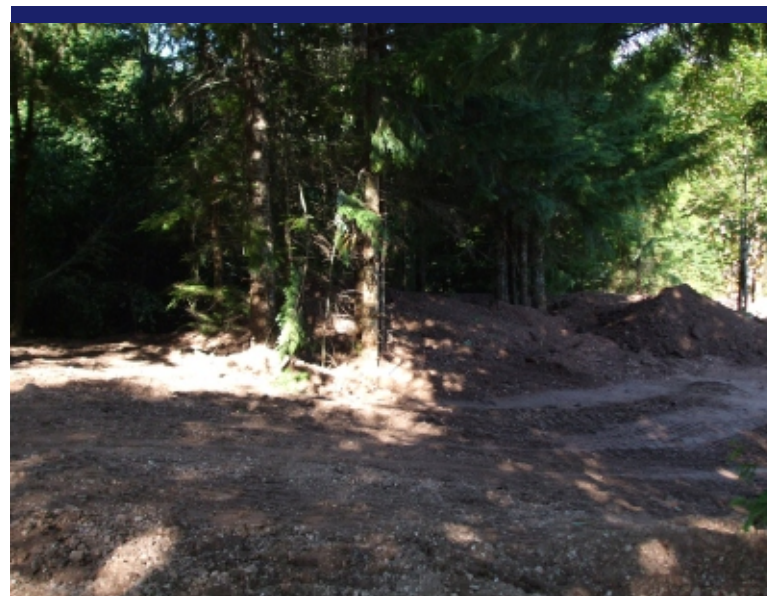
Photo 35 Old Ore Furnace Area cap over debris near Old Ore Furnace.

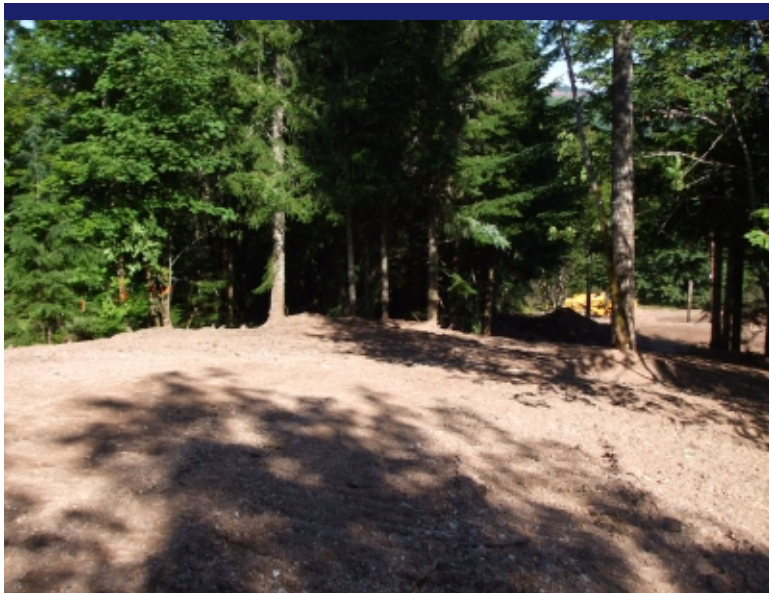
Photo 42 Old Ore Furnace Area cap looking west towards Old Ore Furnace.

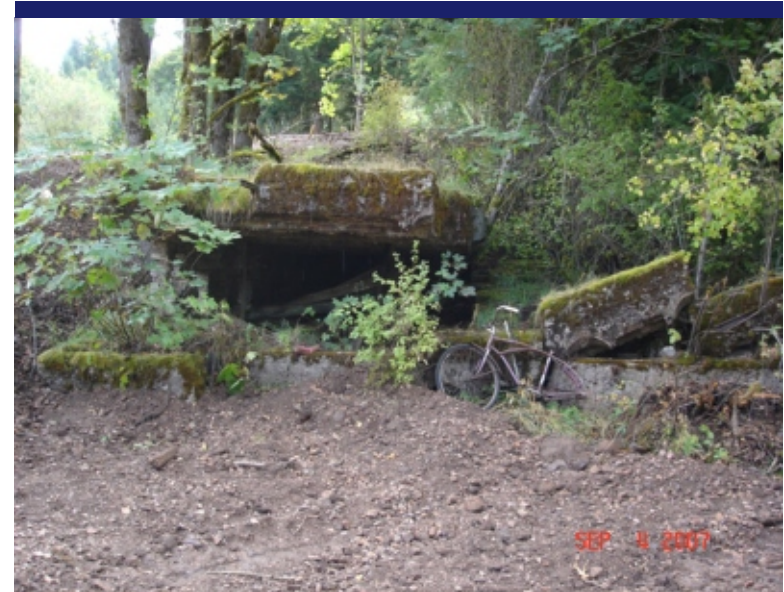
Photo 45 Cap material pushed up to Old Ore Furnace structure.

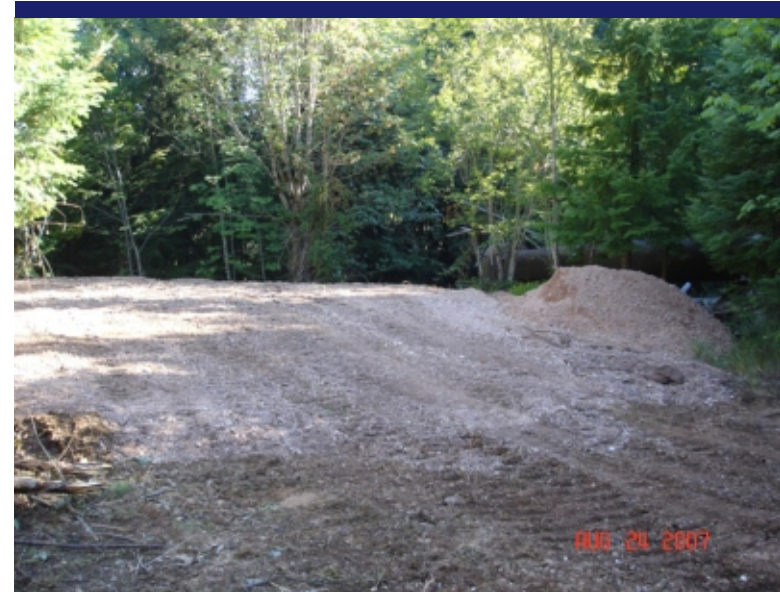
Photo 47 Partial cap in New Furnace Area.

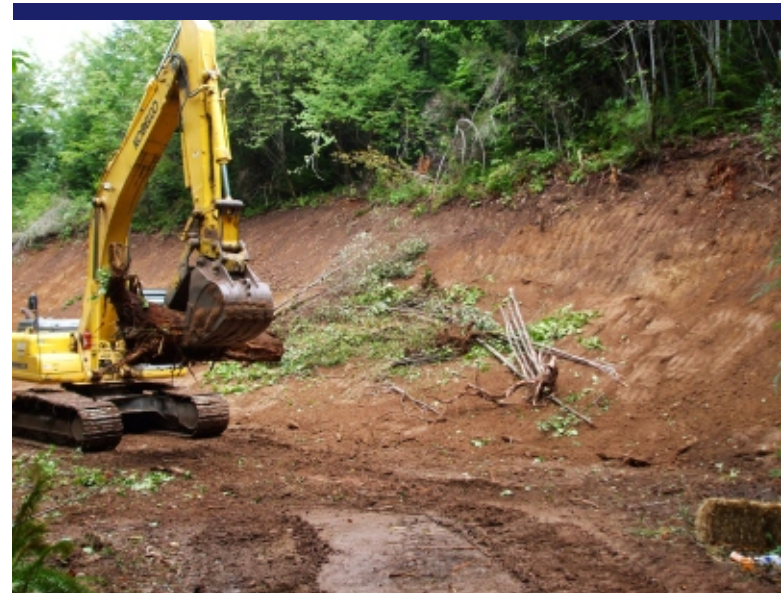
Photo 53 South of New Furnace - Slope reconstruction after fill material removal.
