## Lisbon Valley Mining District Removal Site Update

**Operations Period:** 05 November 7-13, 2022

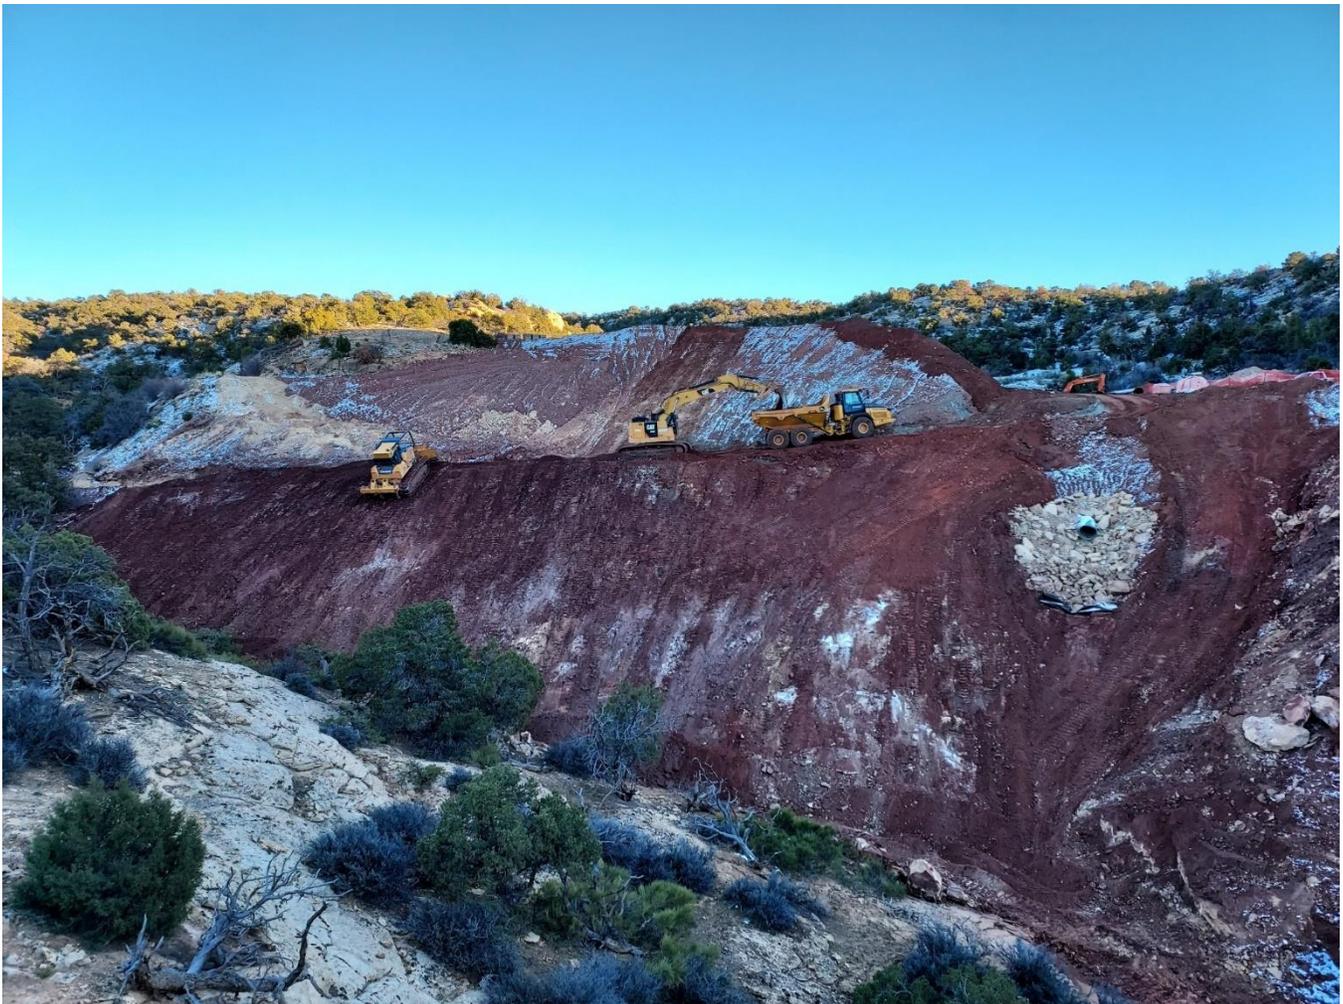
### **Regrading the Lower Slope of the Waste Pile at the Radon Mine**

The Team removed mine waste from the toe of the pile starting at the furthest point downstream and worked its way upstream. The crew regraded the pile and moved its new toe back away from the drainage to a point that is at least 10 vertical feet from the low point in the adjacent ephemeral stream.

The mine waste that was excavated was placed back away from the slope and used to continue establishing a more gentle gradient. The entire waste pile will eventually be regraded to better control erosion and keep the material from entering the drainage and migrating off-Site.

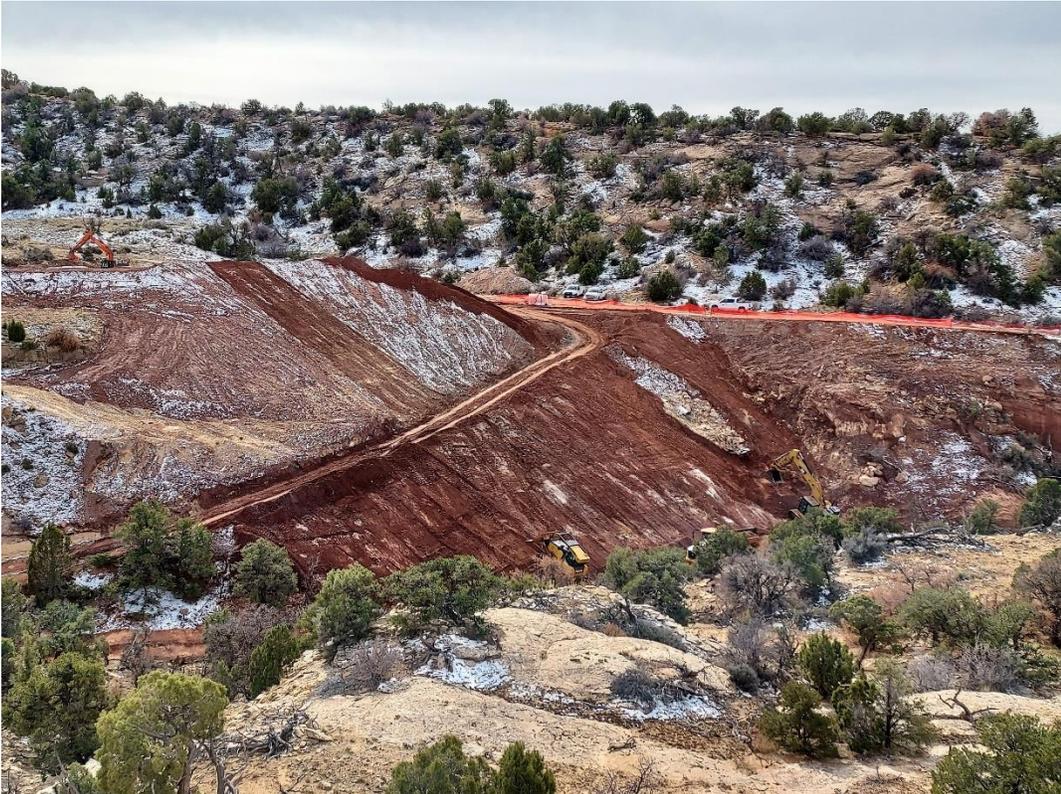
**Radon Mine at the end of Operations Period:**

EPA's Response Team replaced the last section of culvert before its outfall. The old culvert was not connected and was damaged. Rock collected from along the terraces of the former facility was used to rip rap its outfall and down the slope of the waste pile.
