Lisbon Valley Mining District Removal Site Update

Operations Period: 07 November 21-27, 2022

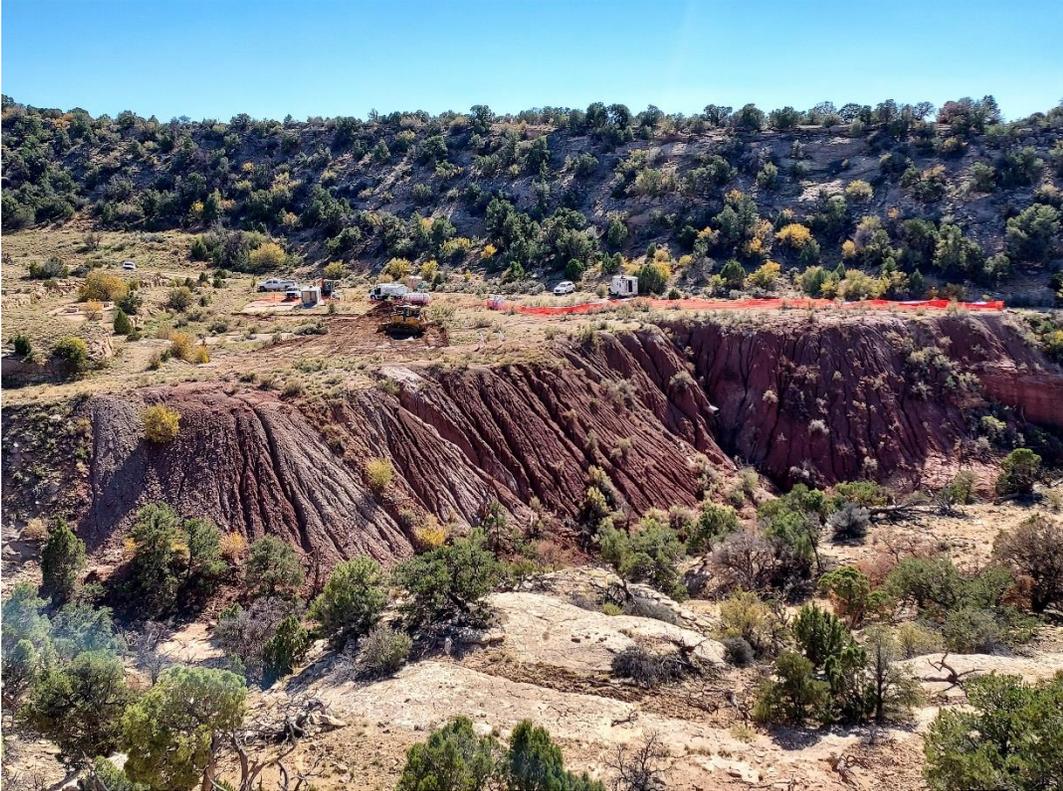
Radon Mine at the beginning of EPA's Removal Action:

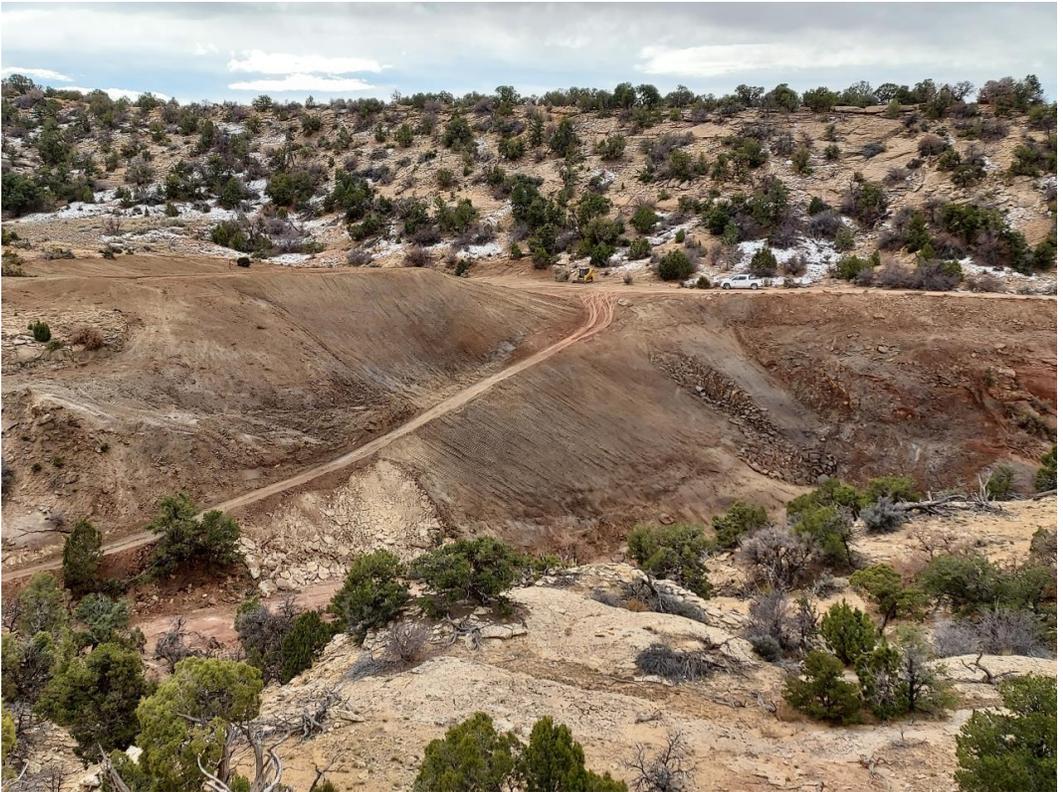
Radon Mine at the End of this Operations Period:

The Response Team procured a seed mix recommended by BLM and spread the seed on all disturbed areas using a hydro mulch mix which contained an organic amendment, mulch and a tackifier.

A ranch gate was installed across the mine access road at the point where it leaves the the County Road. The gate will be locked until vegetation on the waste pile is established.
