# United States Environmental Protection Agency

## 2023 Maui Wildfires

### Damaged Lithium-Ion Battery Management Guide for Electric Vehicles & Mobility Devices

**Version: November 27, 2023**

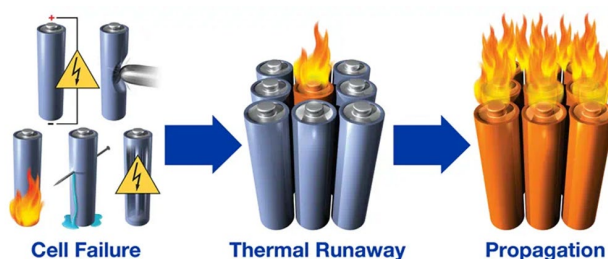
**Figure 1:** Diagram depicting a cascading thermal runaway event.

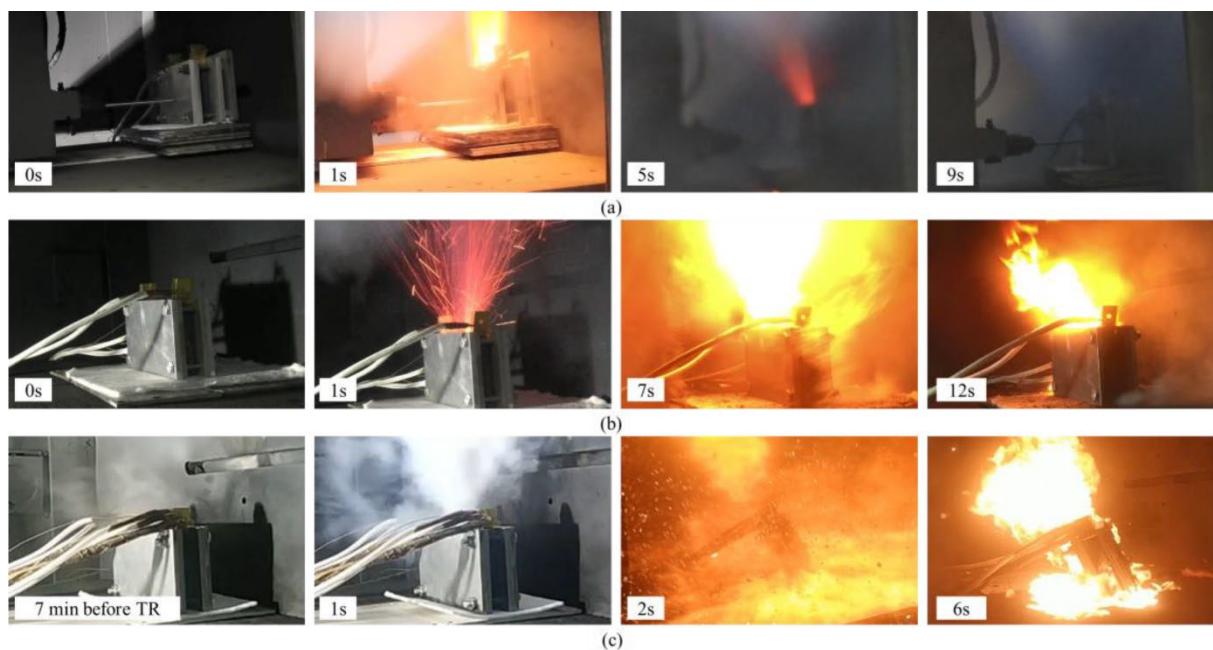
**Figure 2:** Several views of the stages of lithium-ion batteries in thermal runaway conditions.

**NOTE:** When a lithium-ion battery is about to undergo thermal runaway, the following may be observed: bulging, cracking, hissing, popping sounds, leaking, rising temperature, and white smoke. The entirety of this process typically occurs within 3-5 seconds.

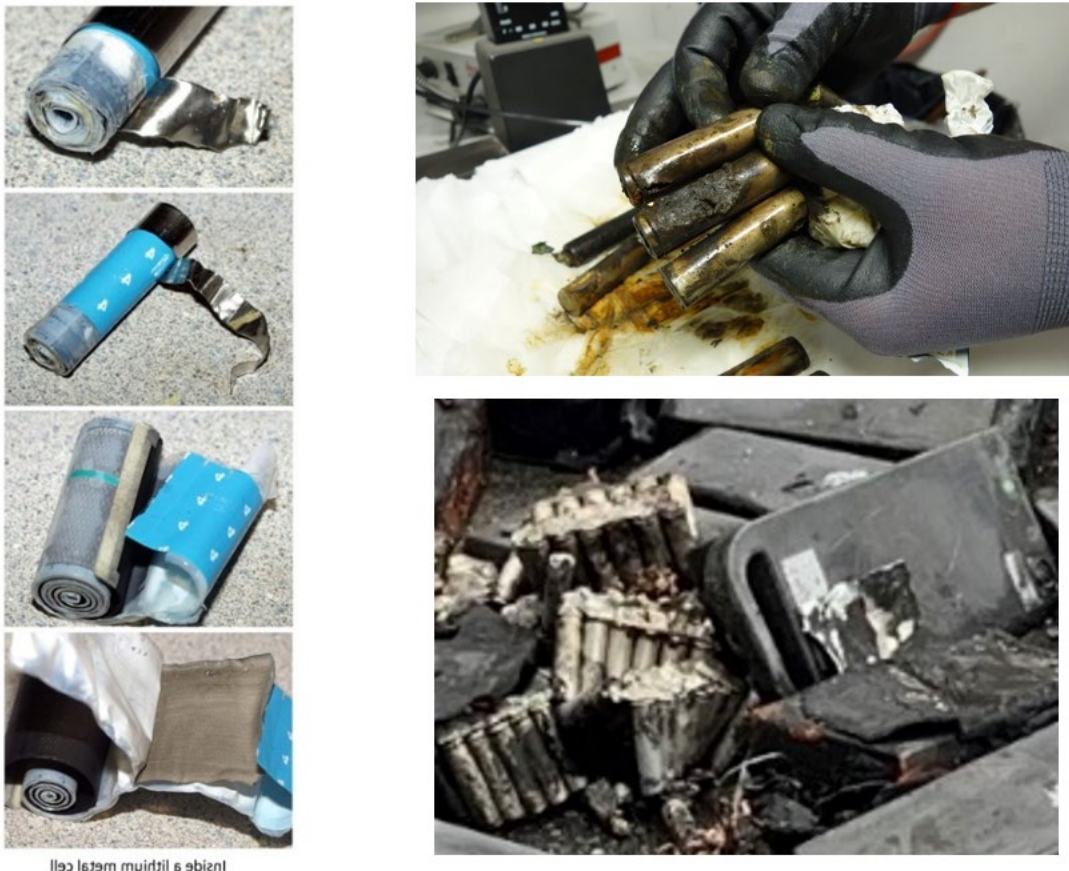
**Figure 4:** (Left) Lithium metal battery cell (not a lithium-ion battery) depicting a rolled-up strip of lithium metal; (Upper right) burned 18650 cells; (bottom right) fire-damaged cylindrical cells.

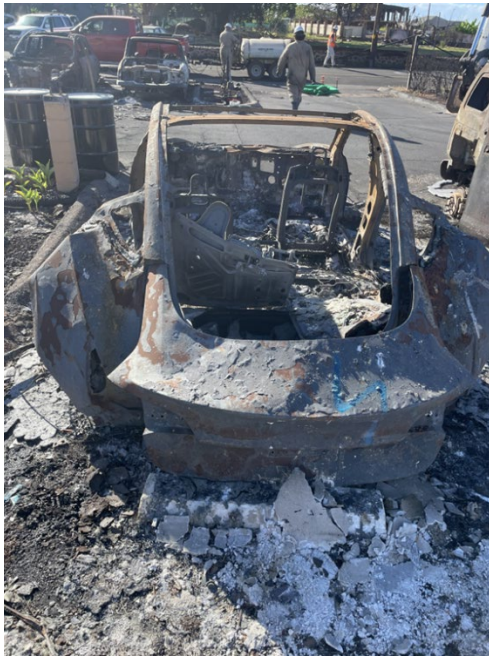
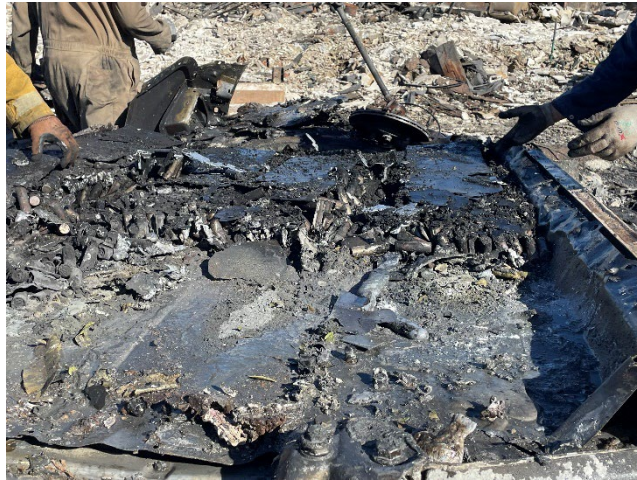
**Figure 5:** Tesla vehicle damaged by fire (left) and battery pack undercarriage with cylinder cells being harvested. While the battery pack may still be fully intact, the cells may be damaged and present a risk of thermal runaway and propagation.

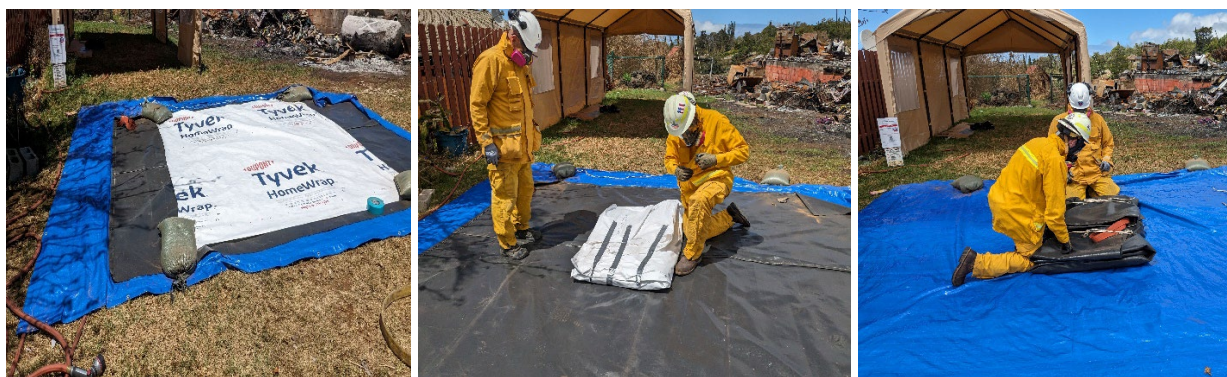
**Figure 8:** “Lau Lau” wrapping process as described above.

15. If the battery was wrapped on the ground, use lift straps and 4 personnel to move the wrapped battery onto the transport trailer. If the battery was wrapped on the trailer, use lift straps and 4 personnel to move the wrapped battery to the appropriate position for transport. Alternatively, heavy equipment may be used to move the battery case onto the transport trailer. Secure the wrapped batteries to the trailer.

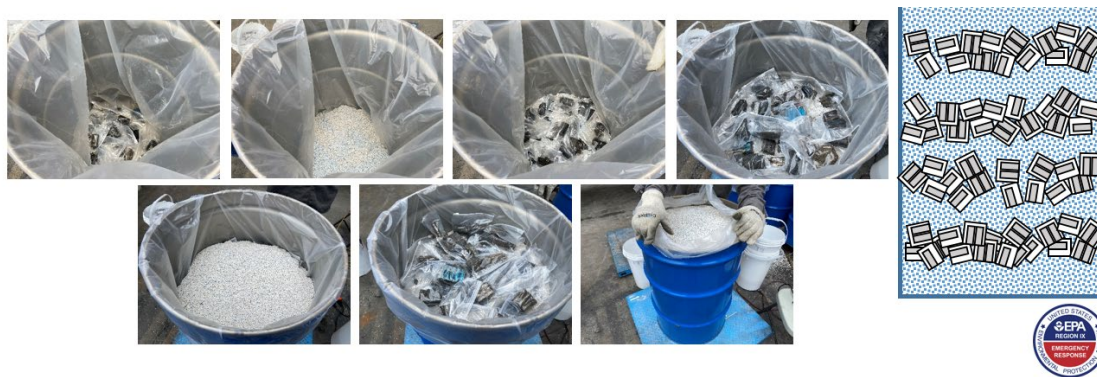
**Figure 9:** Small lithium-ion batteries can be transported according to Department of Transportation (DOT) [Special Permit-16532](#) in a regular drum with cell block packing materials.

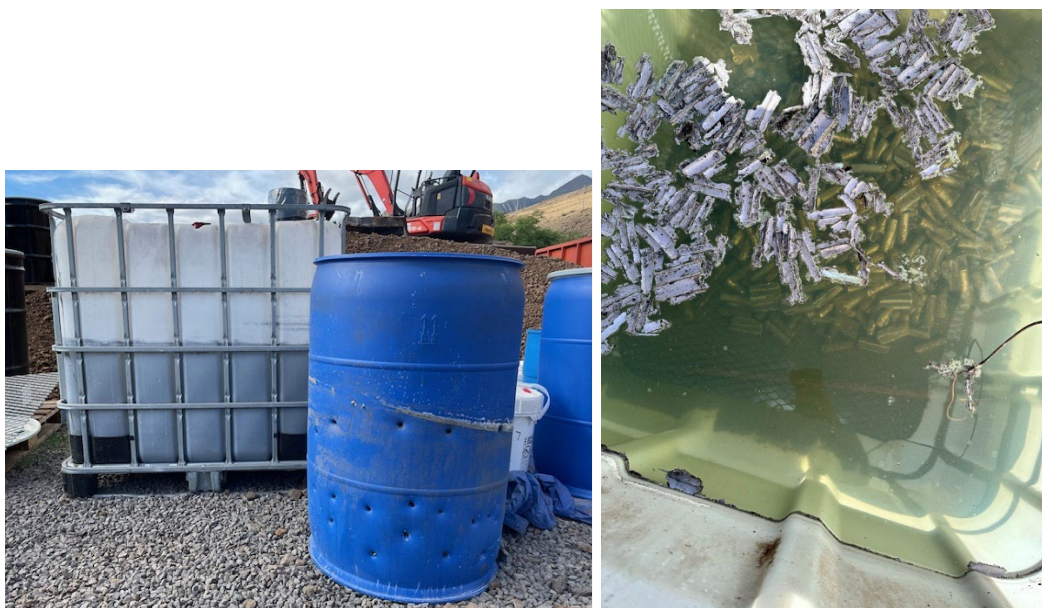
**Figure 12:** Brining options using a perforated drum (left) and tote (right).

Loose pouch and prismatic cells can be placed directly in the brine solution. If they are contained in a larger outer box, you may need to open the box to ensure the brine can reach the appropriate battery terminals. It is best practice to use perforated drums (similar to a fry basket) to place materials in and safely lower the materials into a brine solution.

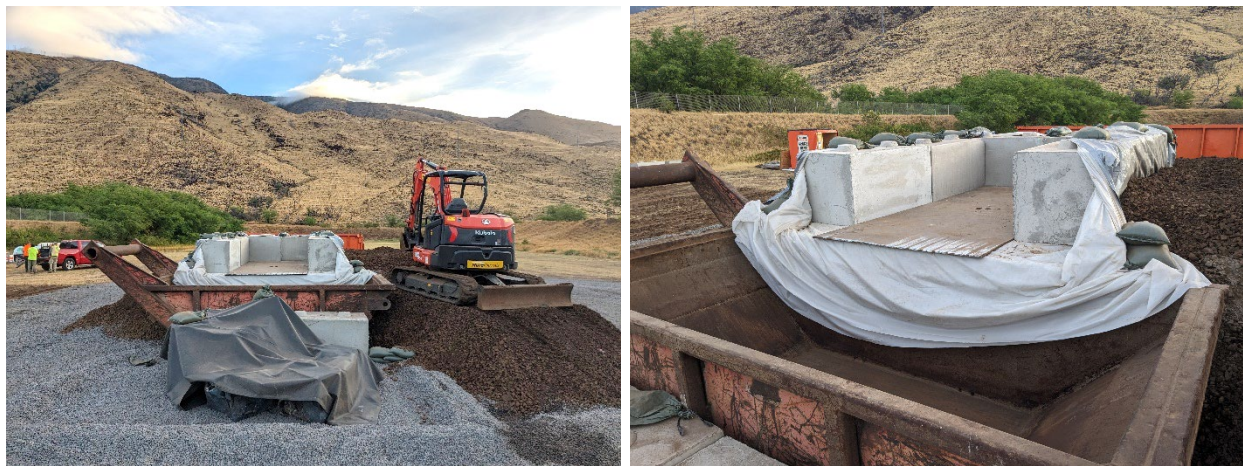
**Figure 13:** Battery termination setup where batteries are first processed to determine if de-energizing is necessary.

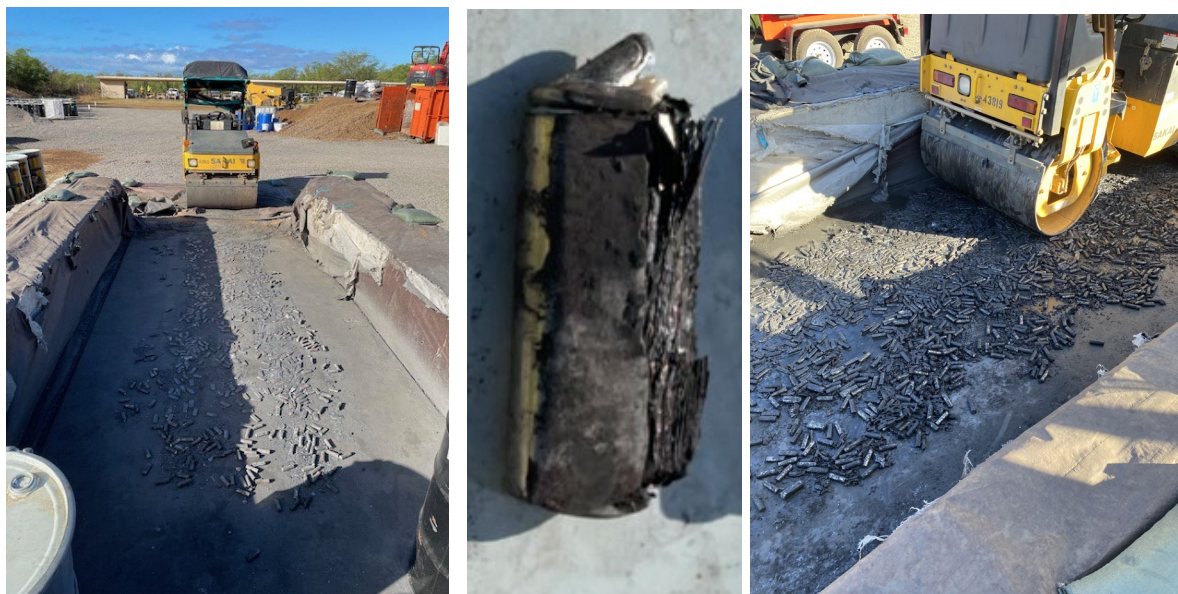
**Figure 14:** Using a drum roller to crush cylindrical batteries (left and right) and get to a final product for disposal (center).

First use an excavator to remove the cells from the outer box. Cylindrical cells should be placed in a thin window (about the width of the shovel head or less) on the trench plate and rolled with the smooth drum roller. Unburned cells are best smashed with a 12-ton smooth drum roller. Due to the strength of the cells, adding too many cells will lead to only partial destruction of the cells making the process take much longer.

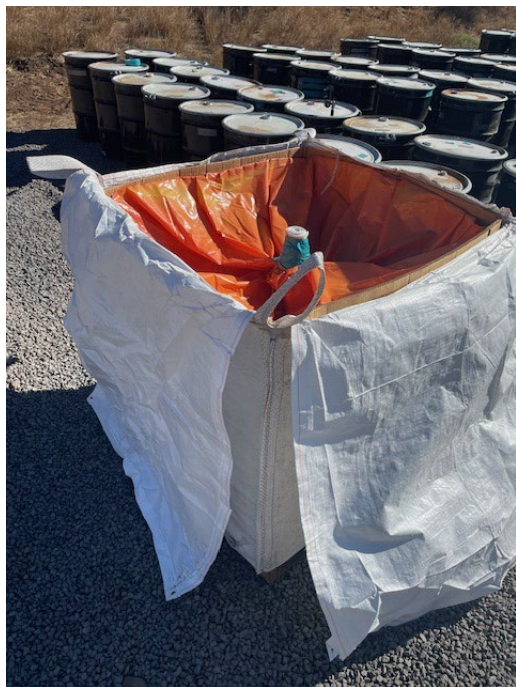
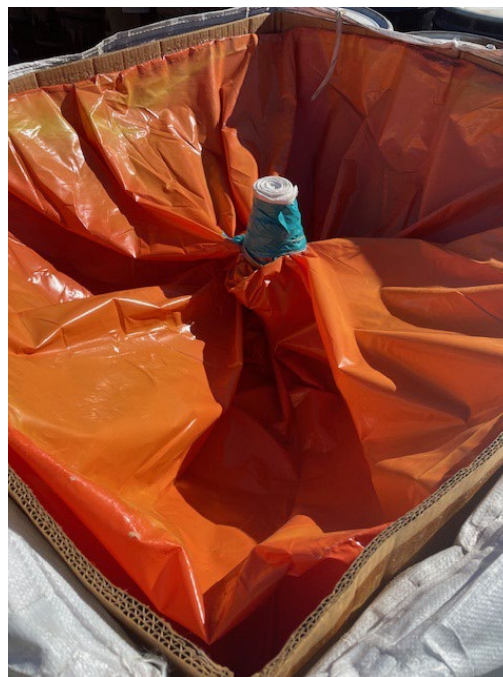
**Figure 15:** Cubic yard boxes with liners inserted into a supersack. A sorbent pad is tightly rolled and inserted in the middle of the box to provide for ventilation and protection from water intrusion.

interior cubic yard box should have a thin gauge plastic bag that can be glued to the sides. To provide ventilation while attempting to keep water out, a sorbent pad can be rolled, inserted into the box and taped to the thin plastic liner to the rolled sorbent pad. These steps will allow for ventilation of crushed material to properly ventilate. If materials are placed in a sealed container, such as a drum, the air space may build up with flammable gas. Ensure that the box is not filled too high or exceed any weight restrictions.

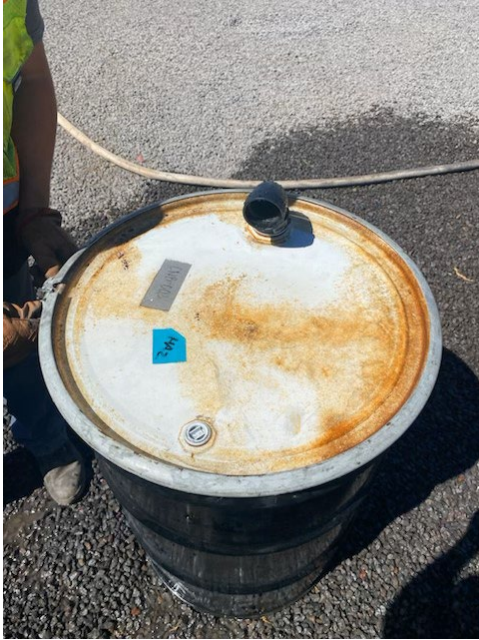
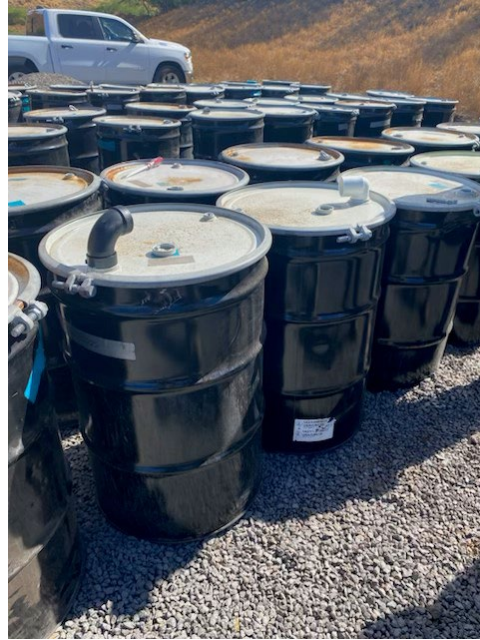
**Figure 16:** Using 55-gallon drums equipped with a ventilation snorkel can be used to safely store and transport material.

An additional option for packaging material can include the use of 55-gallon drums. It is recommended to utilize steel drums in case of fire or reaction while in transport. Crushed material should be placed within an inner liner, consisting of a low-density gauge poly to allow for ventilation. The drum lid should be placed on the drum and properly secured. The 2" bung should be removed and replaced with a PVC angled fitting. The fitting will allow the interior space of the drum to ventilate while providing protection from water intrusion.

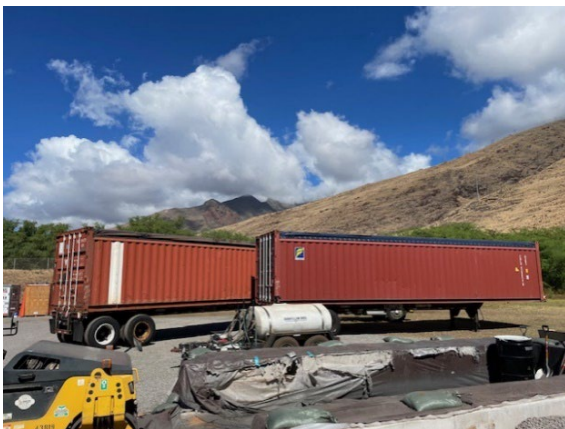
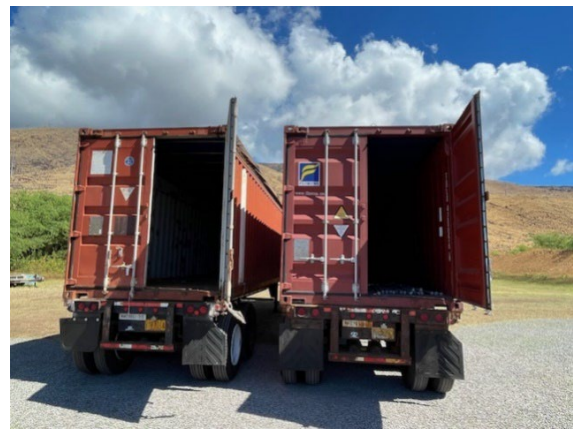
**Figure 17:** Transport containers that are open top with tarps. These should be placed above-deck when using barge or ship services.

Containers, whether cubic yard boxes, 55-gallon drums or other appropriate containers should be placed in open top shipping containers, equipped with tarps. Containers (drums, boxes, etc.) should not be stacked on top of each other and no other materials, particularly household hazardous materials, should be carried in the same sea-land box. If possible, segregation of package type should also be performed. Shipping containers must be transported above deck to ensure additional ventilation of materials.

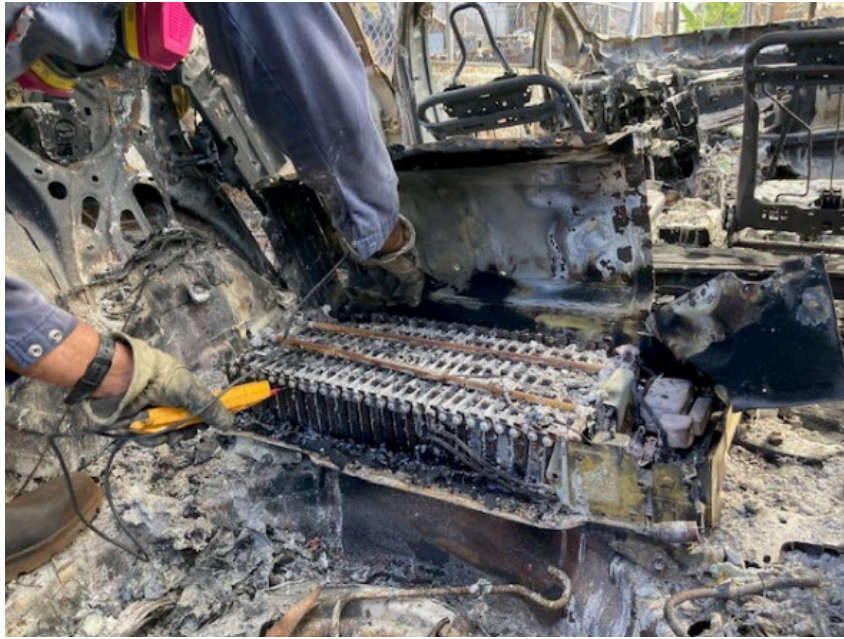
*Certified electrician testing Ni-MH battery pack for remaining battery charge prior to removal*

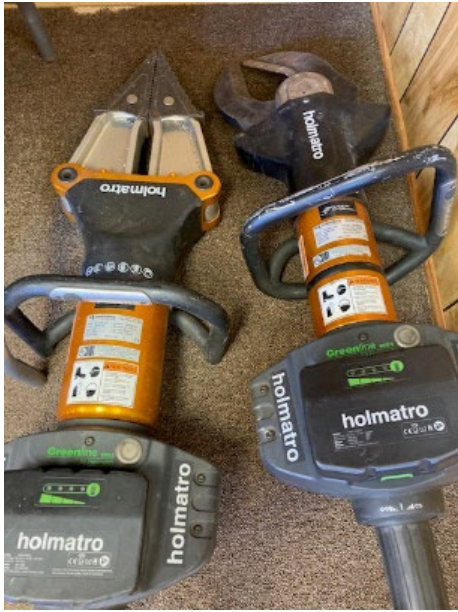
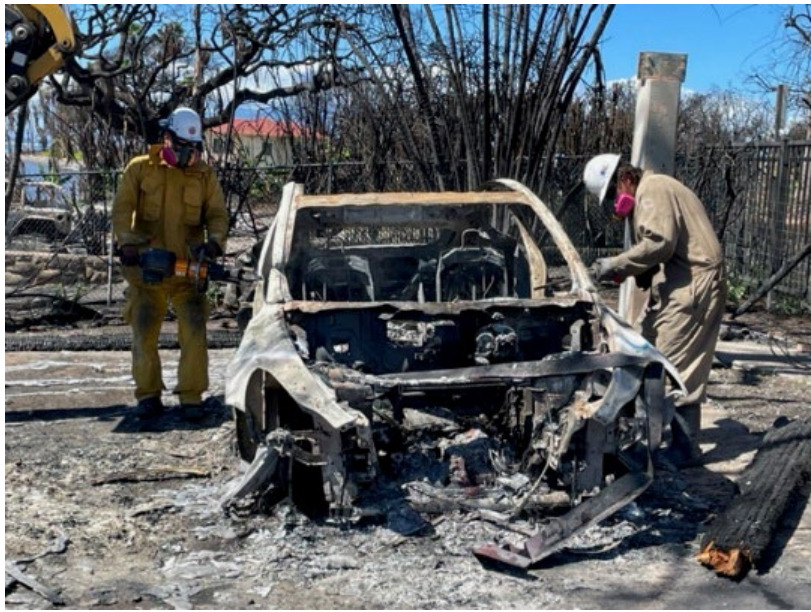
*(Left) Rescue spreader and cutter. (Right) Cutting roofing support beams (A, B, C pillars) prior to flipping vehicle for battery pack access on some vehicles.*

A combination of power tools and hand tools will be used to remove batteries from EVs. Fire responder tools (spreader and cutter) are also utilized for accessing damaged vehicles and rendering the vehicle structurally safe for battery access. Doors and/or the roof of the vehicle may be removed for easier battery access or to safely flip the vehicle to access undercarriage batteries. A mini excavator with thumb attachment is also used for repositioning vehicles as well as assisting with access by removing seats or other obstructions. Dust suppression is provided prior to and during vehicle repositioning by a support vehicle with water buffalo trailer, however the batteries are not to be oversaturated with water.

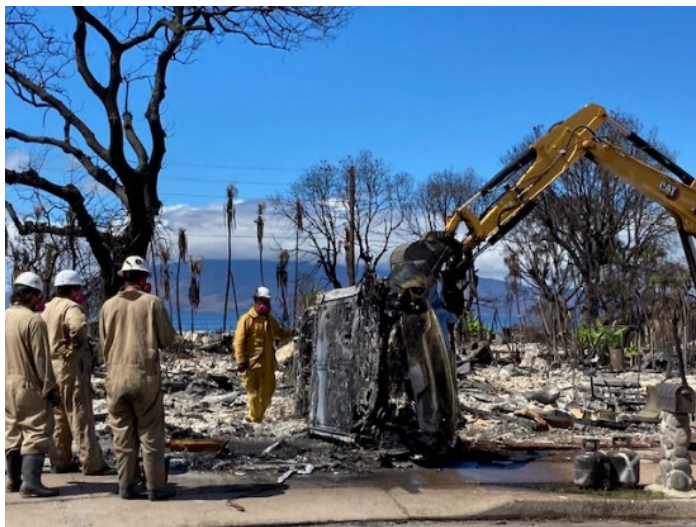
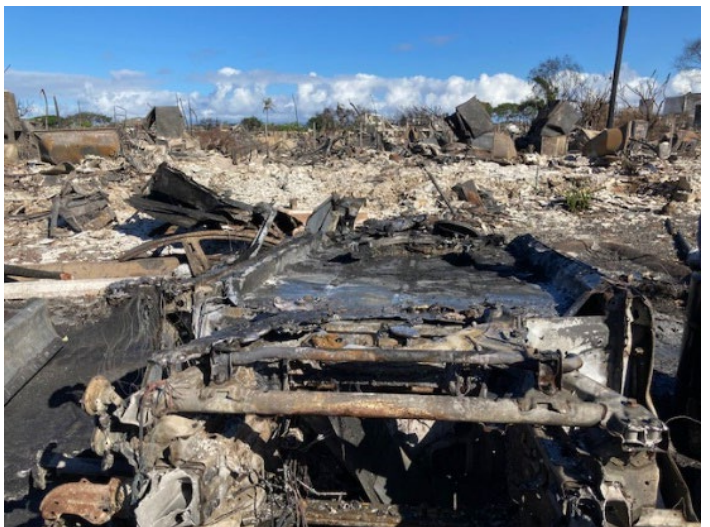
*Flipping Tesla Model S to access batteries in undercarriage.*

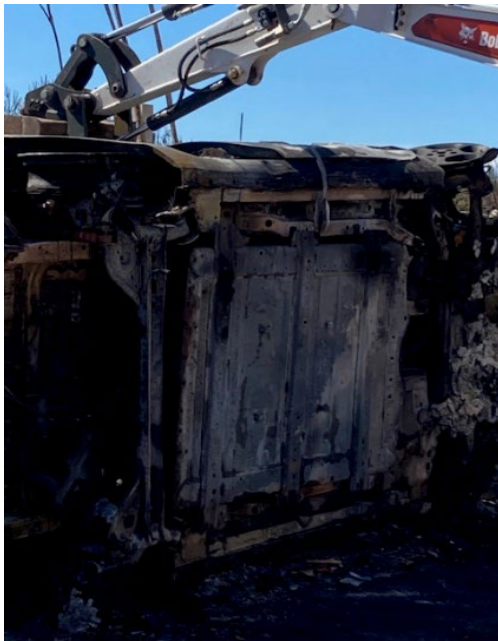
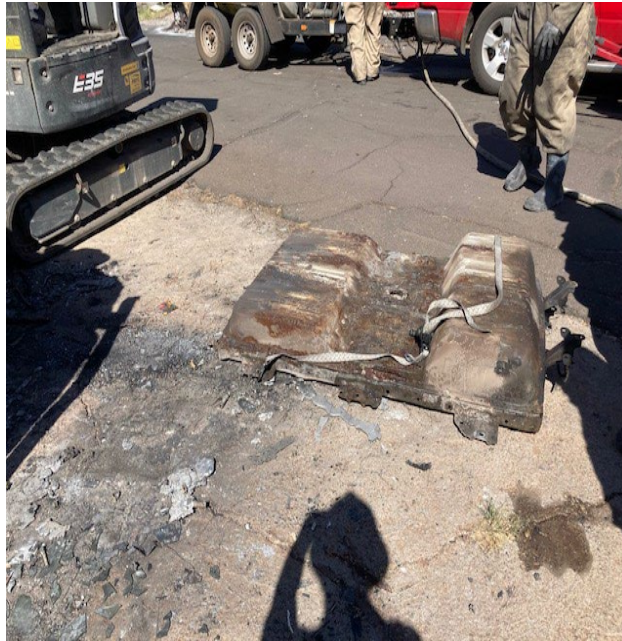
(Left) Nissan Leaf li-ion battery pack in undercarriage. (Right) Nissan Leaf battery pack after removal.

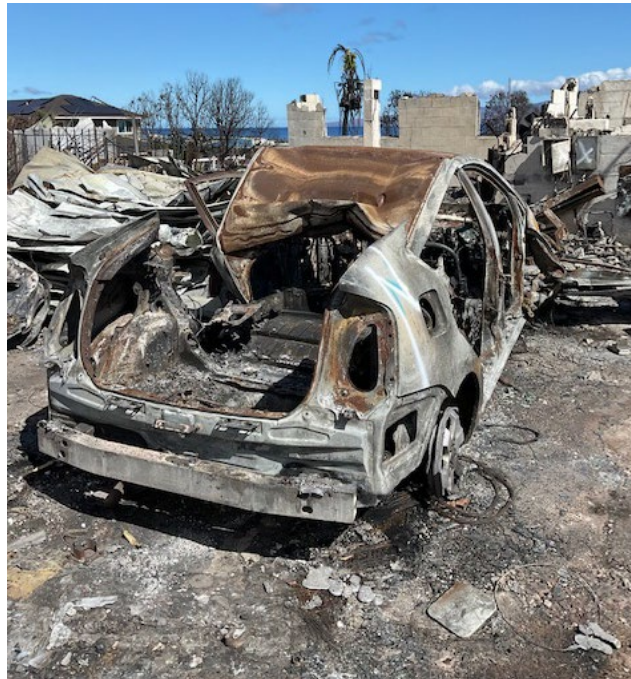
*White lightning bolt painted over blue lightning bolt indicating that battery has been removed.*
