**Otsego Township Dam Area
Time Critical Removal Action**

**DRAFT
Final Maintenance and Monitoring Report**

Prepared by:
**Wood Environment & Infrastructure Solutions, Inc.
Novi, Michigan**

November 15, 2019

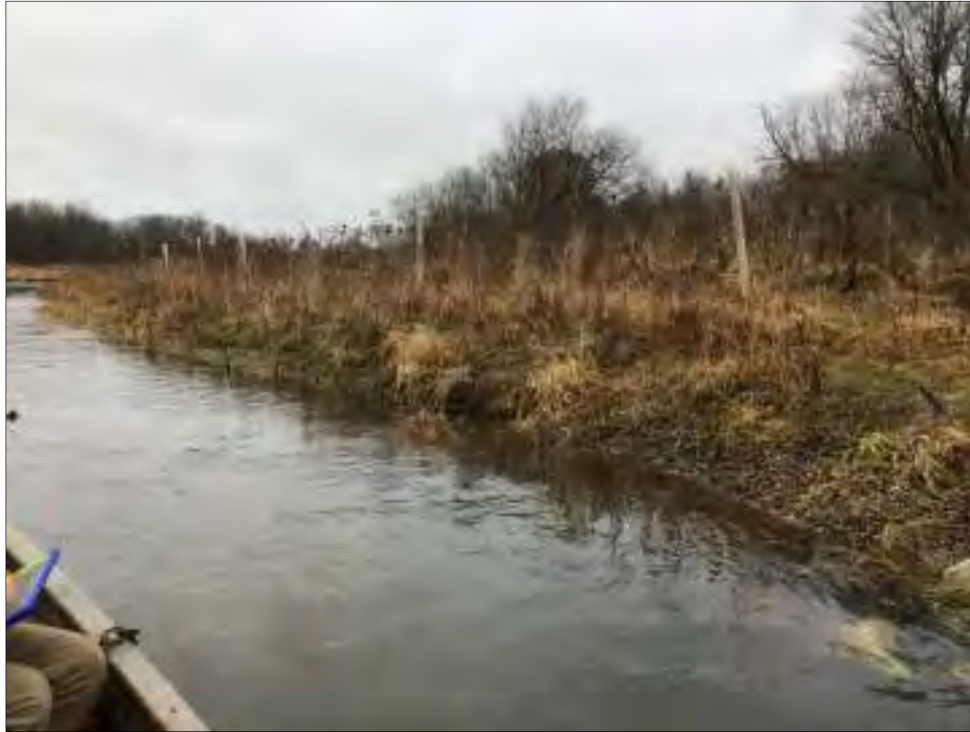
Photo 1: BRSA 1 erosional area repaired during construction; no new erosion observed.

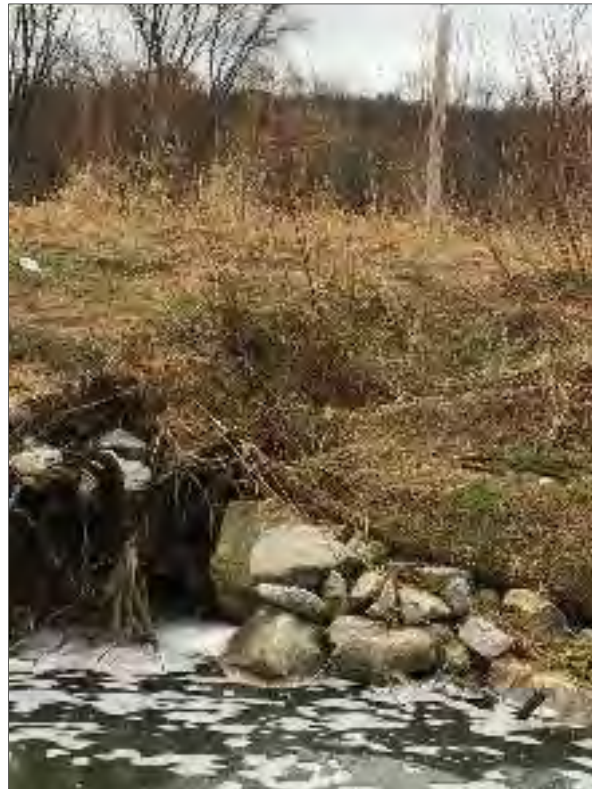
Photo 2: BRSA 1 along right-descending bank (RDB) of Pine Creek confluence. Void observed below coir fabric at rootwad/joint planting transition. Void measures approx. 2 ft. deep by 3 ft. parallel to river by 6 ft. perpendicular to river.

1.0	BRSA 1 along RDB of Pine Creek - void below coir fabric at rootwad/joint planting transition	No	12/3/2018		Continue to monitor, repair in spring/summer 2019 (photos 2 and 3)

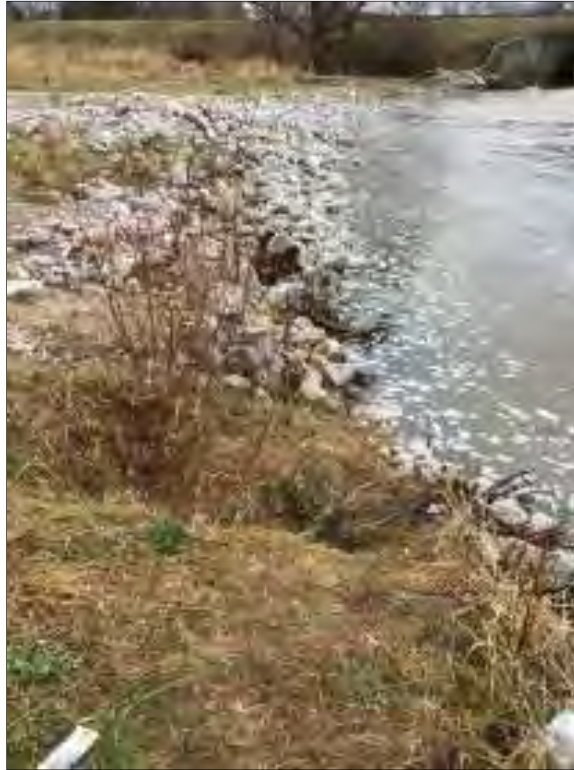
Photo 3: BRSA 1 along RDB of Pine Creek confluence. Void observed below coir fabric at rootwad/joint planting transition (same location as Photo 2).

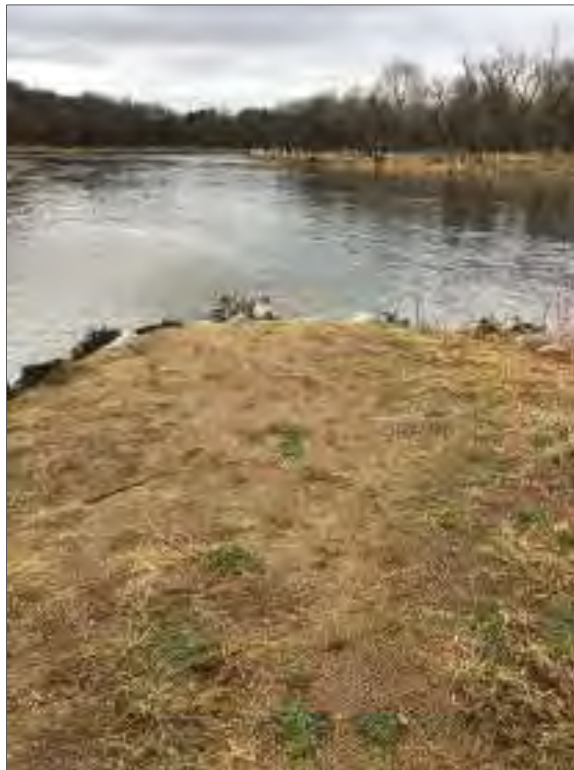
Photo 4: BRSA 1 at Pine Creek confluence. Note that live stakes are missing.

2.0	BRSA 1 at Pine Creek confluence - plant live stakes	No	12/3/2018		See photo 4
3.0	BRSA 4 settling along bank downstream of staging area	No	12/3/2018		Continue to monitor, repair in spring/summer 2019 (photo 7)

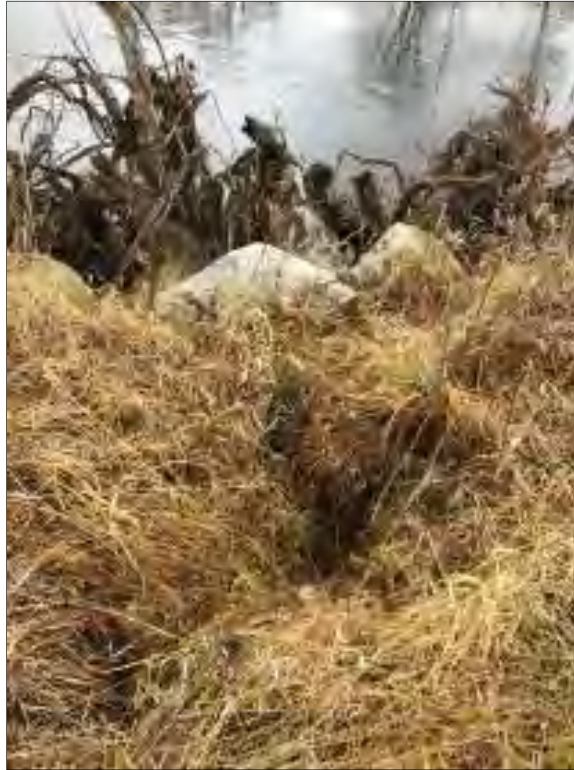
Photo 5: Approx. 10 square feet of surface erosion observed on BRSA 1 bank.

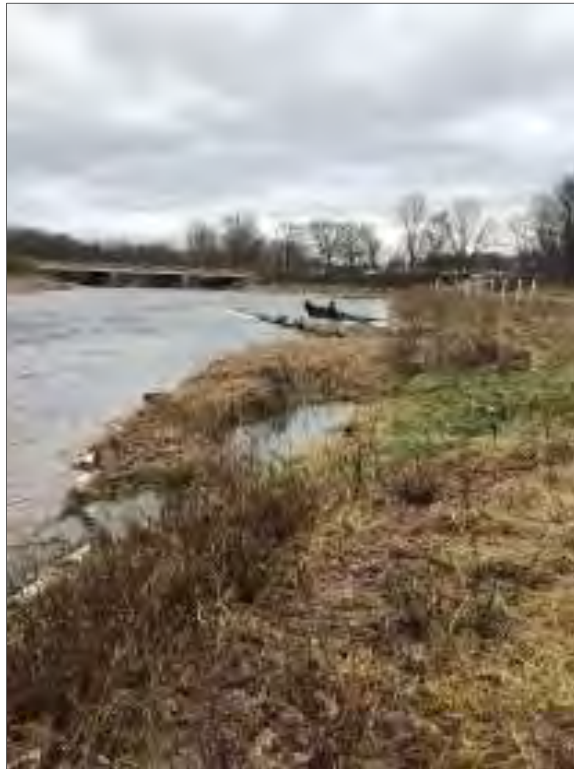
Photo 6: BRSA 3 deposition downstream of J-hooks. No issues observed.

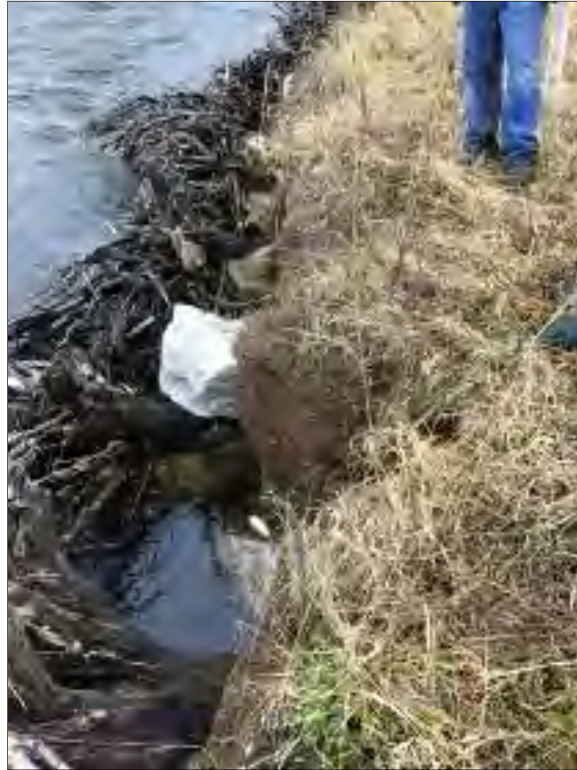
Photo 9: Area of settling observed along approx. 20 lineal feet of BRSA 4 bank, located in root wads across from BRSA 3 J-hooks.

4.0	BRSA 4 settling along bank downstream of staging area	No	12/3/2018		Continue to monitor, repair in spring/summer 2019 (photo 8)
5.0	BRSA 4 settling along bank across from BRSA 3 J-hooks	No	12/3/2018		Continue to monitor, repair in spring/summer 2019 (photo 9)

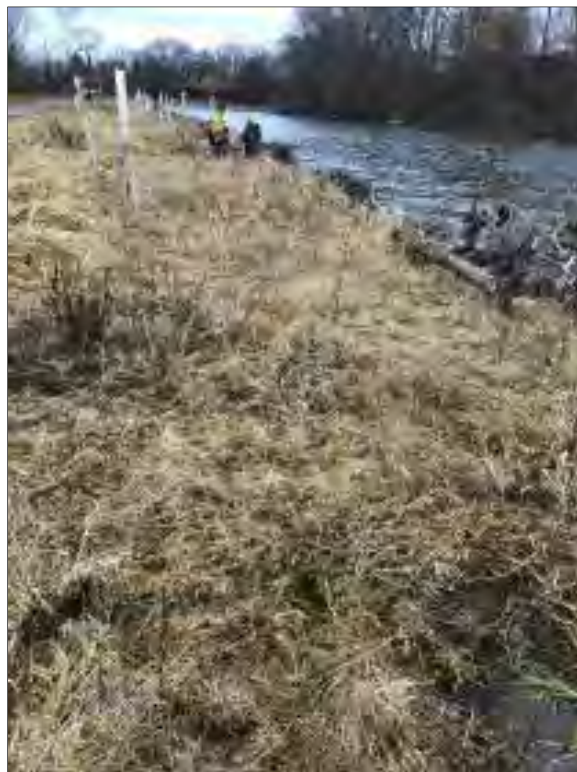
Photo 10: BRSA 4 shrubs appear to have been dislodged during high water event.

2.0	BRSA 4 shrubs dislodged	No	12/3/2018		See photo 10. Vegetation success will be assessed in spring 2019
3.0	BRSA 6 root wads	No	12/3/2018		See photo 13. Confirm next steps with MDNR

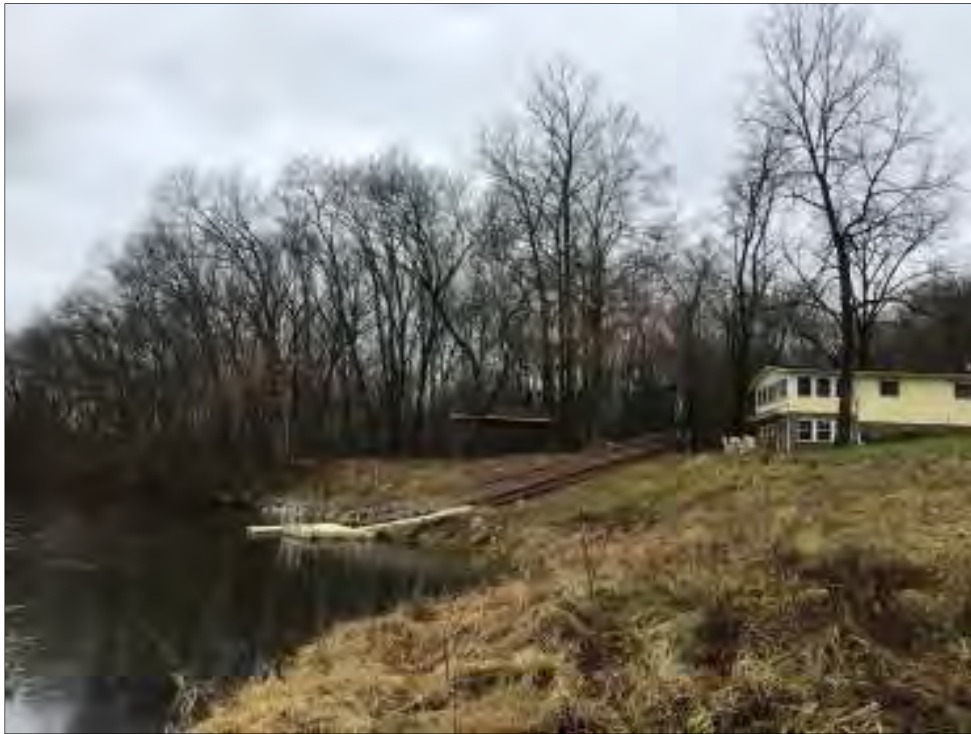
Photo 11: BRSA 4 residential restoration area. No issues observed.

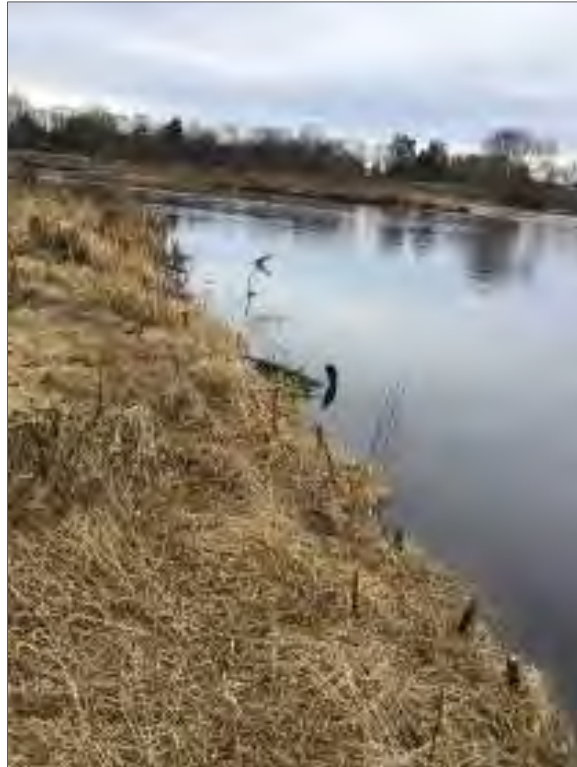
Photo 12: BRSA 6, across from Pine Creek confluence. No issues observed.

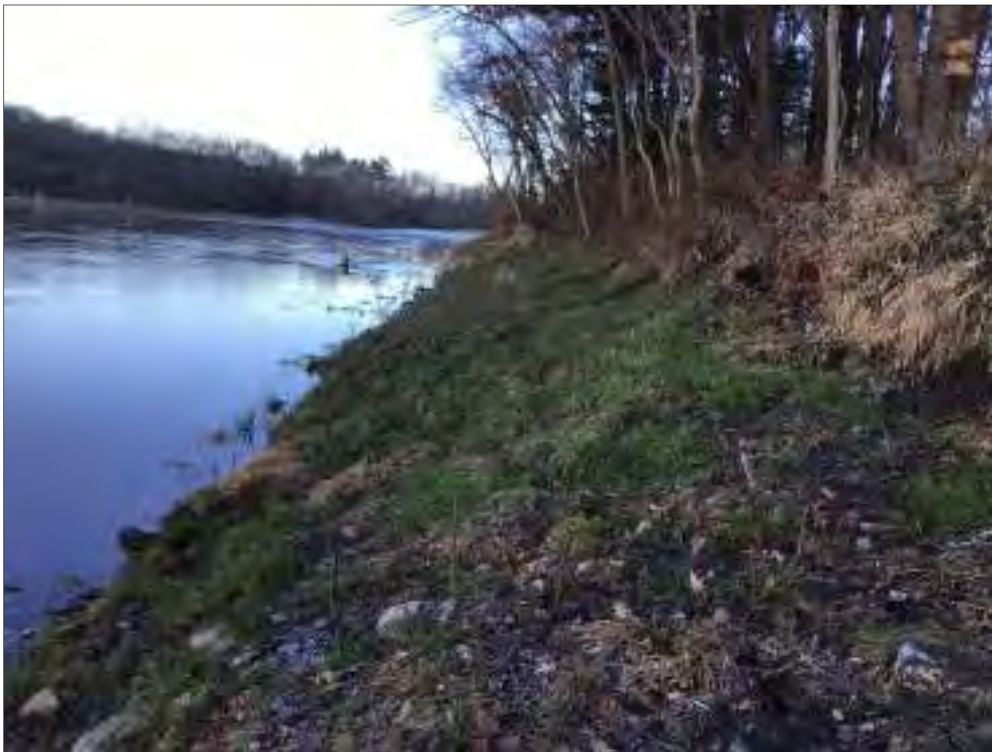
Photo 14: BRSA 7 near transition to high bank zone. No issues observed.

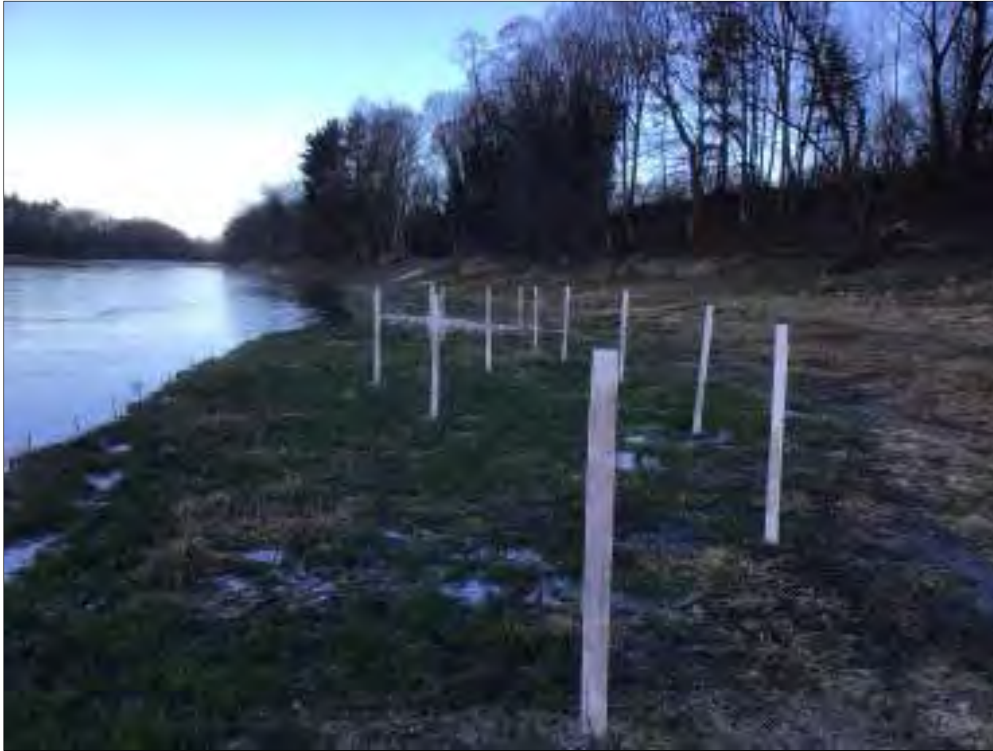
Photo 15: BRSA 7 near constructed access road. No issues observed.

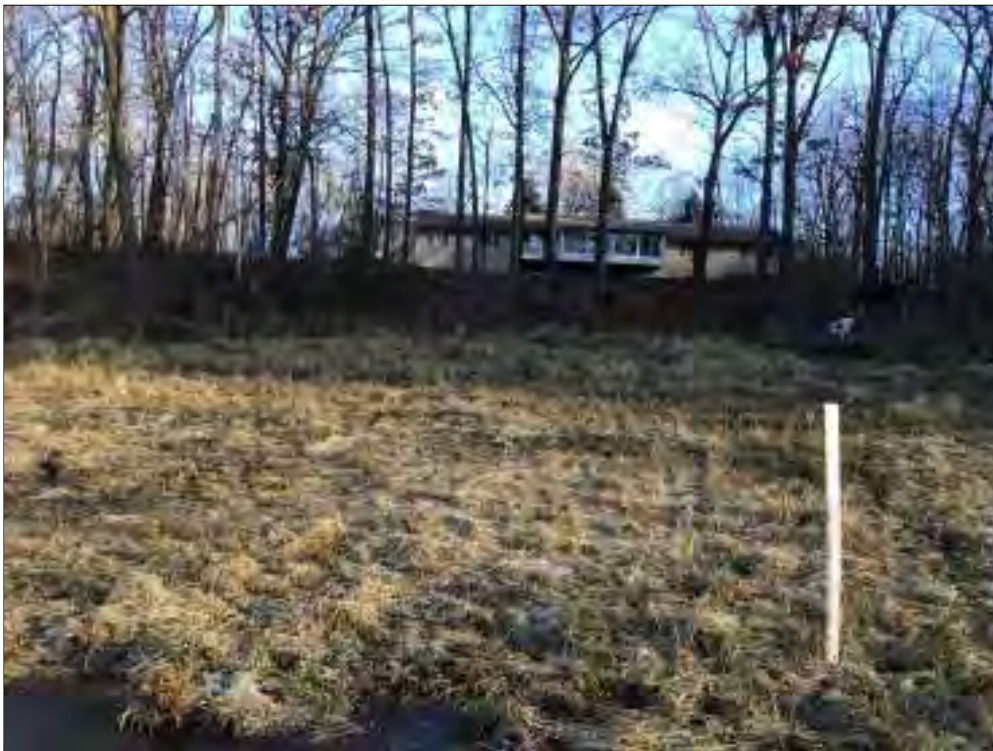
Photo 16: BRSA 7 residence with restored bank in foreground. No issues observed.

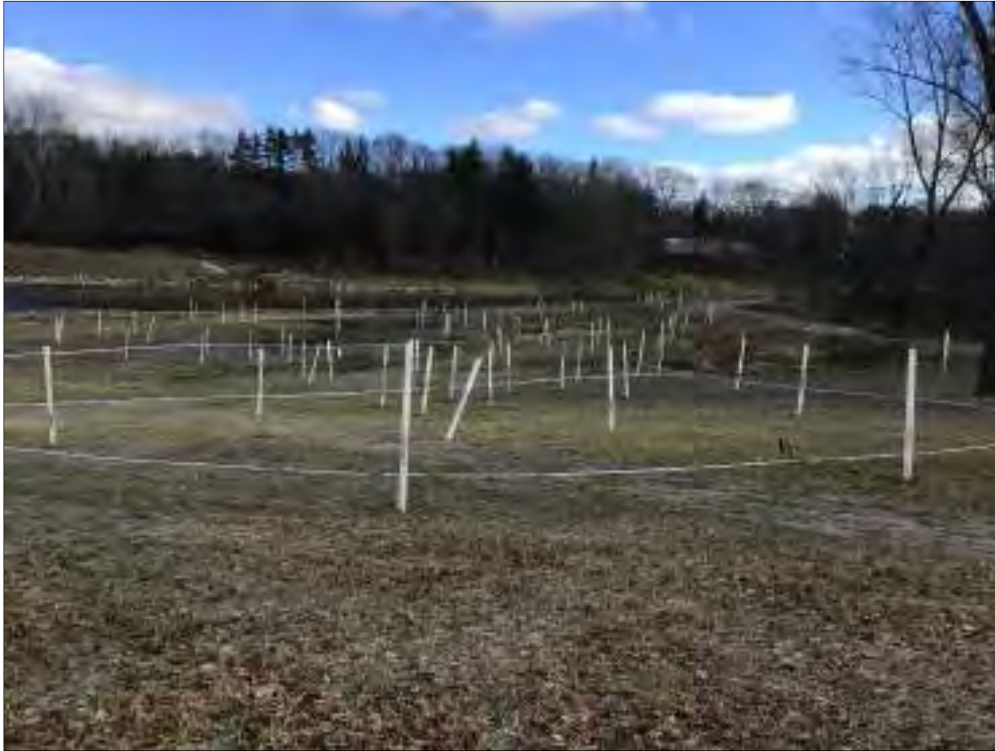
Photo 17: BRSA 8 floodplain near MDNR access and former auxiliary spillway. No issues observed.

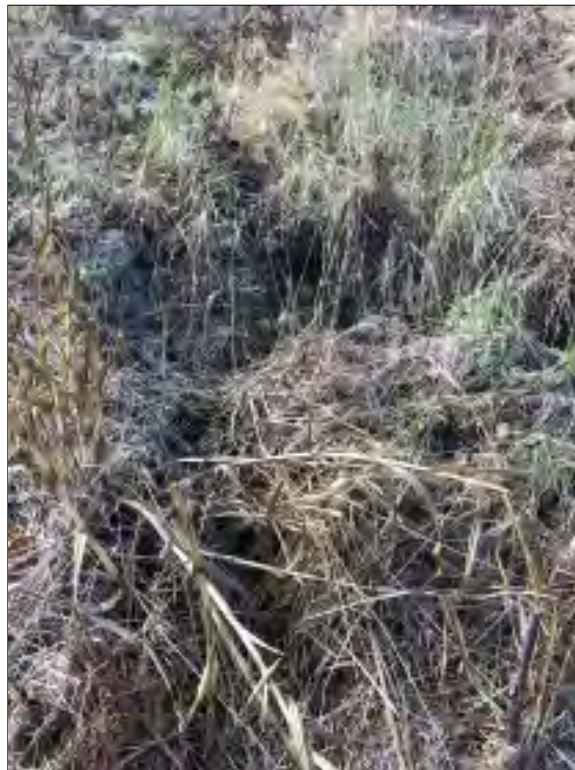
Photo 18: Approx. 12 lineal feet (perpendicular to river) of settling observed on BRSA 8 bank.

4.0	BRSA 8 bank area of settling	No	12/3/2018		See photo 18
MINOR REPAIRS (Item Number)	INSPECTION REFERENCE	REPAIR SCOPE OF WORK SUBMITTED? YES / NO	DATE REPORTED	DATE REPAIR COMPLETED	OTHER COMMENTS

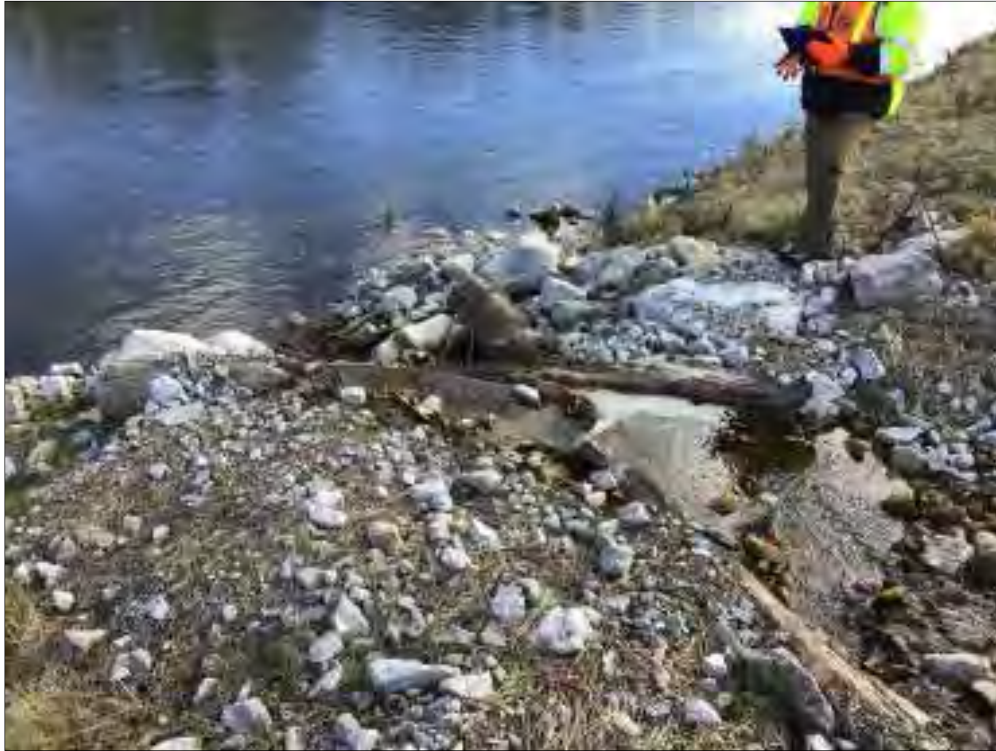
Photo 19: BRSA 8 X-weir (typical). No issues observed.

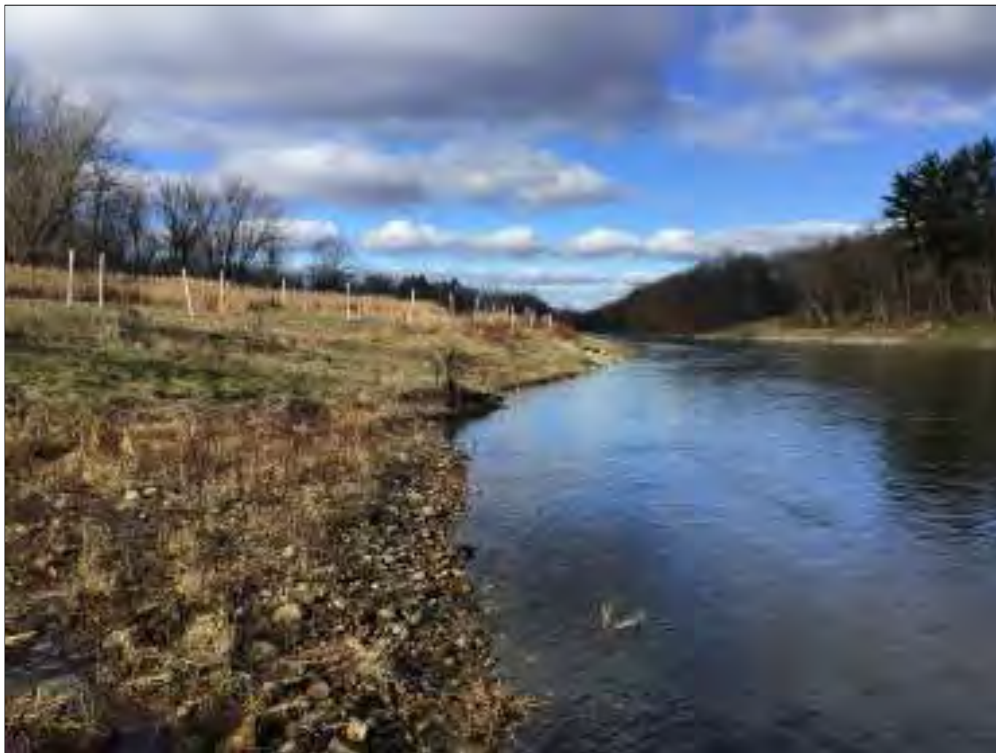
Photo 20: BRSA 8 approaching former dam location. No issues observed.

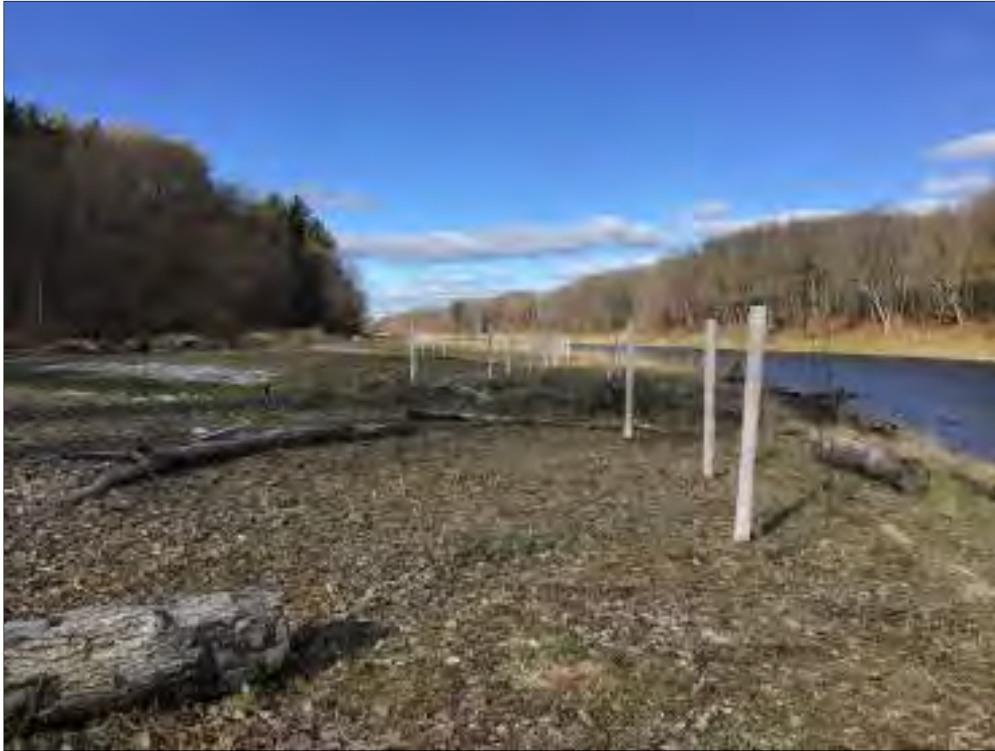
Photo 21: BRSA 8 near river constriction point. No issues observed.

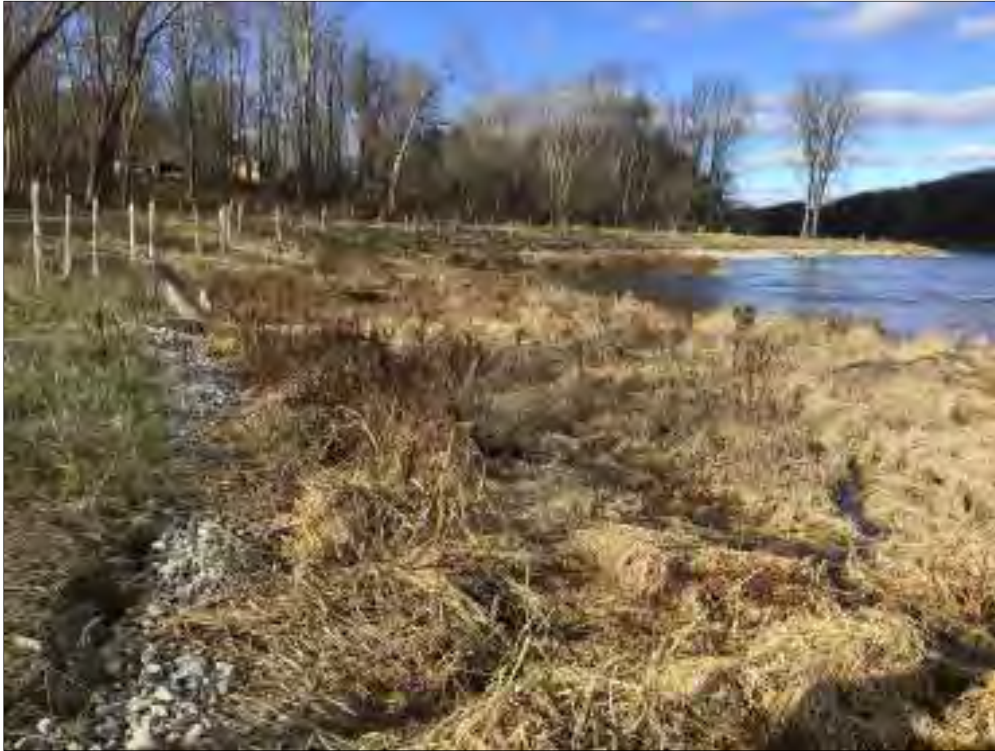
Photo 23: BRSA 9 near river shoals (natural grade control point). No issues observed.

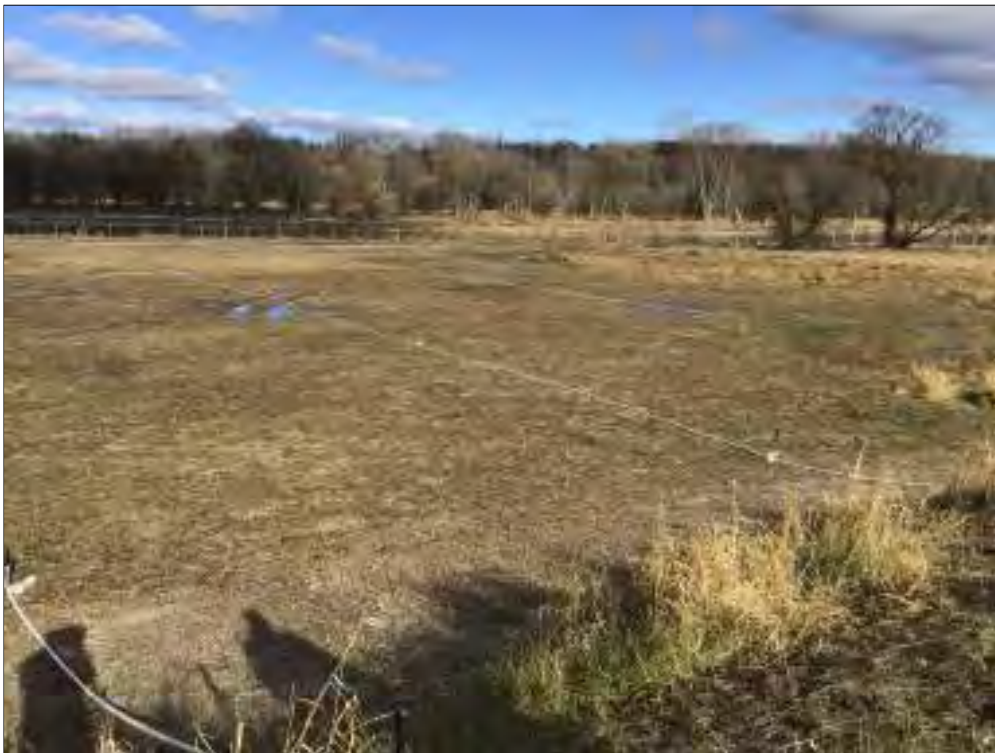
Photo 24: BRSA 9 former staging area. No issues observed.

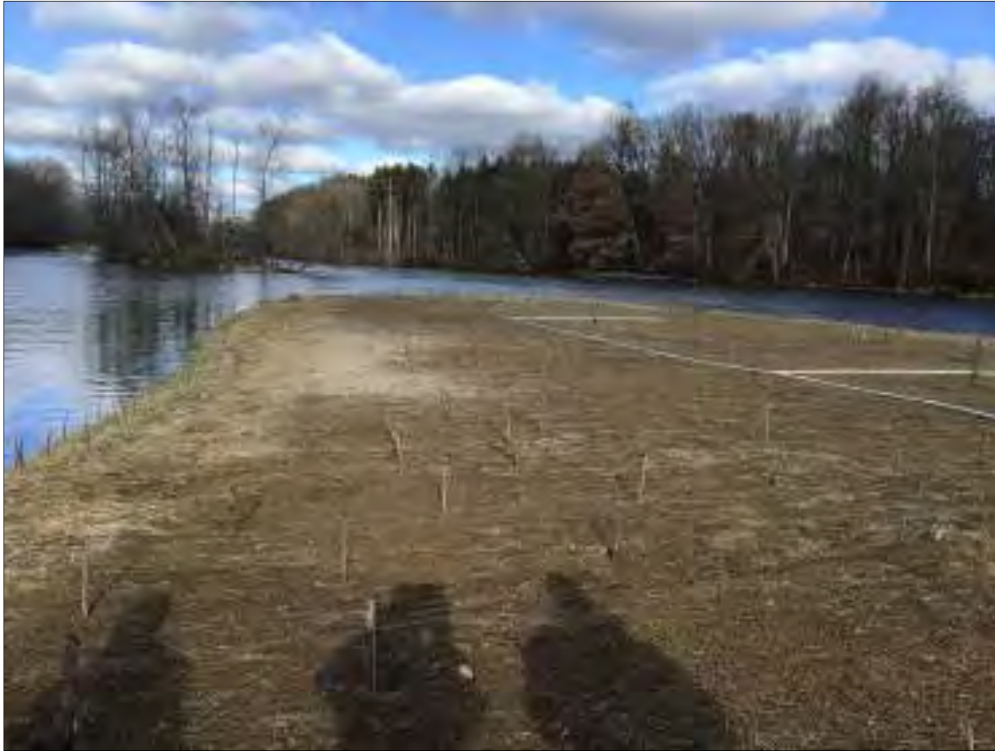
Photo 25: Live stakes planted on plunge pool area peninsula.

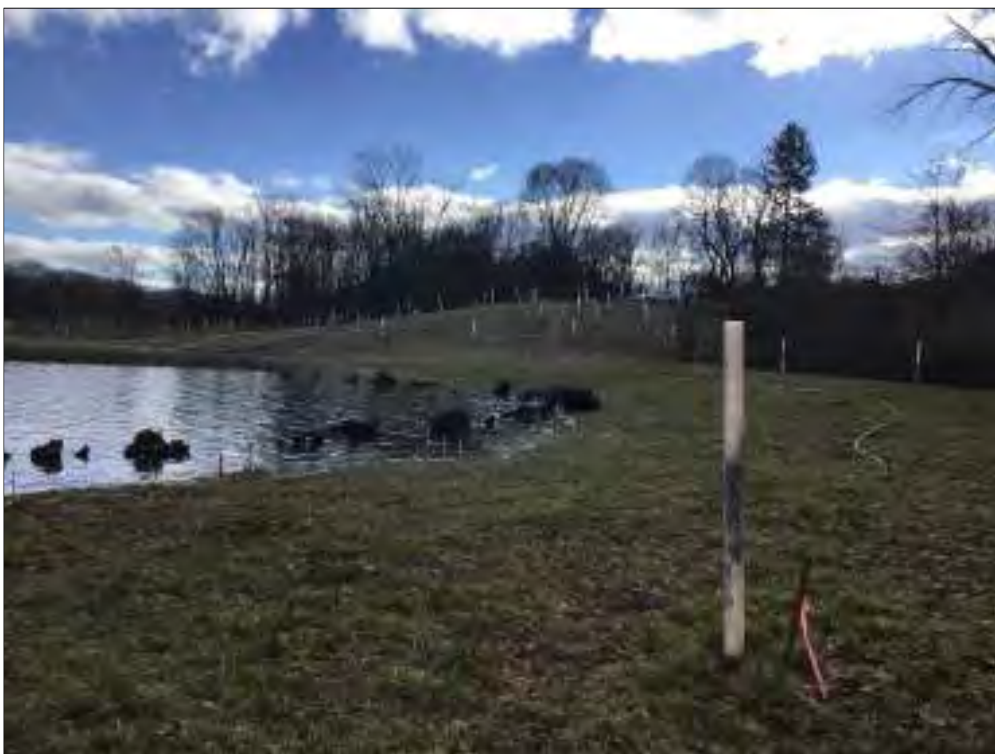
Photo 26: Left-descending bank (LDB) of plunge pool area. No issues observed.

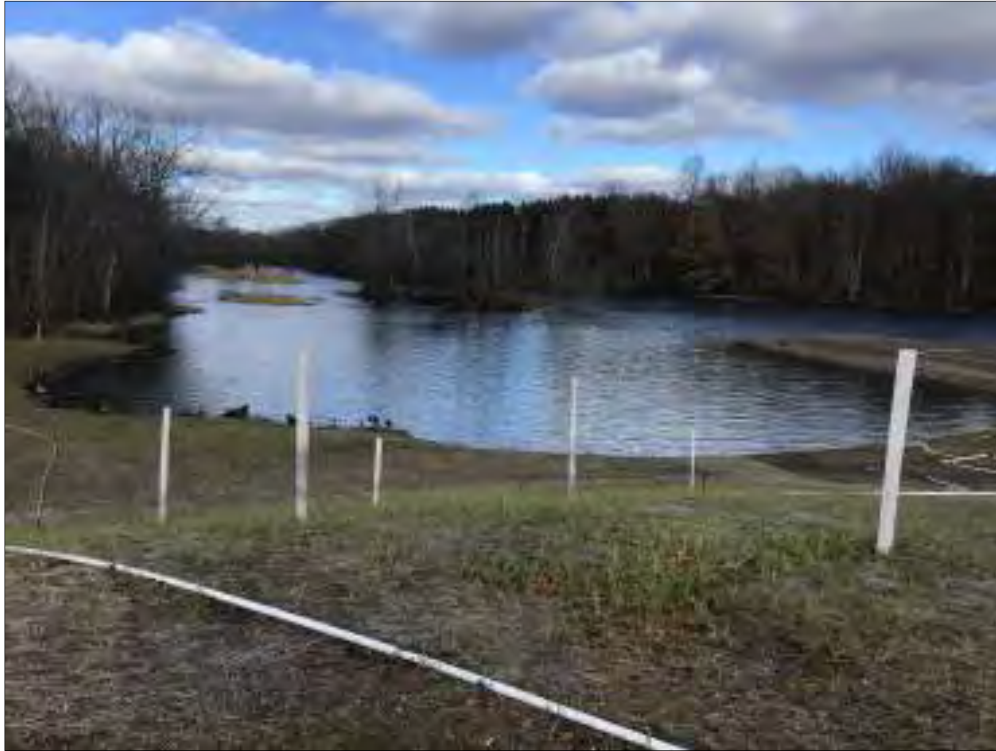
Photo 27: Plunge pool view from MDNR parking area. No issues observed.

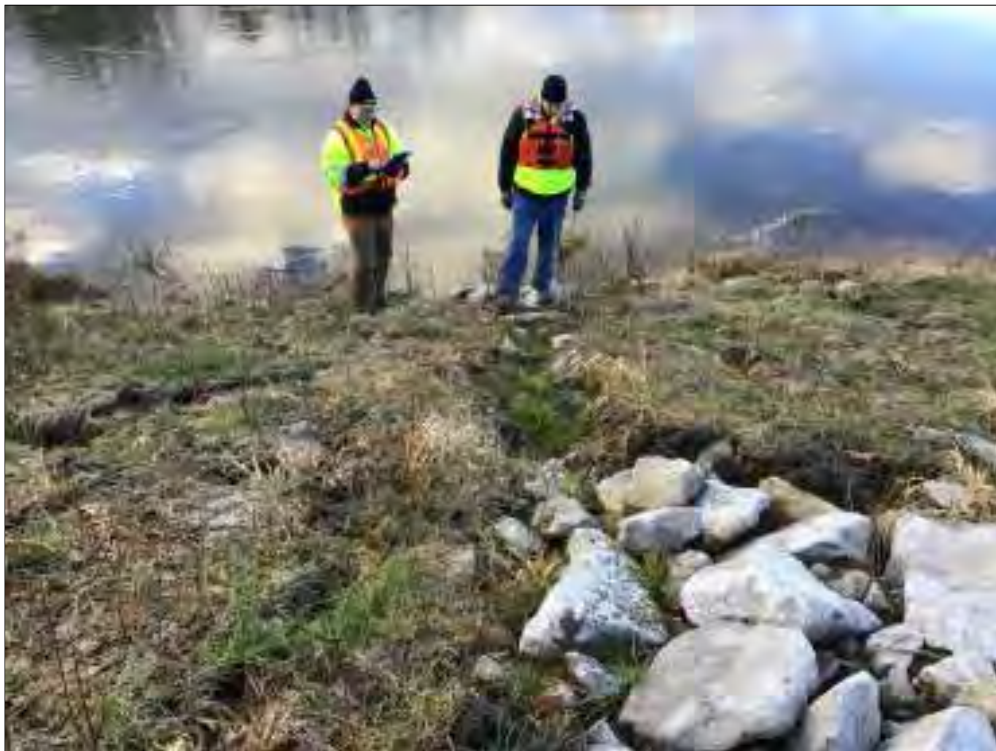
Photo 28: Approx. 8 lineal feet (perpendicular to river) of erosion observed at drainage area on RDB of former water control structure (WCS) corridor.

6.0	BRSA 9 area of coir fabric not secured	No	12/4/2018		Re-stake coir fabric and over-seed as needed (photo 22)
7.0	Former WCS corridor erosion at drainage area on RDB	No	12/4/2018		Continue to monitor, repair in spring/summer 2019 (photo 28)
MAJOR REPAIRS (Item Number)	INSPECTION REFERENCE	REPAIR SCOPE OF WORK SUBMITTED? YES / NO	DATE REPORTED	DATE REPAIR COMPLETED	OTHER COMMENTS

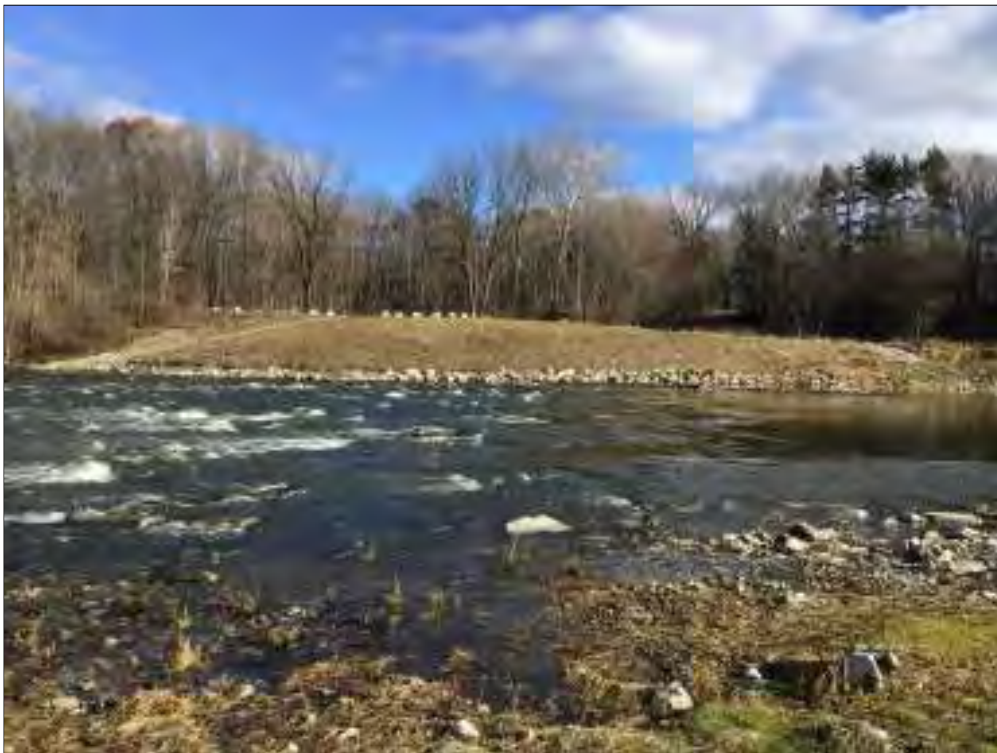
Photo 30: View of former WCS corridor from plunge pool peninsula. No issues observed.

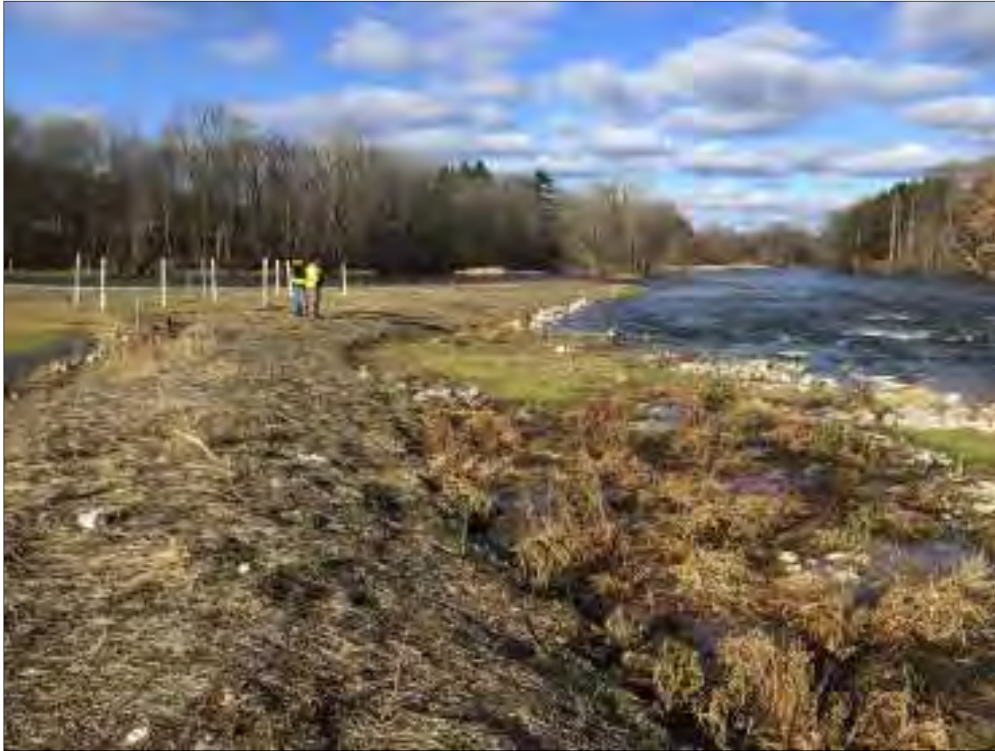
Photo 31: LDB (and low-flow bench) of former WCS corridor. No issues observed.

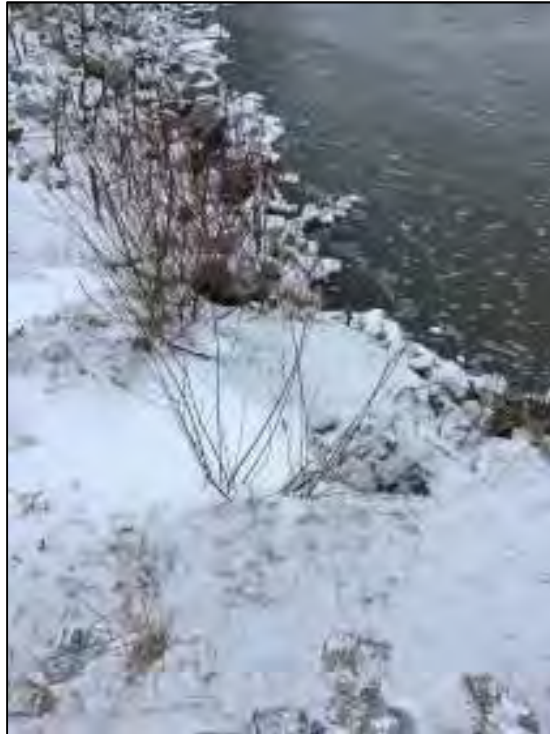
Photo 1: BRSA 1 along right-descending bank (RDB) of Pine Creek confluence. Void observed below coir fabric at rootwad/joint planting transition. No new erosion observed since first quarterly inspection.

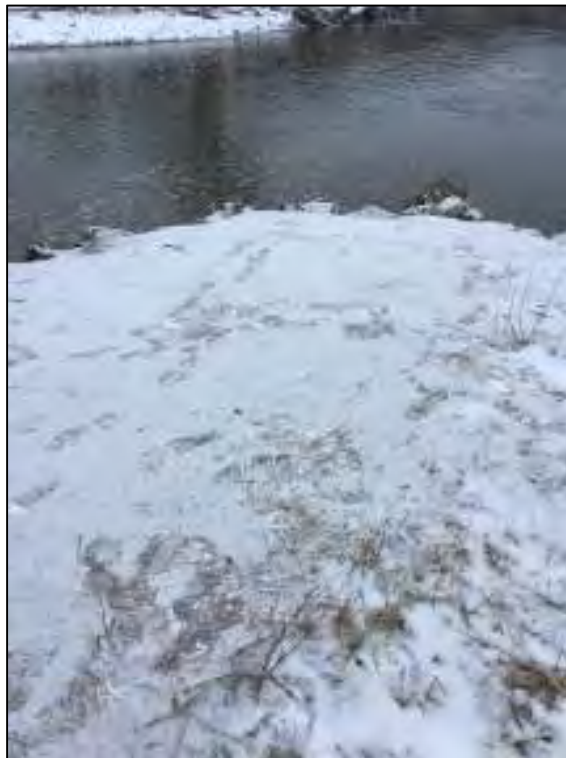
Photo 2: BRSA 1 at Pine Creek confluence. Note that live stakes are missing. No new findings observed since first quarterly inspection.

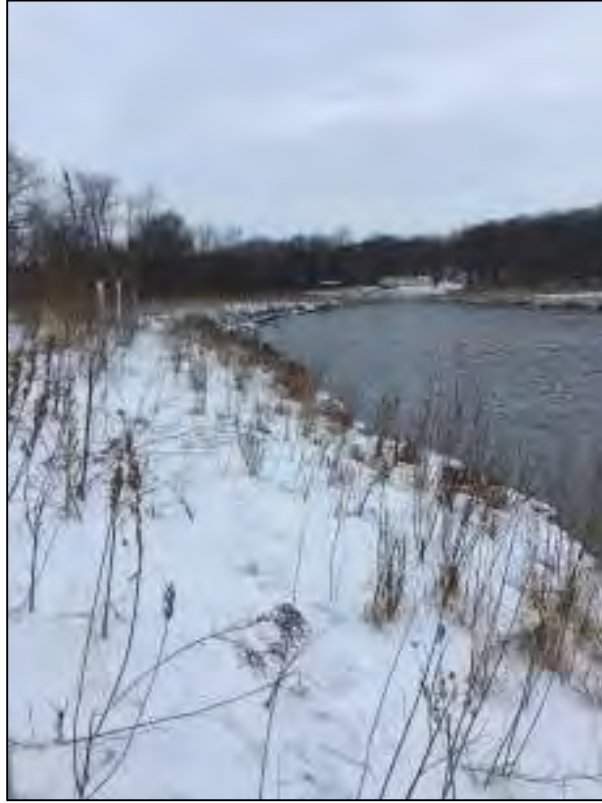
Photo 3: BRSA 1 general view, looking downstream. No issues observed.

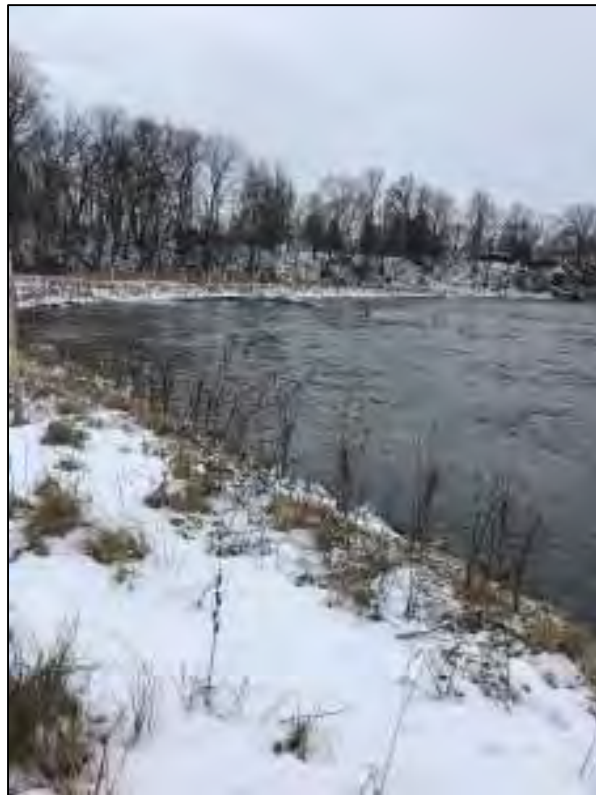
Photo 4: BRSA 3 general view, looking downstream. No issues observed.

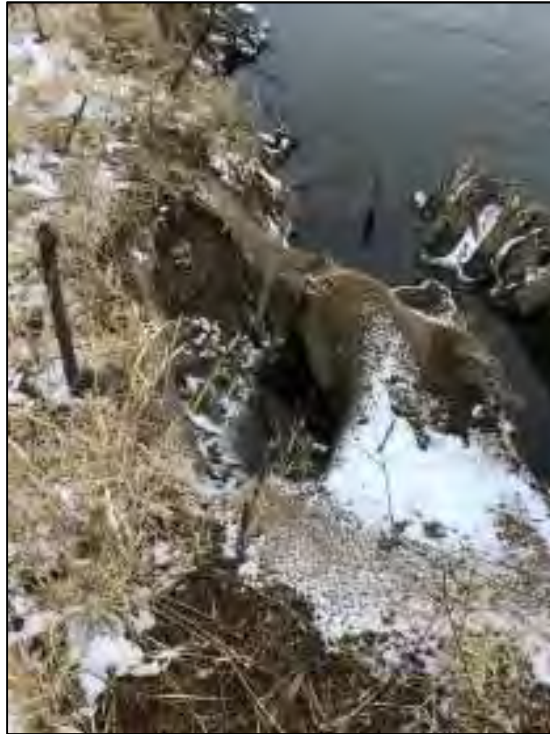
Photo 5: Area of settling observed along approx. 30 lineal feet of BRSA 4 bank, downstream of staging area. Area of settling appears to have extended along bank since first quarterly inspection.

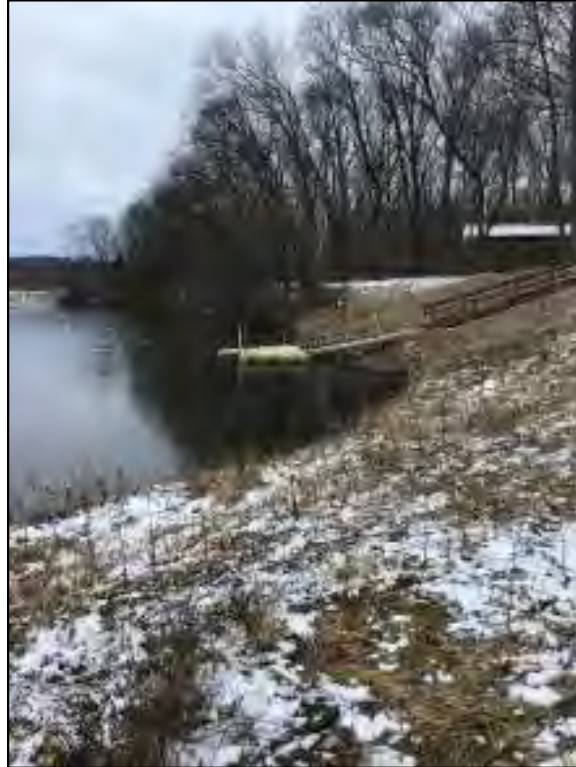
Photo 7: BRSA 4 residential restoration area. No issues observed.

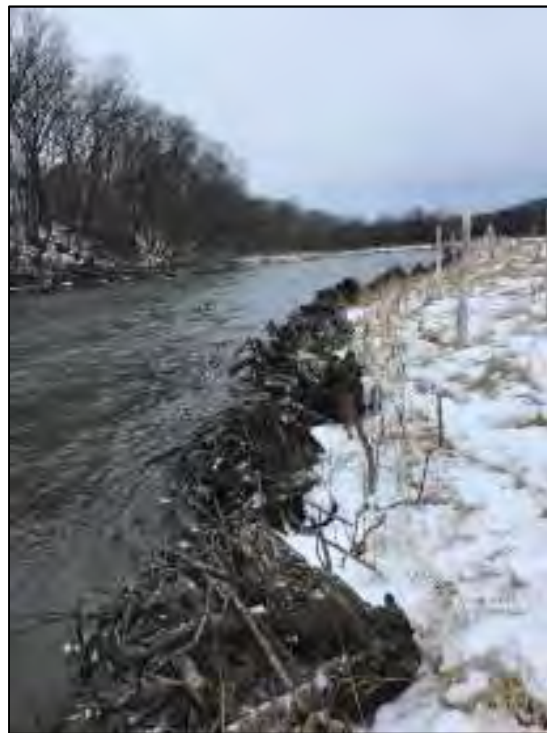
Photo 8: BRSA 4 general view, looking downstream. No issues observed.

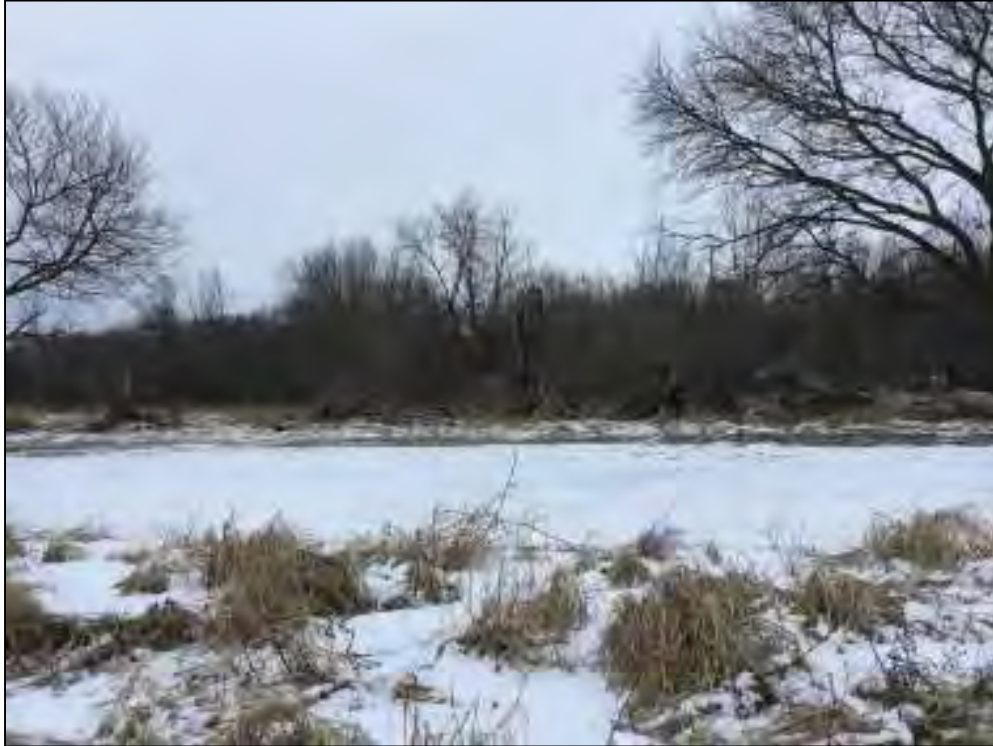
Photo 9: BRSA 6 root wad trees left vertical in turnaround area. No changes observed during second quarterly inspection.

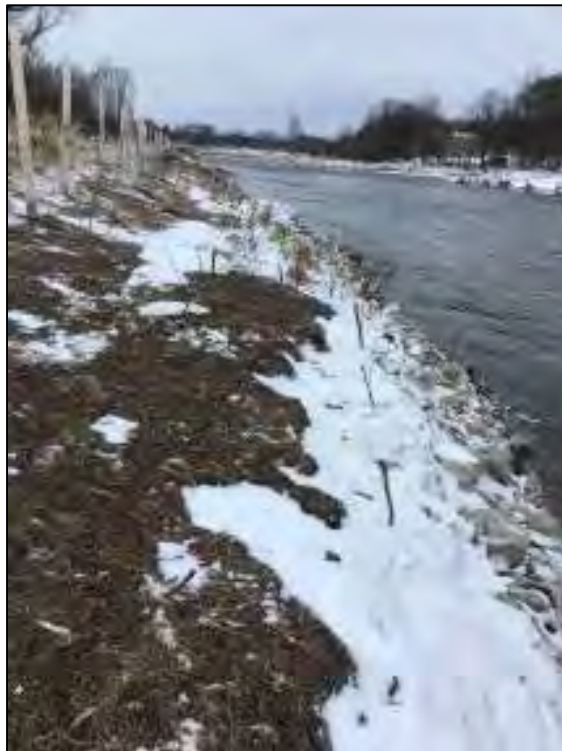
Photo 10: BRSA 6 general view, looking upstream. No issues observed.

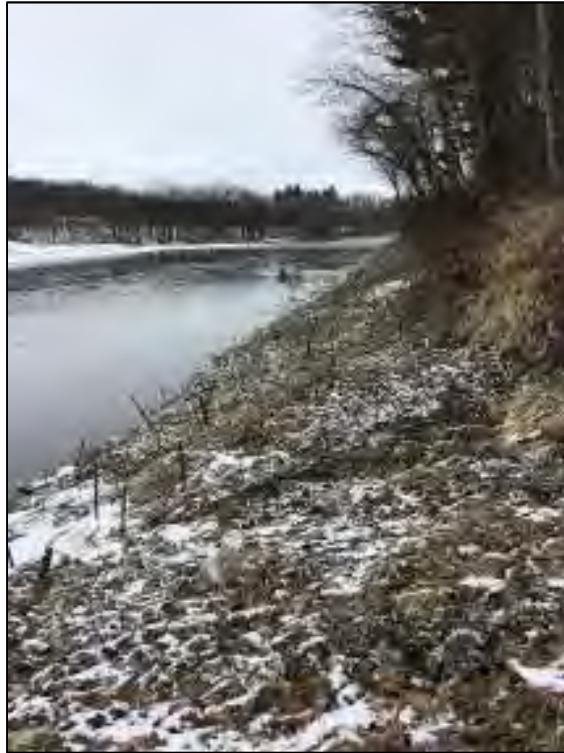
Photo 11: BRSA 7 near transition to high bank zone. Unsafe to walk steep bank; however, no issues observed from view point.

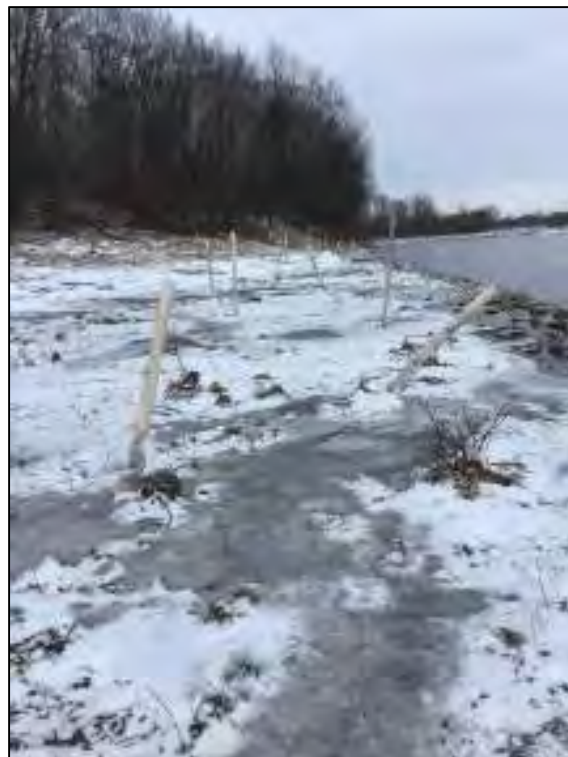
Photo 12: Over 20 tree grow tubes crushed/knocked down along approx. 150 feet of BRSA 7 bank, near constructed access road.
