**Otsego Township Dam Area
Time Critical Removal Action**

**DRAFT
Final Maintenance and Monitoring Report**

Prepared by:
**Wood Environment & Infrastructure Solutions, Inc.
Novi, Michigan**

November 15, 2019

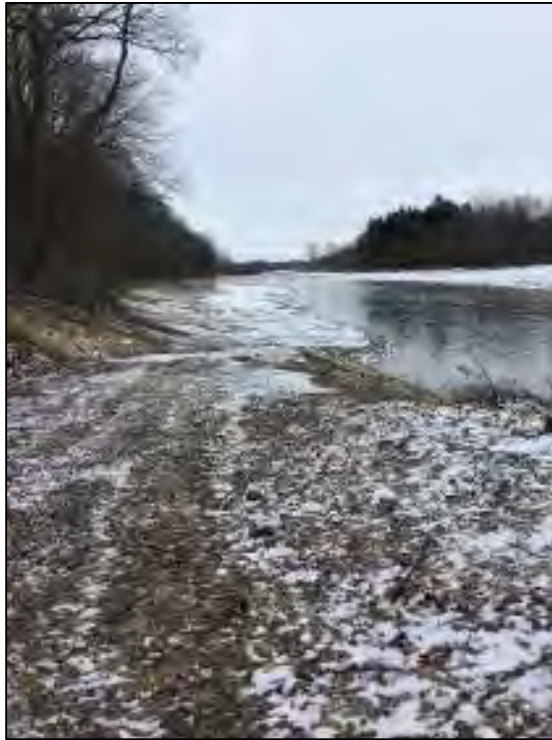
Photo 13: BRSA 7 general view. No issues observed.

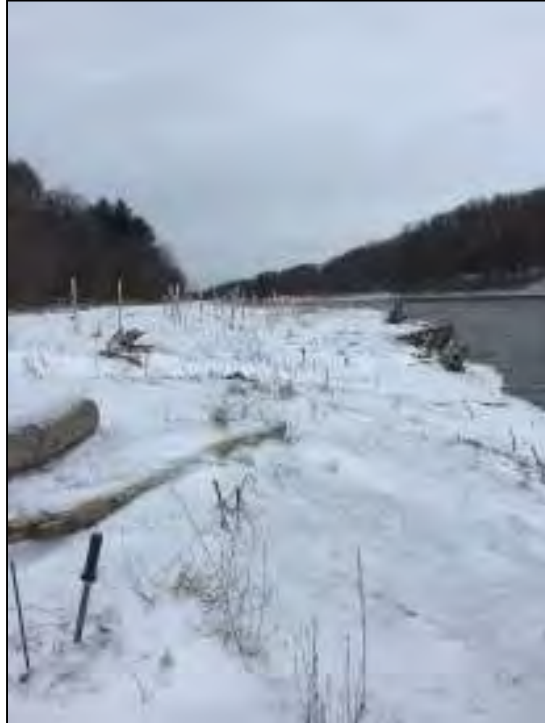
Photo 15: BRSA 8 general view, looking downstream. No issues observed.

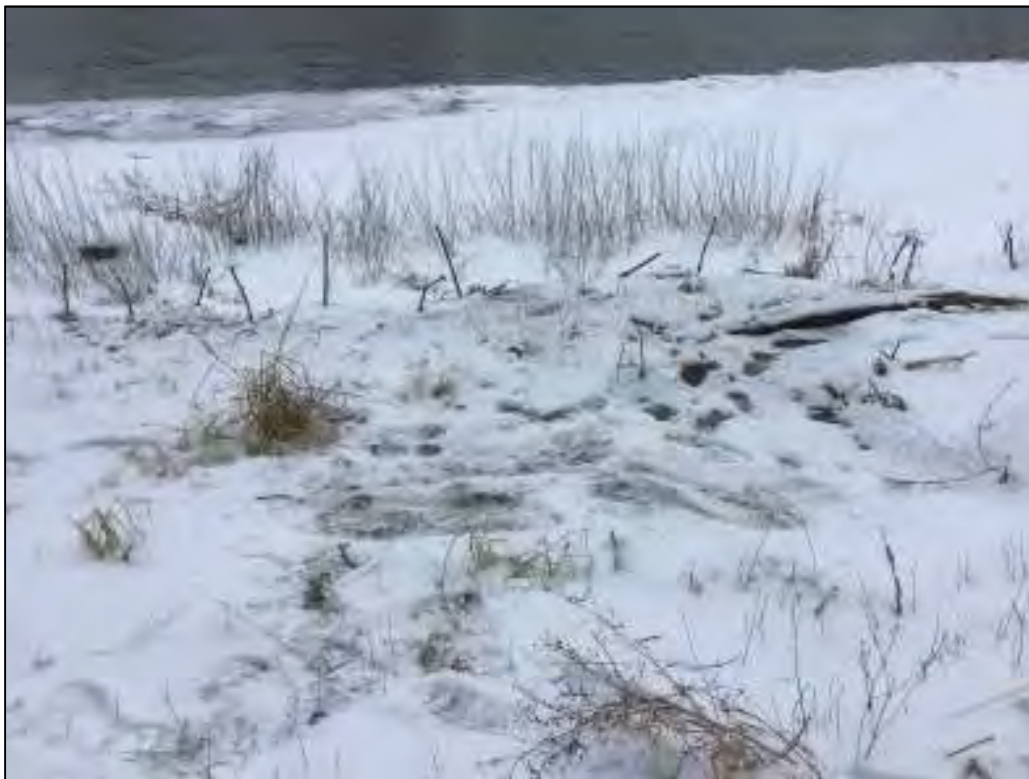
Photo 16: BRSA 9 approaching transition to BRSA 8, coir fabric not secure. No new findings observed since first quarterly inspection.

6.0	BRSA 9 area of coir fabric not secured	No	12/3/2018		Re-stake coir fabric and over-seed as needed (photo 16)
7.0	Former WCS corridor erosion at drainage area on RDB	No	12/4/2018		Not observed during second quarterly inspection; snow cover inhibited view of the ground surface in many areas. Continue to monitor, repair in spring/summer 2019

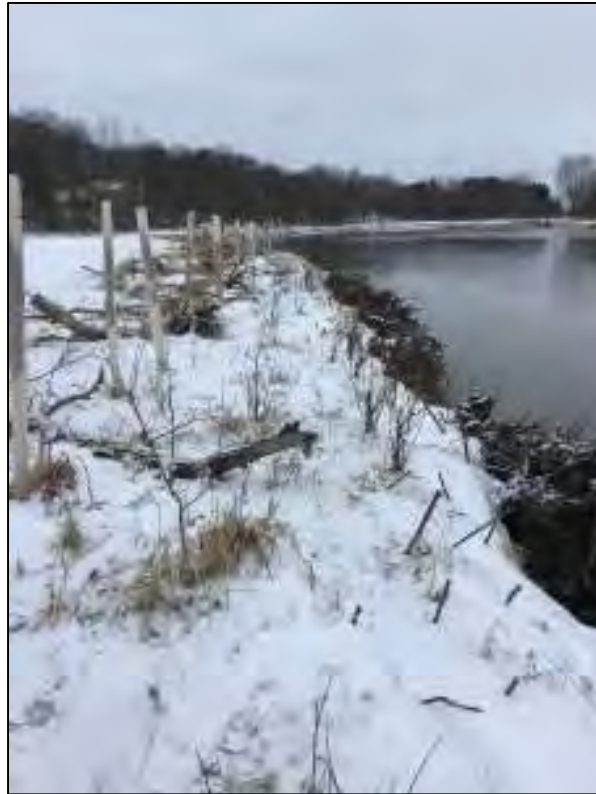
Photo 17: BRSA 9 general view, looking downstream. No issues observed.

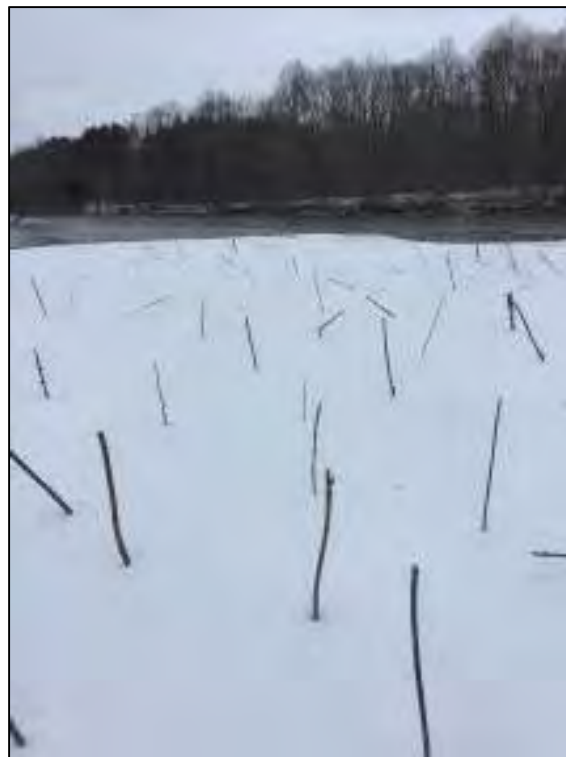
Photo 18: Live stakes knocked down on plunge pool area peninsula.

5.0	Plunge pool live stakes dislodged	No	2/26/2019		Live stakes on LDB and peninsula appeared knocked down, dislodged, or broken (photos 18, 19)
MINOR REPAIRS (Item Number)	INSPECTION REFERENCE	REPAIR SCOPE OF WORK SUBMITTED? YES / NO	DATE REPORTED	DATE REPAIR COMPLETED	OTHER COMMENTS

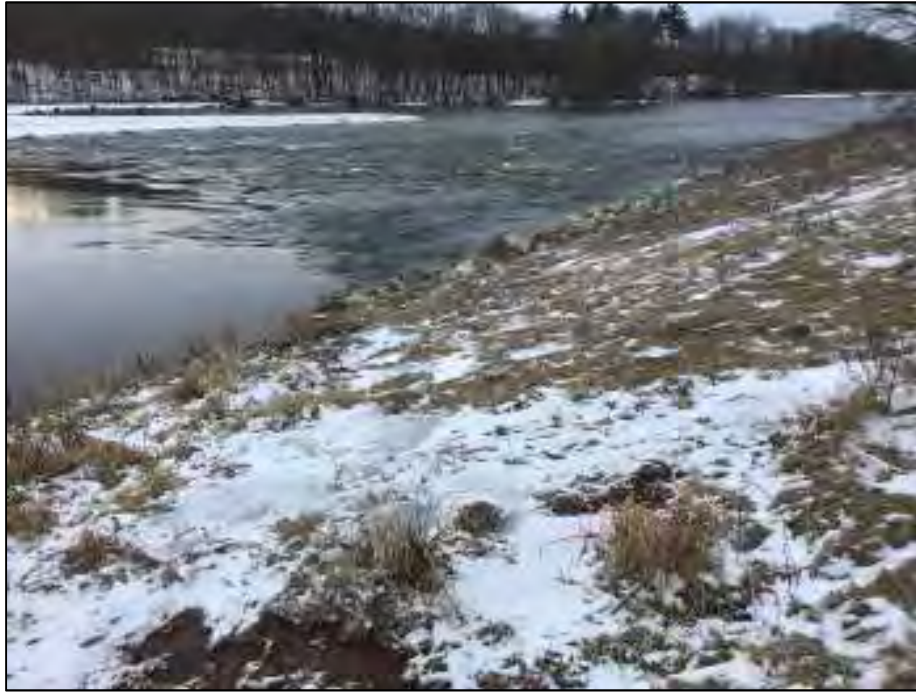
Photo 21: RDB of former WCS corridor. No issues observed.

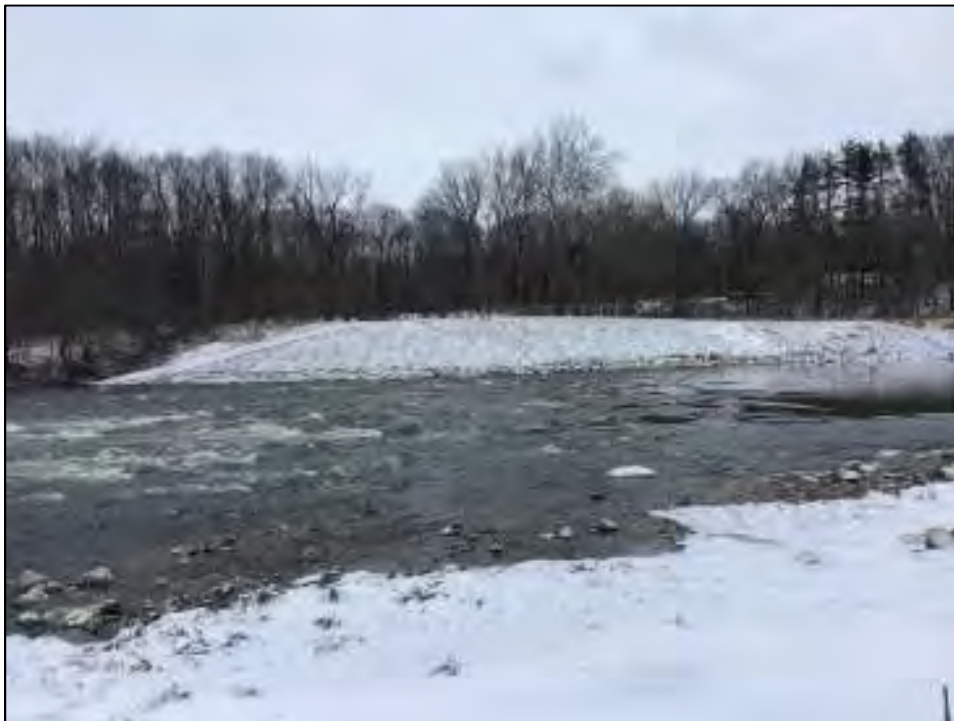
Photo 22: View of former WCS corridor from plunge pool peninsula. No issues observed.

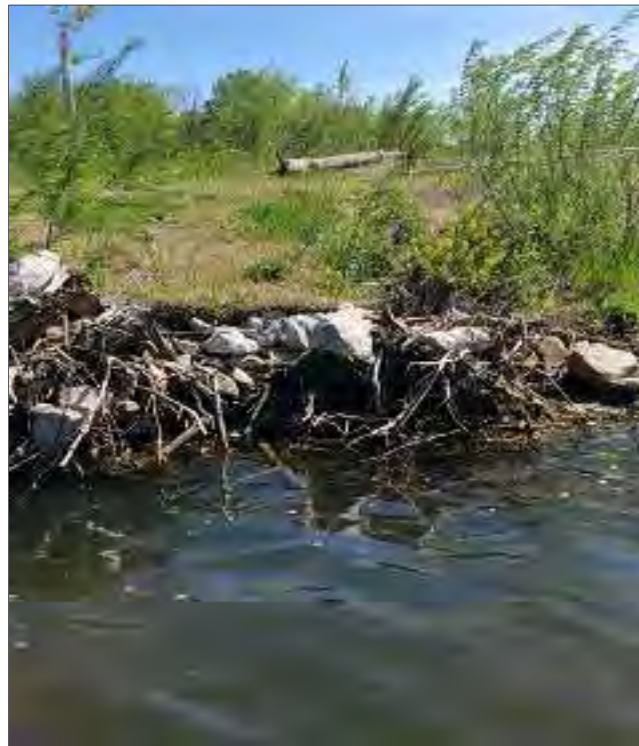
Photo 2: Boat-based view of BRSA 1 along RDB of Pine Creek confluence (same location as Photo 1).

UNDER OBSERVATION (Item Number)	INSPECTION REFERENCE	REPAIR SCOPE OF WORK SUBMITTED? YES / NO	DATE REPORTED	DATE REPAIR COMPLETED	OTHER COMMENTS
1.0	BRSA 1 along RDB of Pine Creek - void below coir fabric at rootwad/joint planting transition	No	12/3/2018		Continue to monitor, repair not necessary at this time (photos 1 and 2)

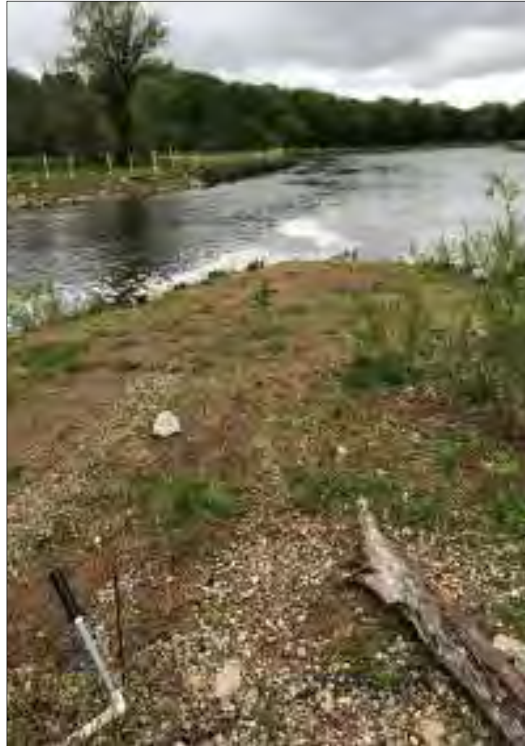
Photo 3: BRSA 1 at Pine Creek confluence where live stakes are missing. Previously identified; no new findings observed.

2.0	BRSA 1 at Pine Creek confluence - live stakes missing	No	12/3/2018		Continue to monitor, repair not necessary at this time (photo 3)
3.0	BRSA 1 bank area of settling	No	12/3/2018		Continue to monitor, repair not necessary at this time (photo 4)

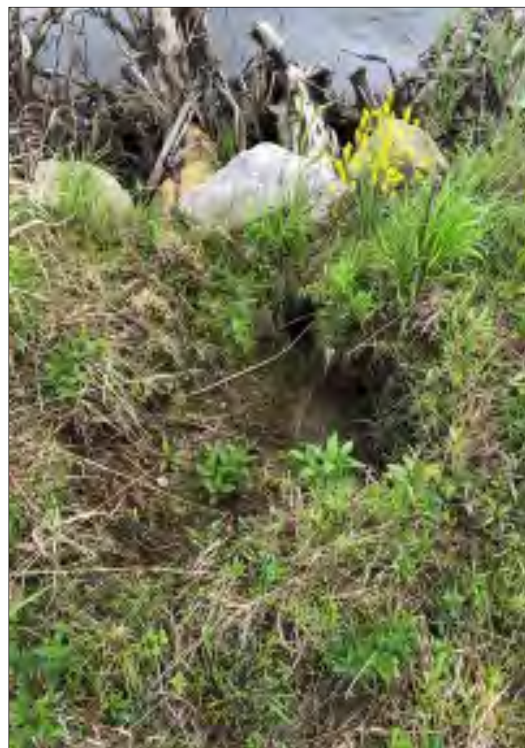
Photo 4: BRSA 1 area of settling. Previously observed during 1st Quarterly Inspection, but snow covered during 2nd Quarterly Inspection. Continue to monitor.

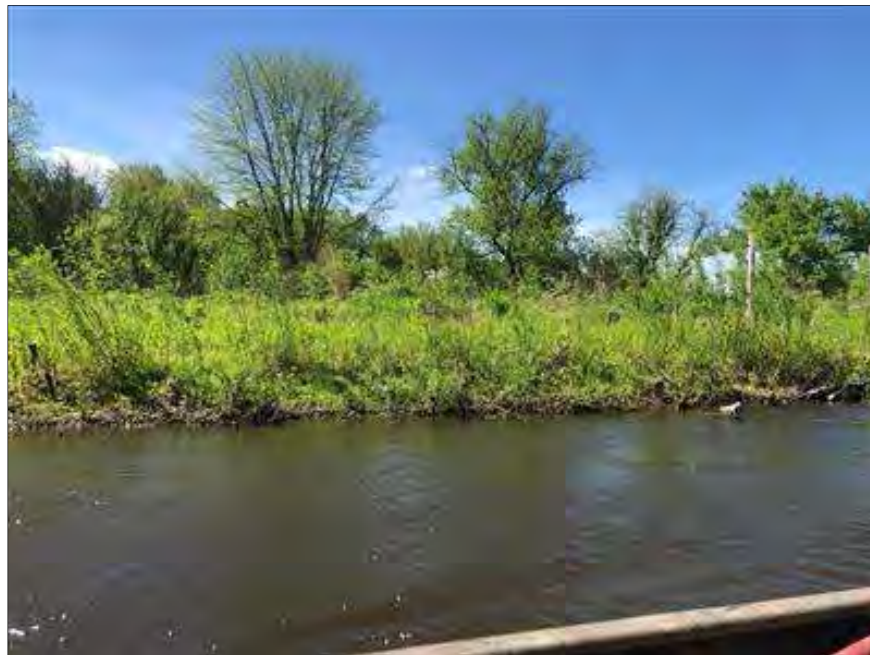
Photo 6: Boat-based view of BRSA 1 bank identified for monitoring during 1st Quarterly Inspection; no issues observed.

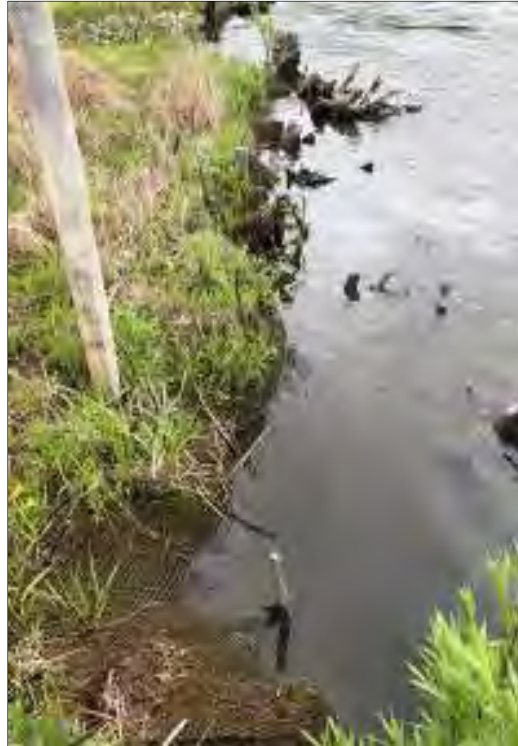
Photo 11: BRSA 4 area of sloughing observed during 1st and 2nd Quarterly Inspections. No new issues observed.

2.0	BRSA 4 settling along bank, approx. 50 LF downstream of staging area	Yes	12/3/2018		Repair scheduled for June/July 2019 (photos 11, 12, 13)
3.0	BRSA 6 - two areas where live stakes are not growing	Yes	5/20/2019		Plant additional live stakes, scheduled for June and July 2019 (photos 16 and 17)

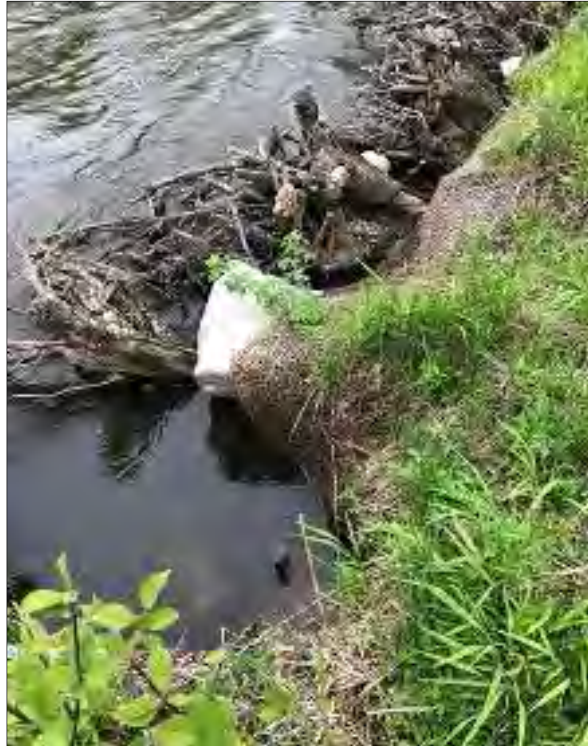
Photo 13: BRSA 4 area of sloughing observed across from BRSA 3 J-hooks during 1st and 2nd Quarterly Inspections. No new issues observed.

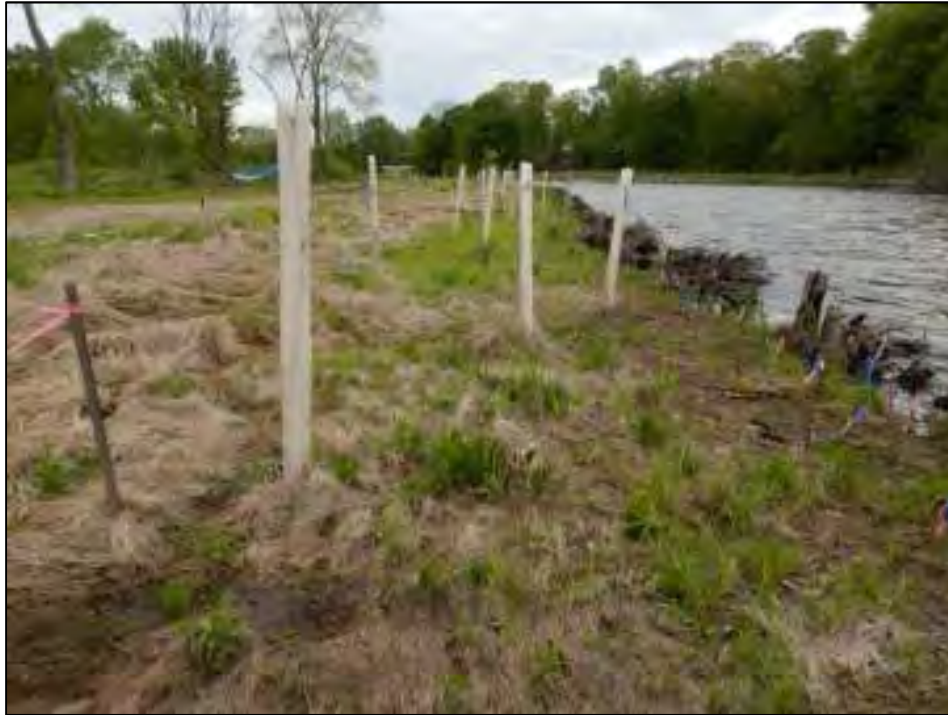
Photo 15: BRSA 4 Study Plot.

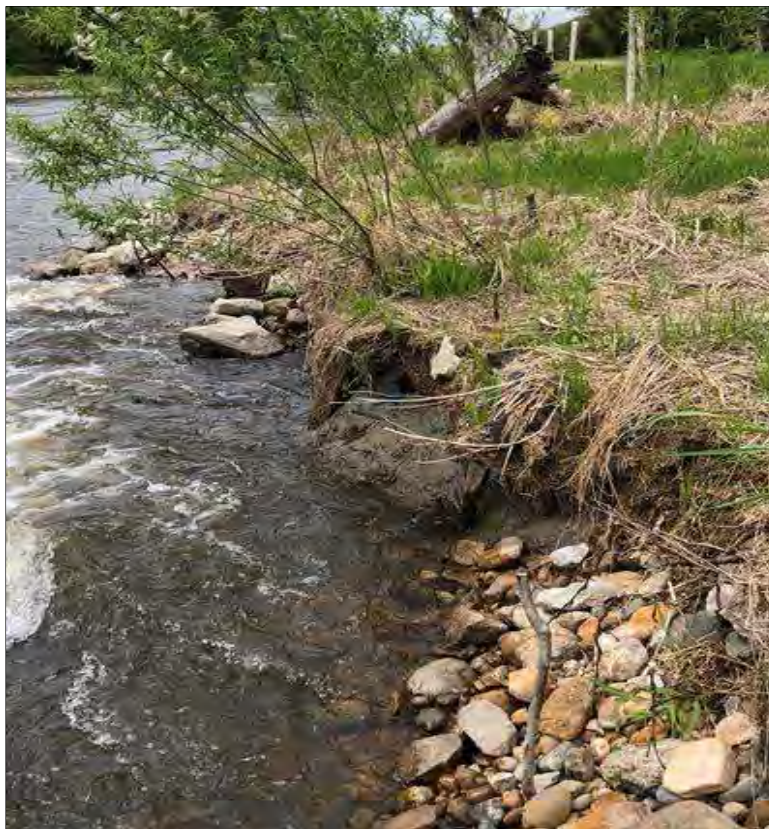
Photo 18: Approx. 75-100 linear feet of scouring along BRSA 6 bank.

4.0	BRSA 6 scouring along approx. 75-100 LF	Yes	5/20/2019		Repair scheduled for June/July 2019 (photo 18)
5.0	BRSA 7 upland water cutting into bank	Yes	5/20/2019		Repair scheduled for June/July 2019 (photo 21)

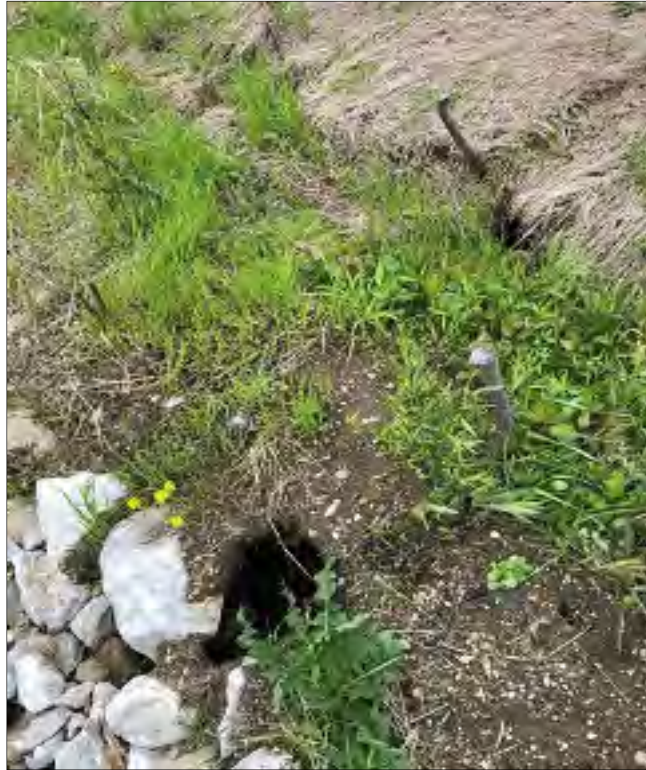
**Photo 19: Hole observed in BRSA 6 bank, approx. 1 ft. deep, extending landward approx. 3 ft.
Continue to monitor.**

8.0	BRSA 6 hole observed in bank	No	5/20/2019		Approx. 1 ft deep, extending landward approx. 3 ft. (photo 19). Repair not necessary at this time.
9.0	BRSA 8 bank area of settling	No	12/3/2018		Not observed during Q2 inspection (likely due to snow cover) or Q3 inspection (likely due to vegetative cover)

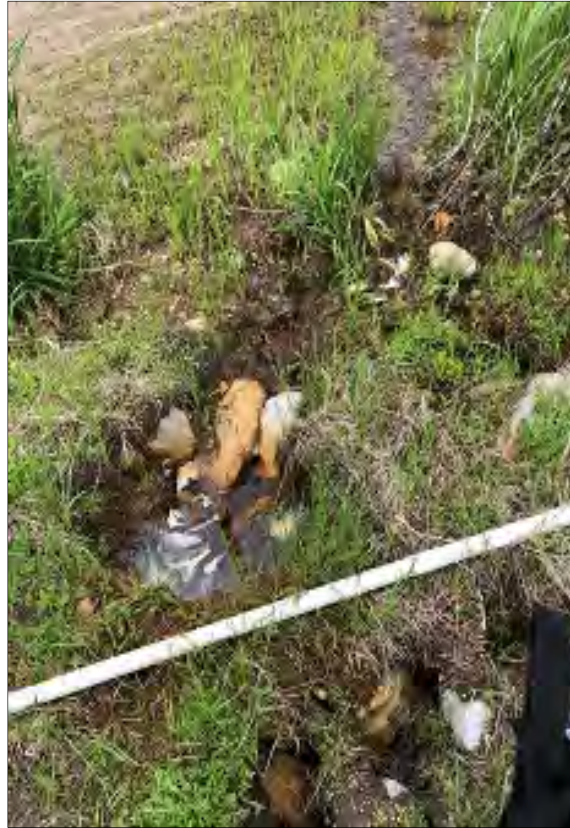
Photo 21: Upland water cutting into BRSA 7 bank.

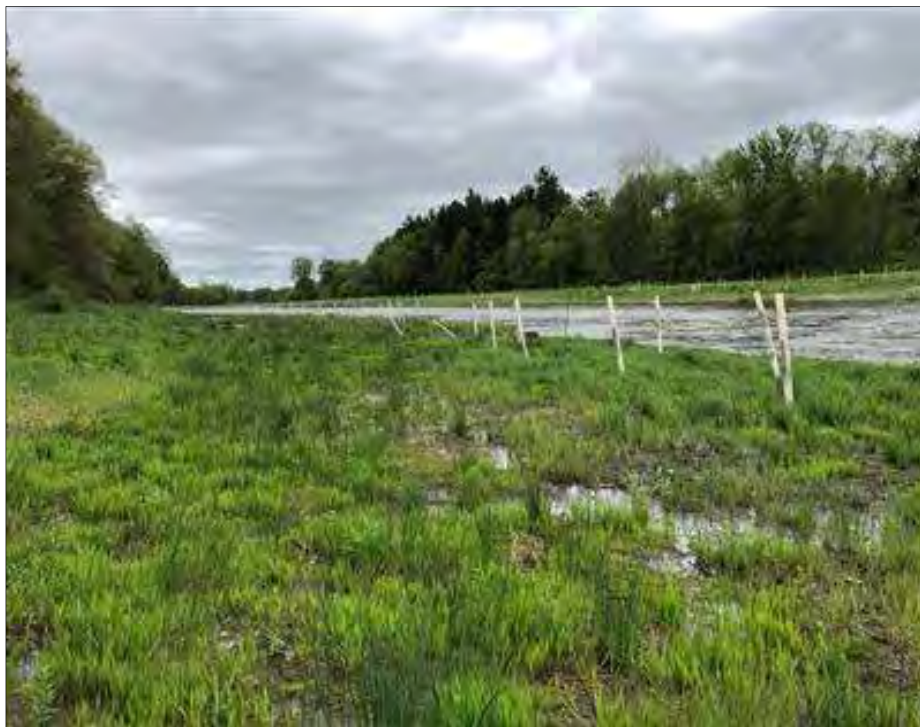
Photo 22: BRSA 7 area where trees were previously knocked over by ice flows. No issues observed.

8.0	BRSA 7 growth tubes knocked down/crushed	No	2/26/2019	4/1/2019	USEPA stood trees back up (photo 22)
9.0	BRSA 8 fallen tree blocking east access gate	No	2/26/2019	3/22/2019	USEPA removed fallen tree

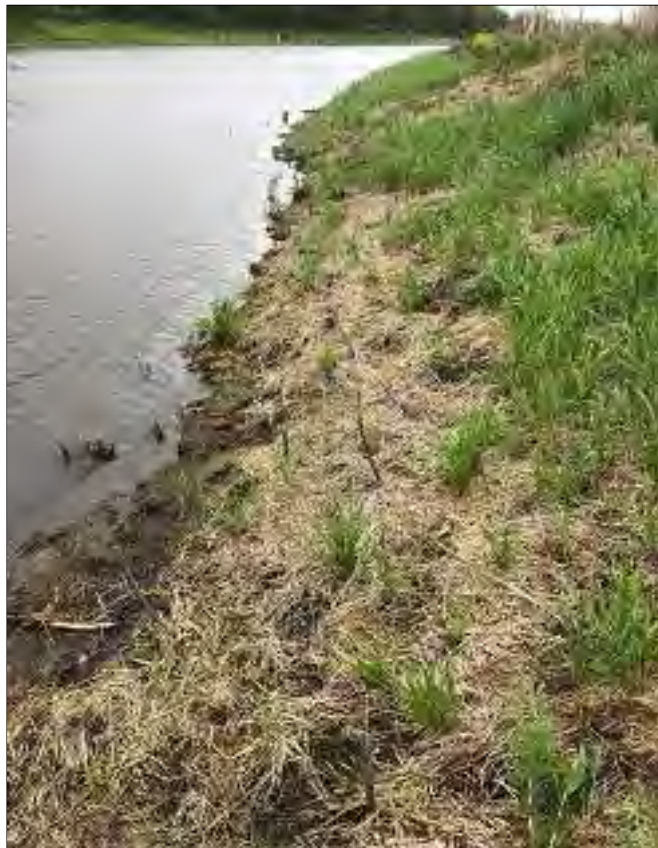
Photo 24: Approx. 20 ft. of BRSA 8 bank with no signs of growth on live stakes.

10.0	BRSA 8 area of no live stake growth	No	5/20/2019		Approx. 20 ft. of bank with no signs of live stake growth (photo 24). Continue to monitor.
11.0	Plunge pool live stakes dislodged	No	2/26/2019		Continue to monitor, repair not necessary at this time

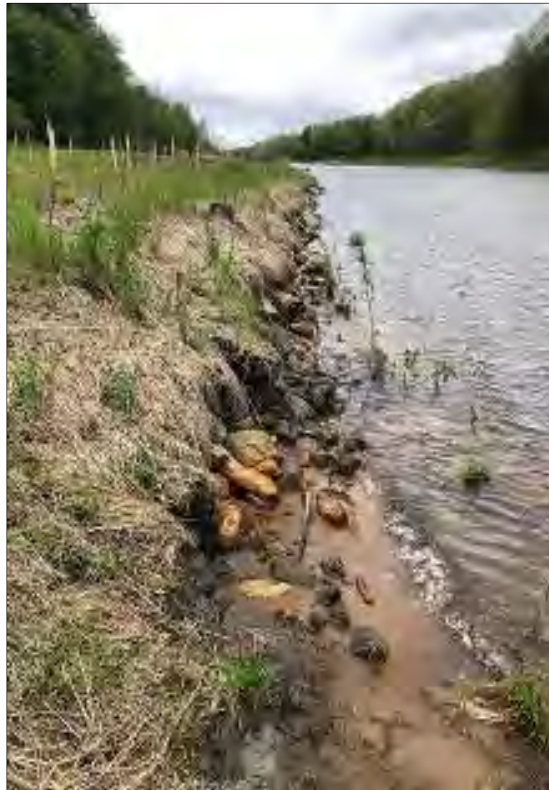
Photo 25: Scour observed along approx. 300-400 linear feet of BRSA 8 bank, beginning near RS 24+75.

Photo 26: Boat-based view of BRSA 8 scour shown in Photo 25.

6.0	BRSA 8 bank scour, approx. 300-400 LF	Yes	5/20/2019		Repair scheduled for June/July 2019 (photos 25 and 26)
7.0	BRSA 9 area of coir fabric not secured	Yes	12/3/2018		Repair scheduled for June/July 2019 (photo 28)

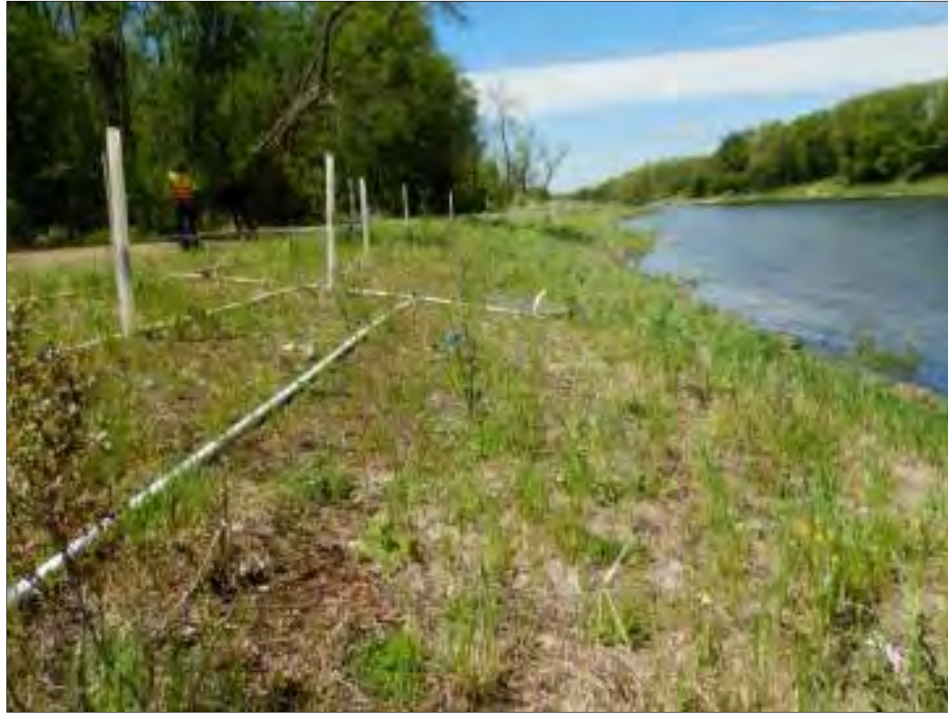
Photo 27: BRSA 8 Study Plot.

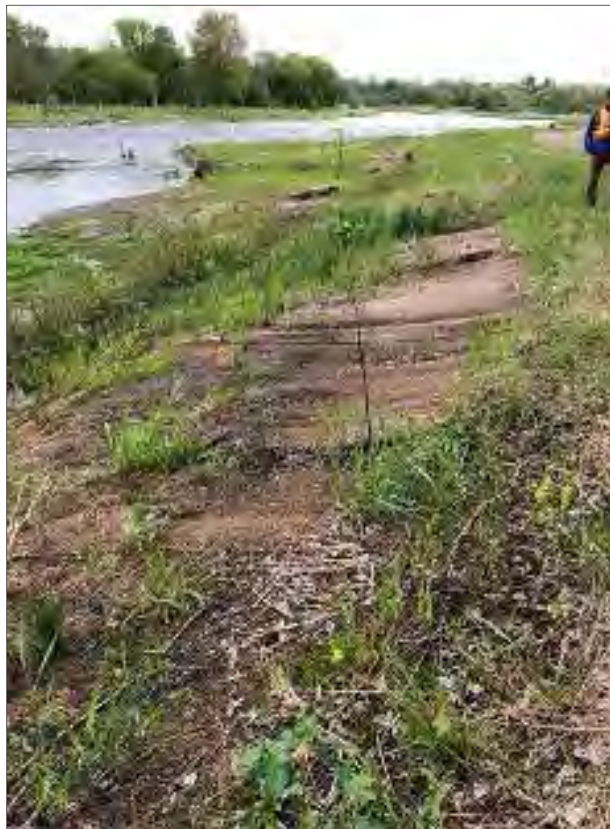
Photo 28: BRSA 9 coir fabric repair area, previously identified in 1st and 2nd Quarterly Inspections.

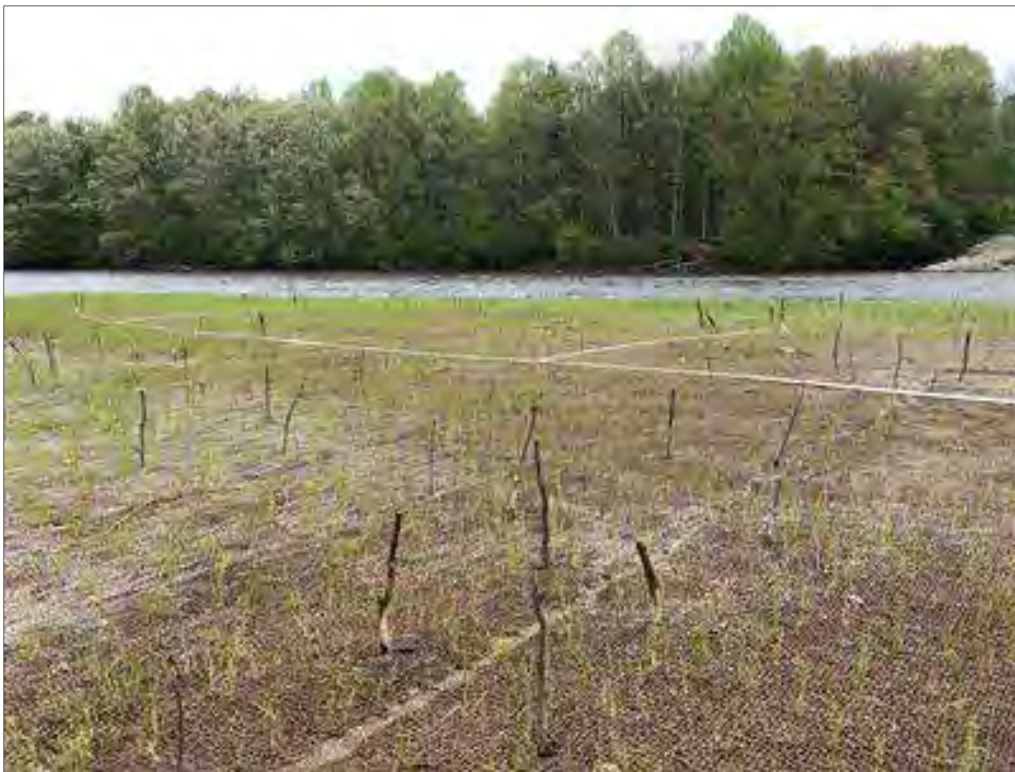
Are there areas bare of vegetation larger than 3ft square?	X		Photo 32	Little grass growth observed on peninsula between Plunge Pool and former WCS corridor
Is there evidence of invasive weeds or undesirable vegetative growth? (e.g., canary grass, purple loosestrife, Japanese knotweed, tree of heaven, etc.)		X

Photo 32: General view of Plunge Pool peninsula. Limited grass and live stake growth observed.

12.0	Peninsula showing limited grass and live stake growth	No	5/20/2019		Continue to monitor, repair not necessary at this time (Photo 32)
13.0	Former WCS corridor erosion at drainage area on RDB	No	12/4/2018		Continue to monitor, repair not necessary at this time (photo 35)
MINOR REPAIRS (Item Number)	INSPECTION REFERENCE	REPAIR SCOPE OF WORK SUBMITTED? YES / NO	DATE REPORTED	DATE REPAIR COMPLETED	OTHER COMMENTS

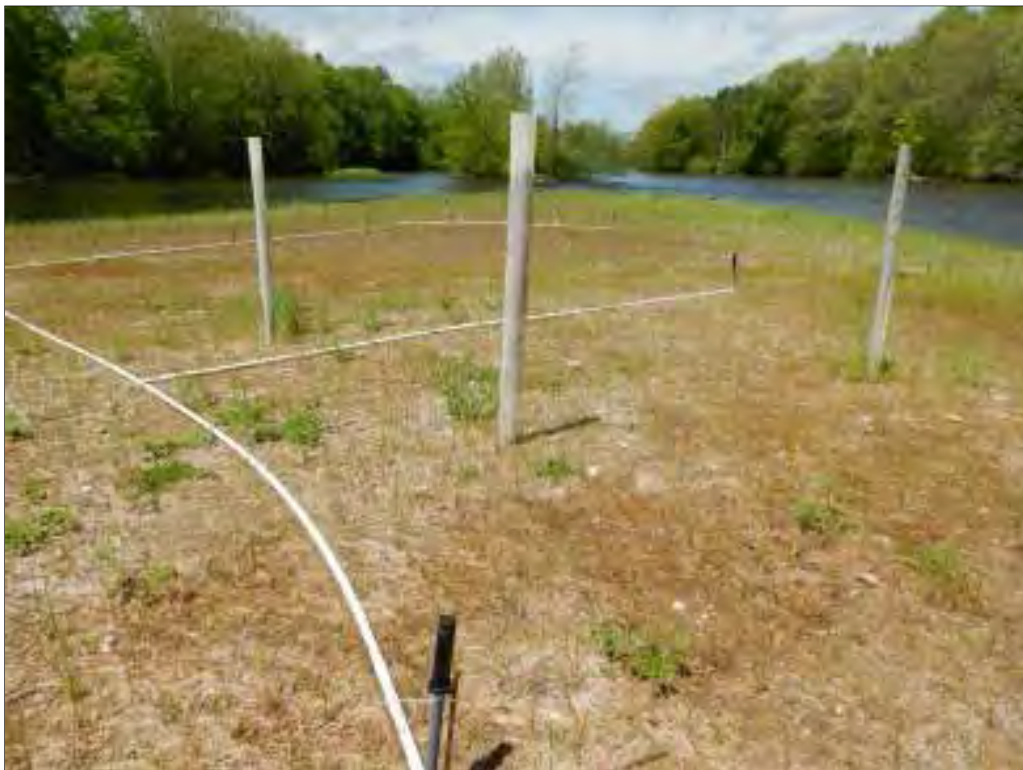
Photo 33: Plunge Pool Study Plot. Note that live stakes appear to have been removed by passersby.

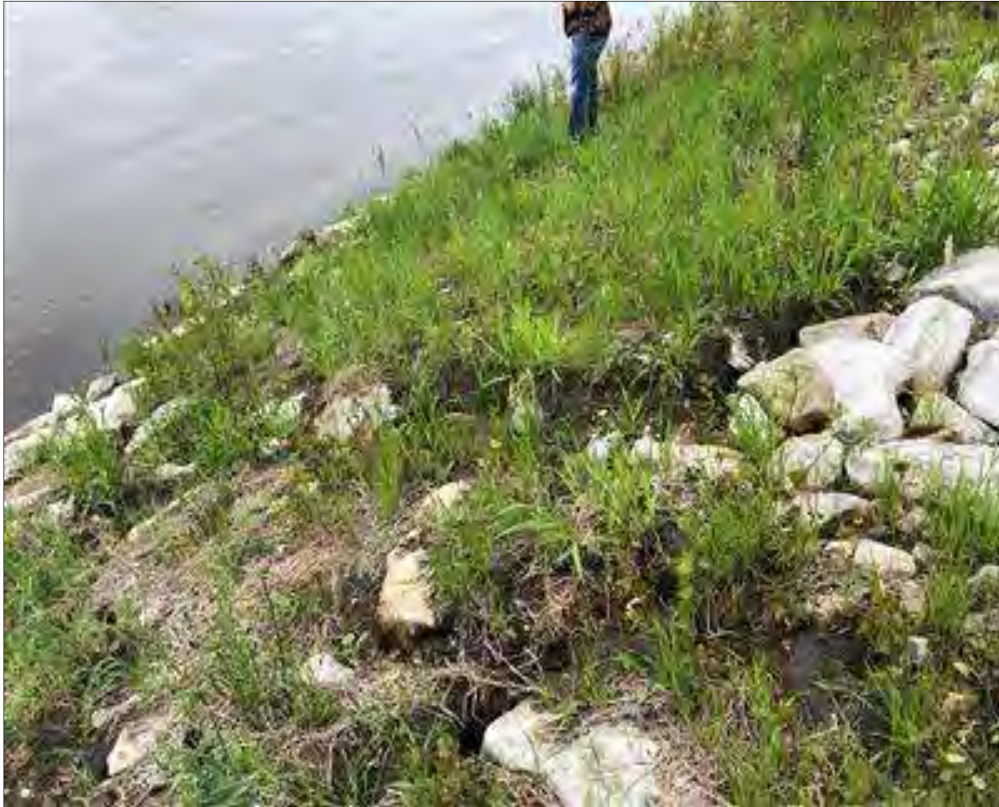
Photo 35: Former WCS corridor area identified during Q1 inspection as area to monitor; no significant change observed.

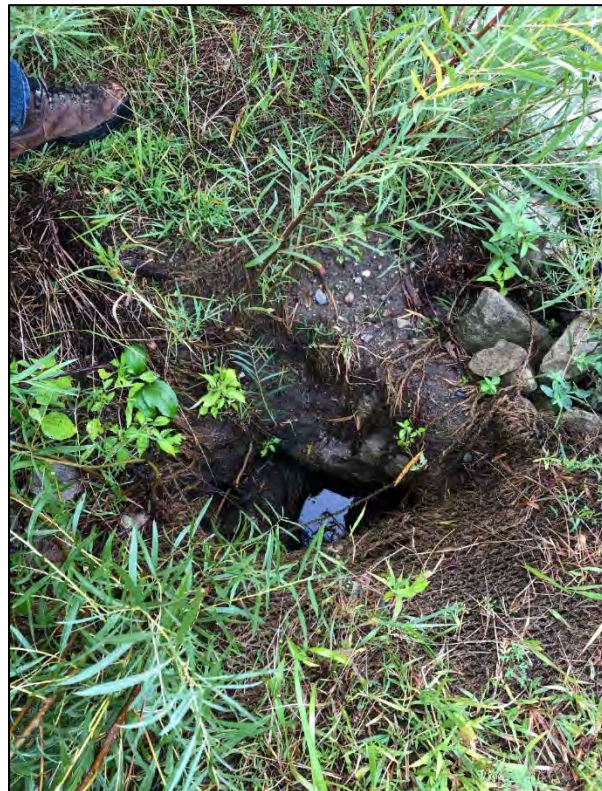
Photo 2: BRSA 1 right-descending bank of Pine Creek confluence. Void observed at rootwad/joint planting transition (observed during previous inspections).

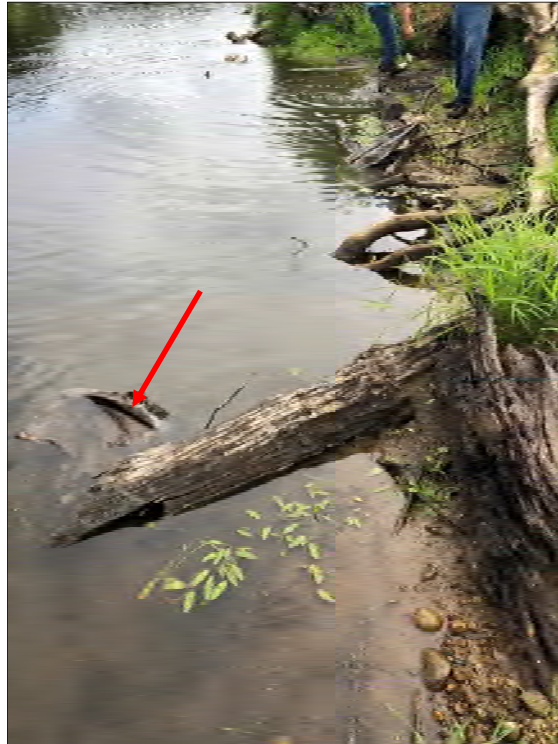
Photo 3: Fabric from cofferdam system remaining in river along BRSA 1 (fabric also observed along BRSA 9).

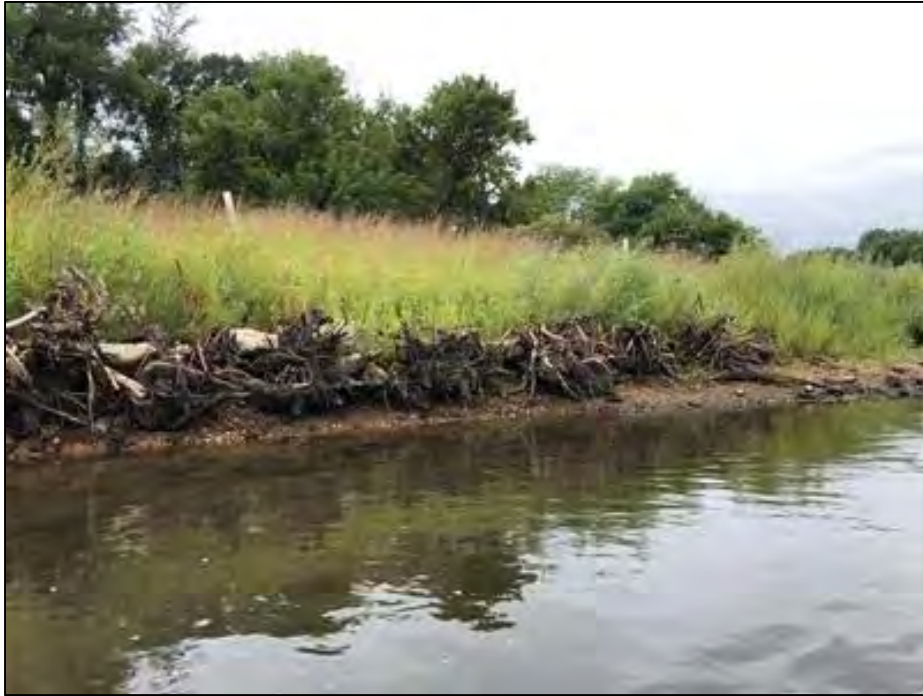
Photo 4: BRSA 1 area of minor settling. Observed during previous inspections. No change in condition observed.

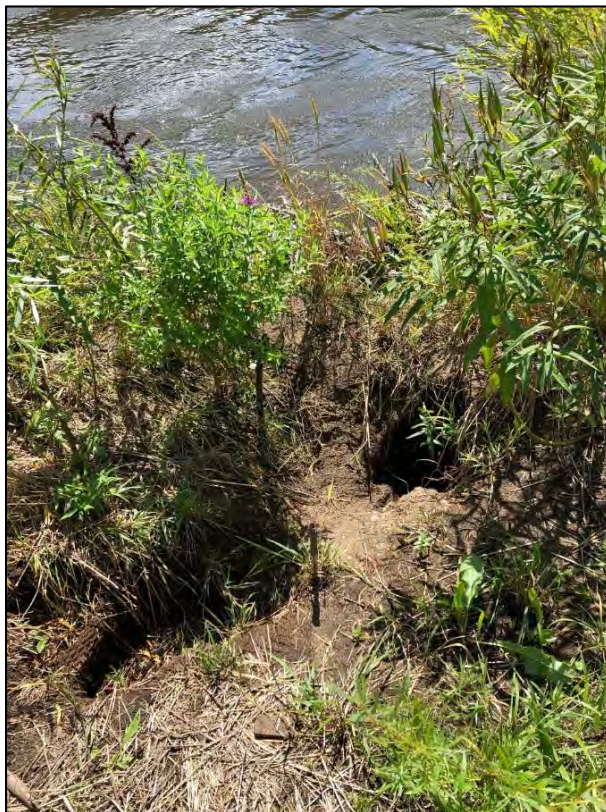
Photo 9: BRSA 4 bank repair area (repair completed July 2019), no live stakes were installed as part of the repair.

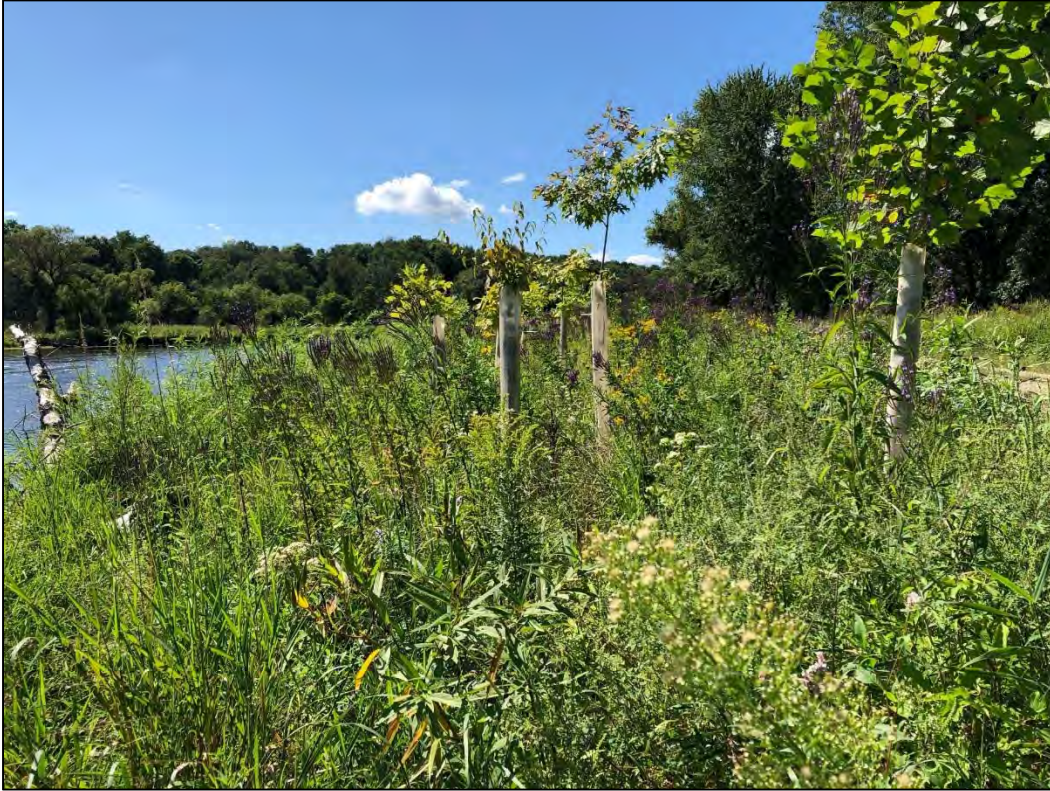
Photo 10: BRSA 4 area of erosion, approximately 25-50 feet upstream of July 2019 repairs.

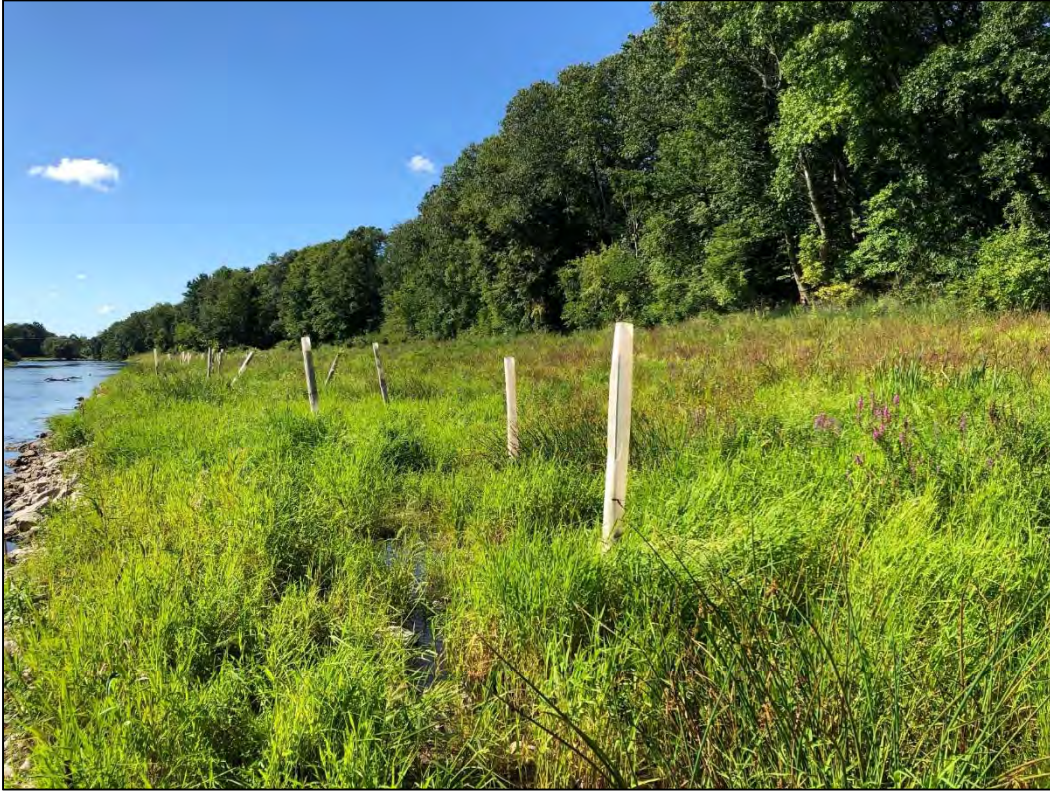
Photo 12: BRSA 6 bank repair area (repair completed July 2019).

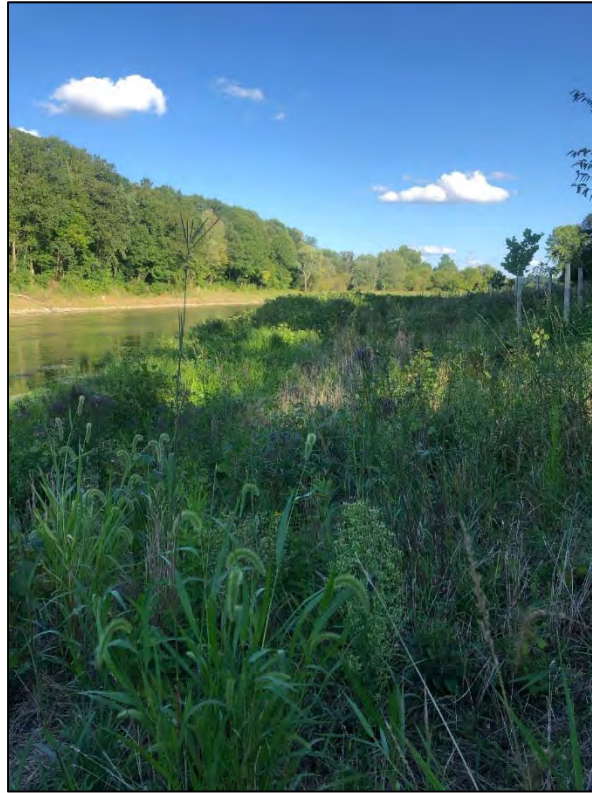
Photo 14: BRSA 7 bank repair area (repair completed July 2019).

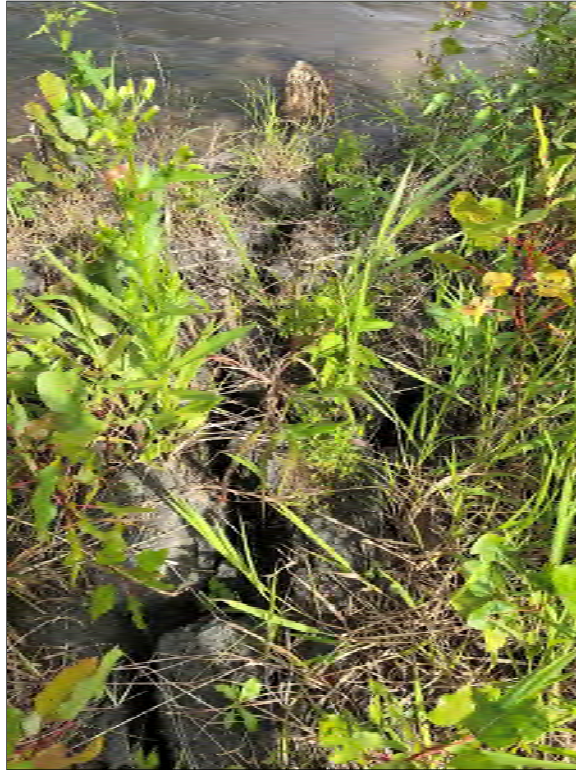
Photo 16: BRSA 8 area of minor erosion (Erosion Area 1).

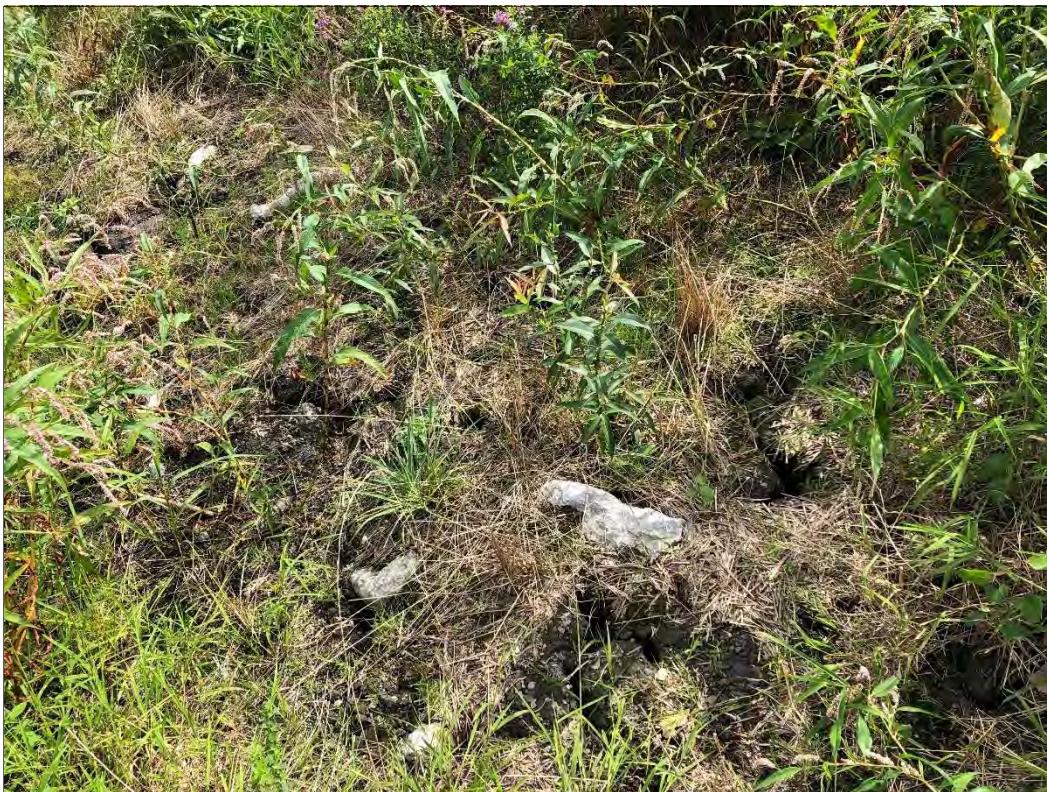
Photo 17: BRSA 8 second area of minor erosion (Erosion Area 2).

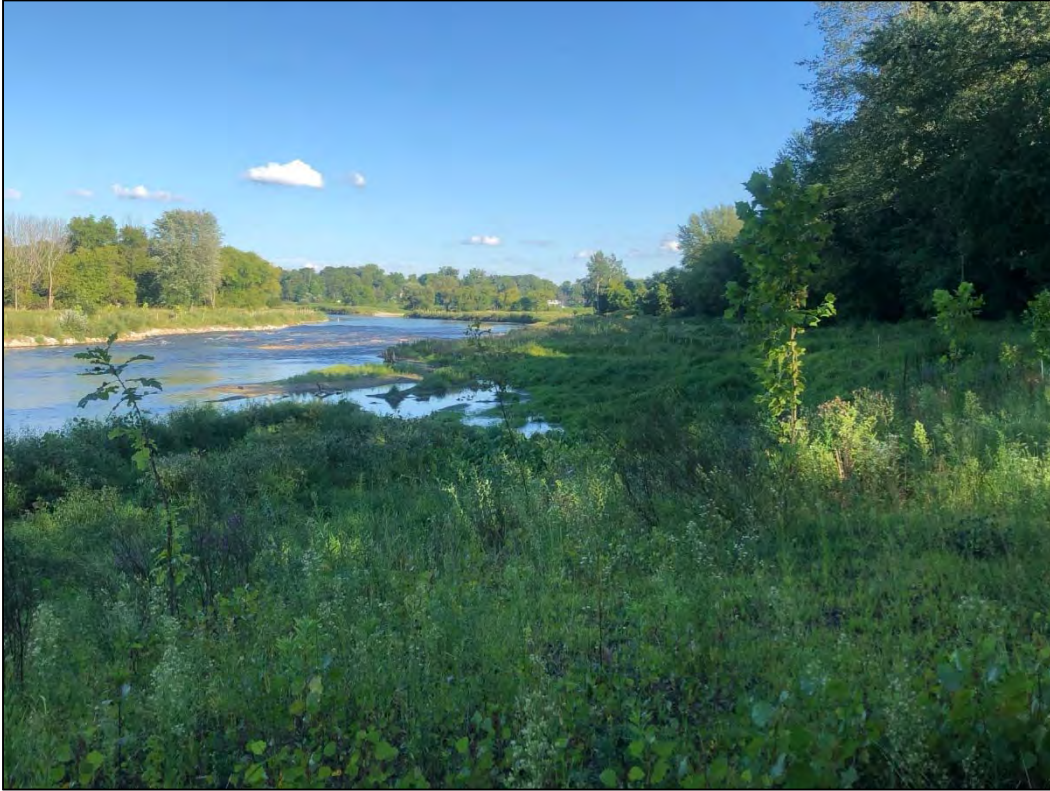
Photo 18: BRSA 8 third area of minor erosion (Erosion Area 3).

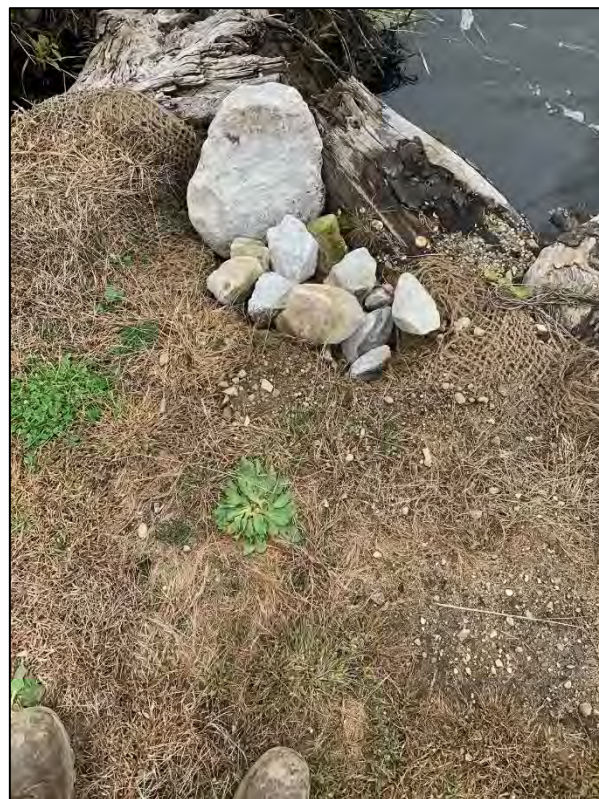
Photo 1A (Before): BRSA 1 near RS 50+00, along the right-descending bank (RDB) of the Pine Creek confluence. Void observed below coir fabric at rootwad/joint planting transition (May 2019).

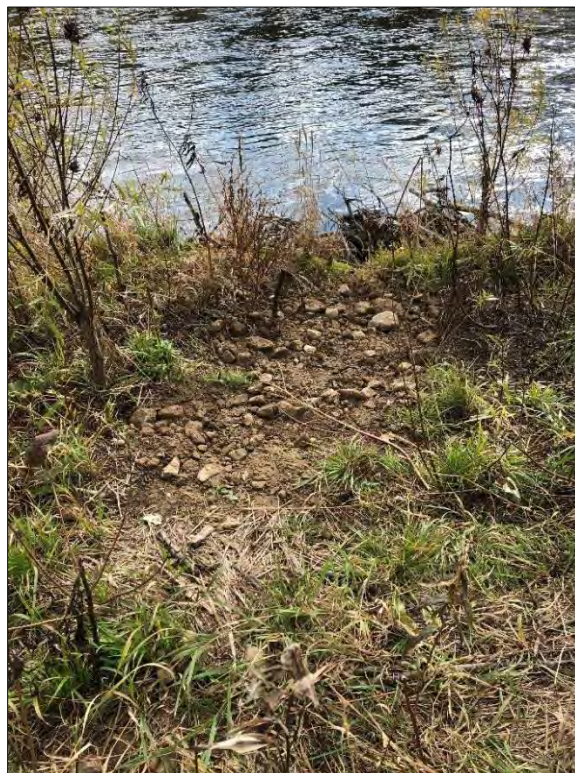
Photo 3A (Before): BRSA 4 near RS 71+50, area of erosion approximately 25-50 feet upstream of July 2019 repairs (August 2019).
