**Otsego Township Dam Area
Time Critical Removal Action**

**DRAFT
Final Maintenance and Monitoring Report**

Prepared by:
**Wood Environment & Infrastructure Solutions, Inc.
Novi, Michigan**

November 15, 2019

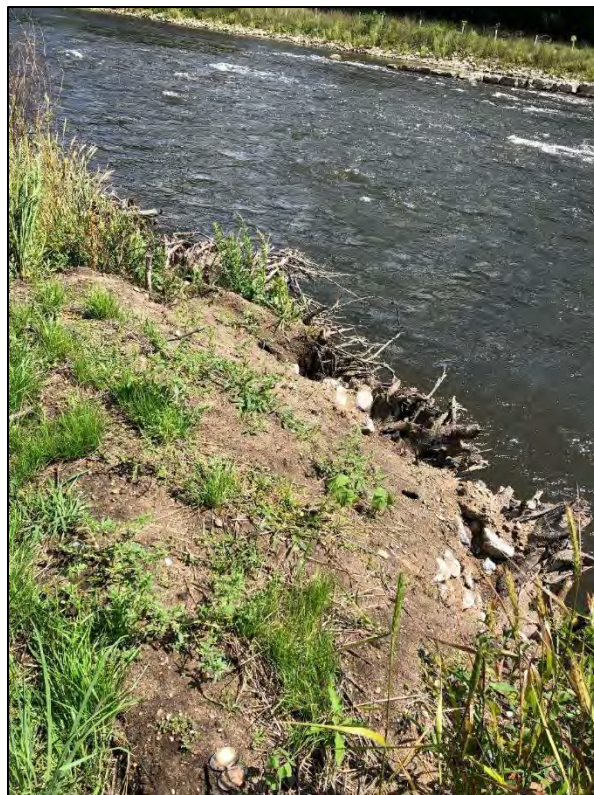
Photo 4A (Before): BRSA 4 near RS 86+00, area of sloughing observed across from BRSA 3 J-hooks during Q1 through Q3 Inspections (May 2019).

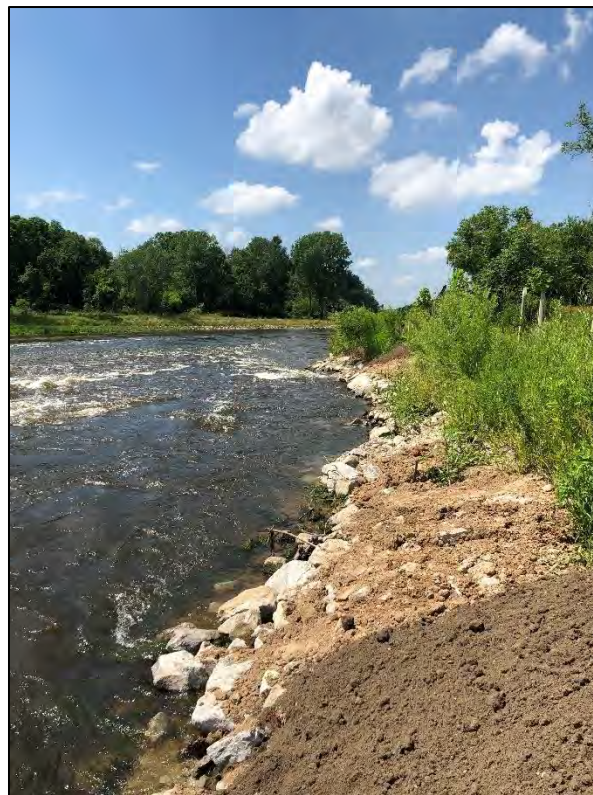
Photo5A (Before): BRSA 6 near RS 38+50, bank scour along approximately 75-100 linear feet (LF) of bank (May 2019).

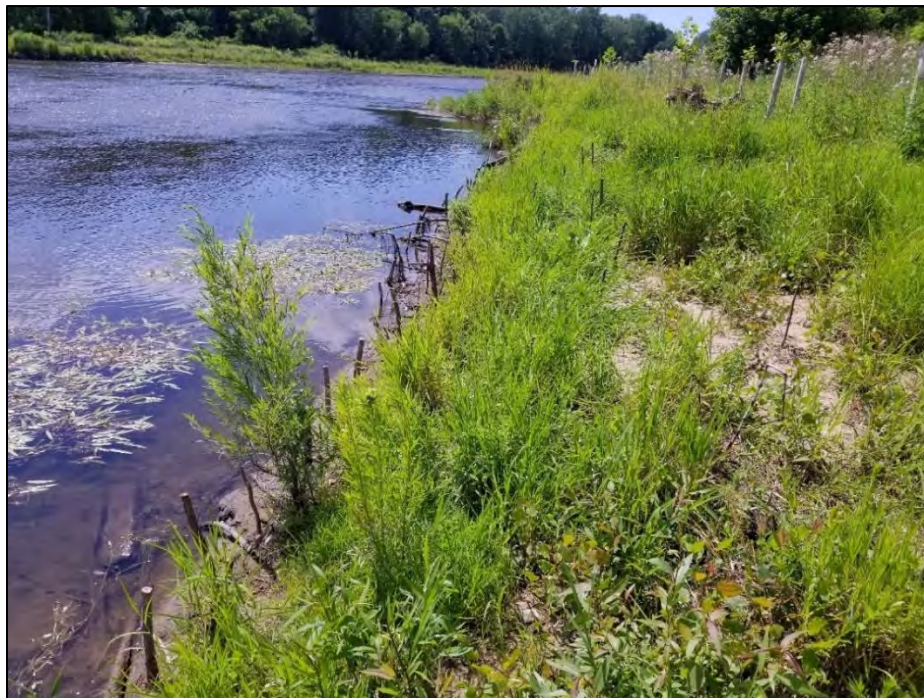
Photo 6A (Before): BRSA 6 near RS 48+00, area of low-growth on live stakes along approximately 50 LF (May 2019).

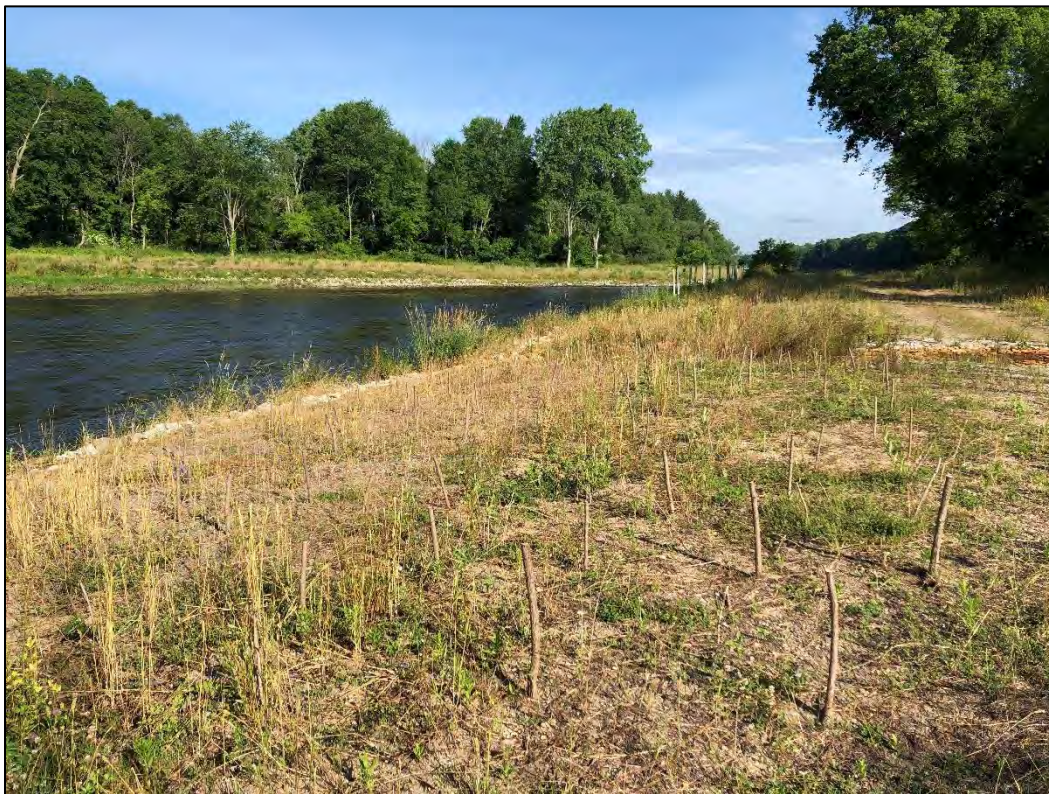
Photo 7A (Before): BRSA 6 near RS 37+00 (oxbow discharge area), live stakes not showing signs of growth (May 2019).

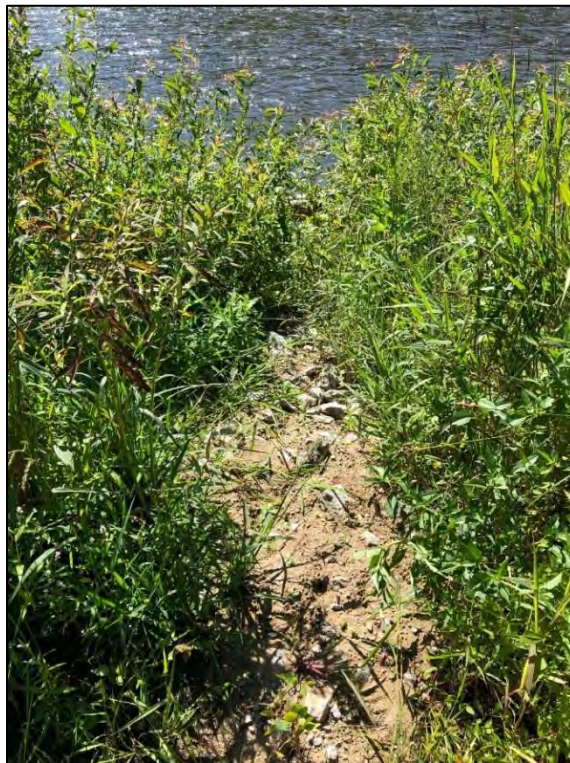
Photo 8A (Before): BRSA 7 near RS 29+50, upland water cutting into bank (May 2019).

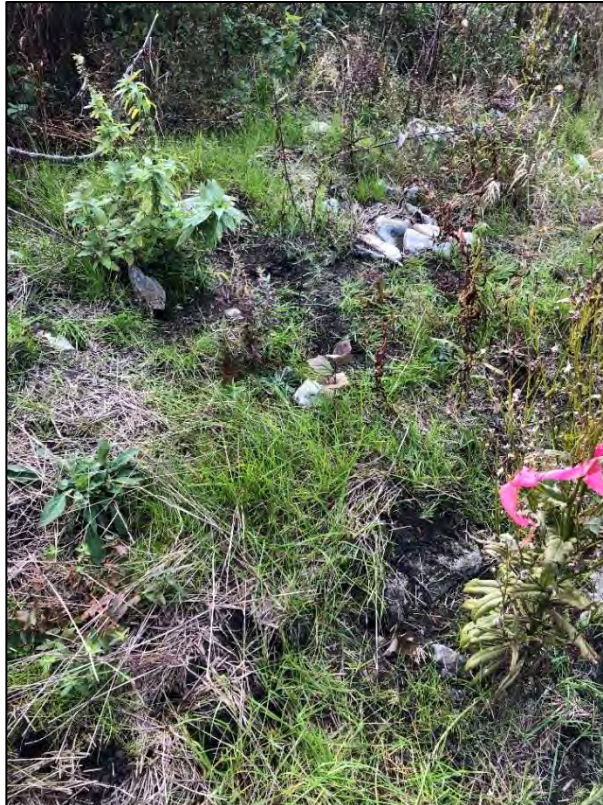
Photo 10A (Before): BRSA 8 near RS 7+00, area of minor erosion (Erosion Area 1, August 2019).

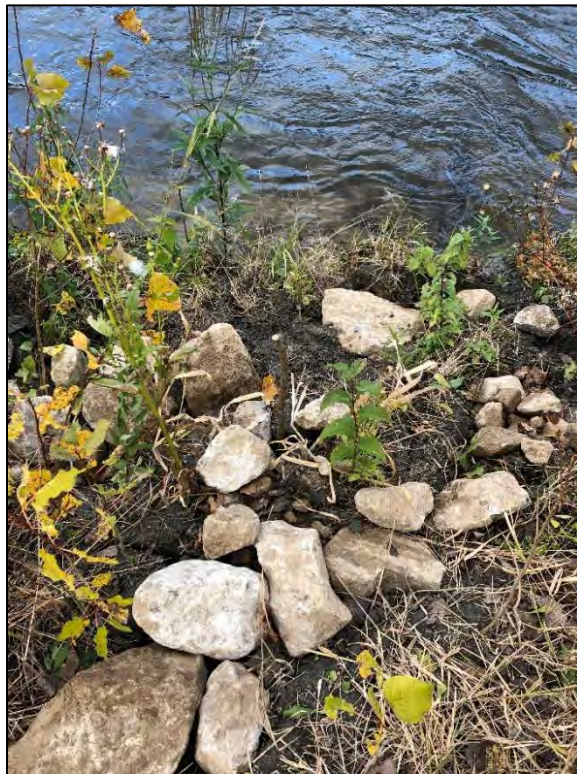
Photo 11A (Before): BRSA 8 near RS 30+50, second area of minor erosion (Erosion Area 2, August 2019).

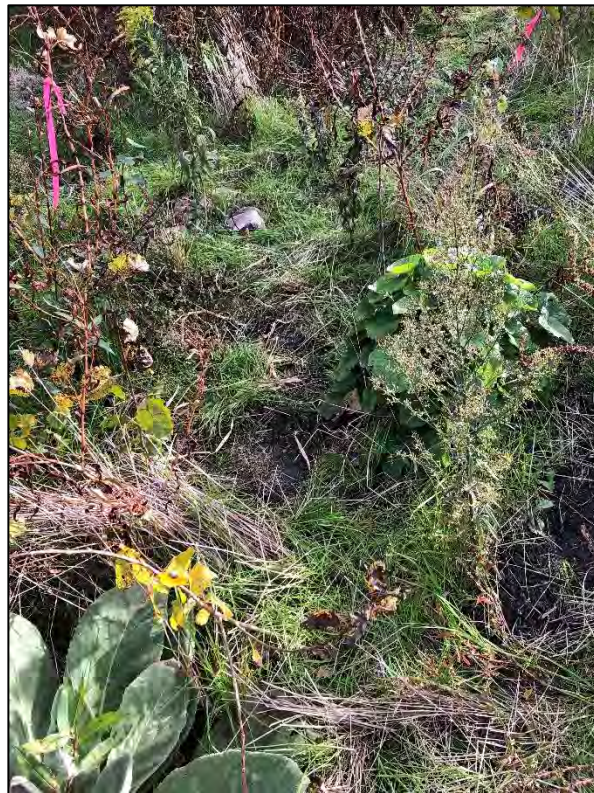
Photo 12A (Before): BRSA 8 near RS 7+00, third area of minor erosion (Erosion Area 3, August 2019).

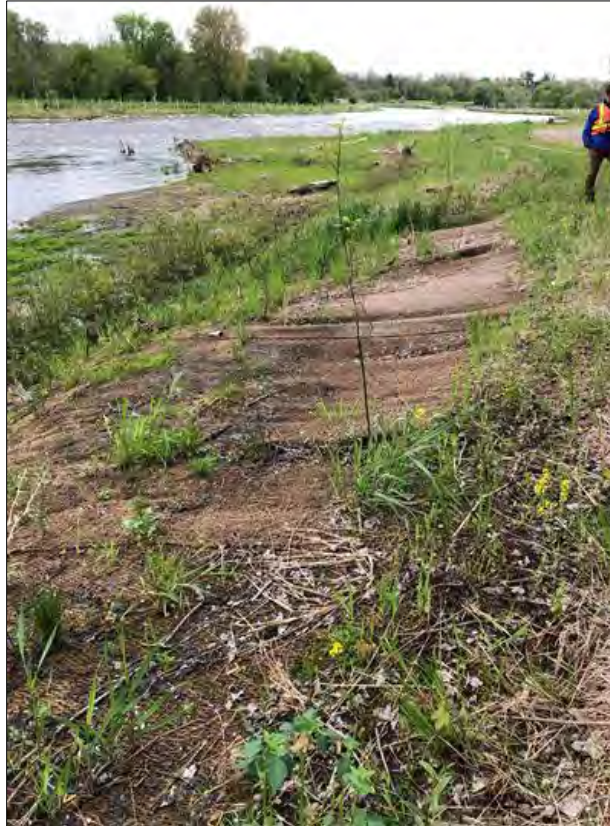
Photo 14: BRSA 8 near RS 32+00, erosion observed during October 2019 repairs. Repaired at the request of MDNR by installing riprap, common fill, topsoil, seed, and live stakes (October 2019).

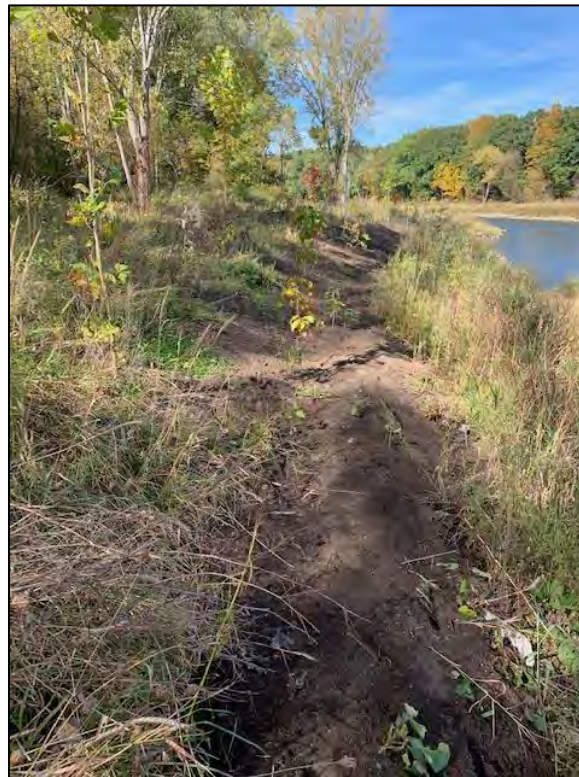
Photo 16A (Before): BRSA 9 near RS 34+00, void observed beneath approximately 150 to 200 LF of coir fabric (August 2019).
